COMPREHENSIVE DISTRICT-WIDE MOBILITY STUDY

*An evaluation of pavement condition, pedestrian accessibility,
cut-through traffic, and markings within the Montrose District*

WALTER P MOORE

February 2012

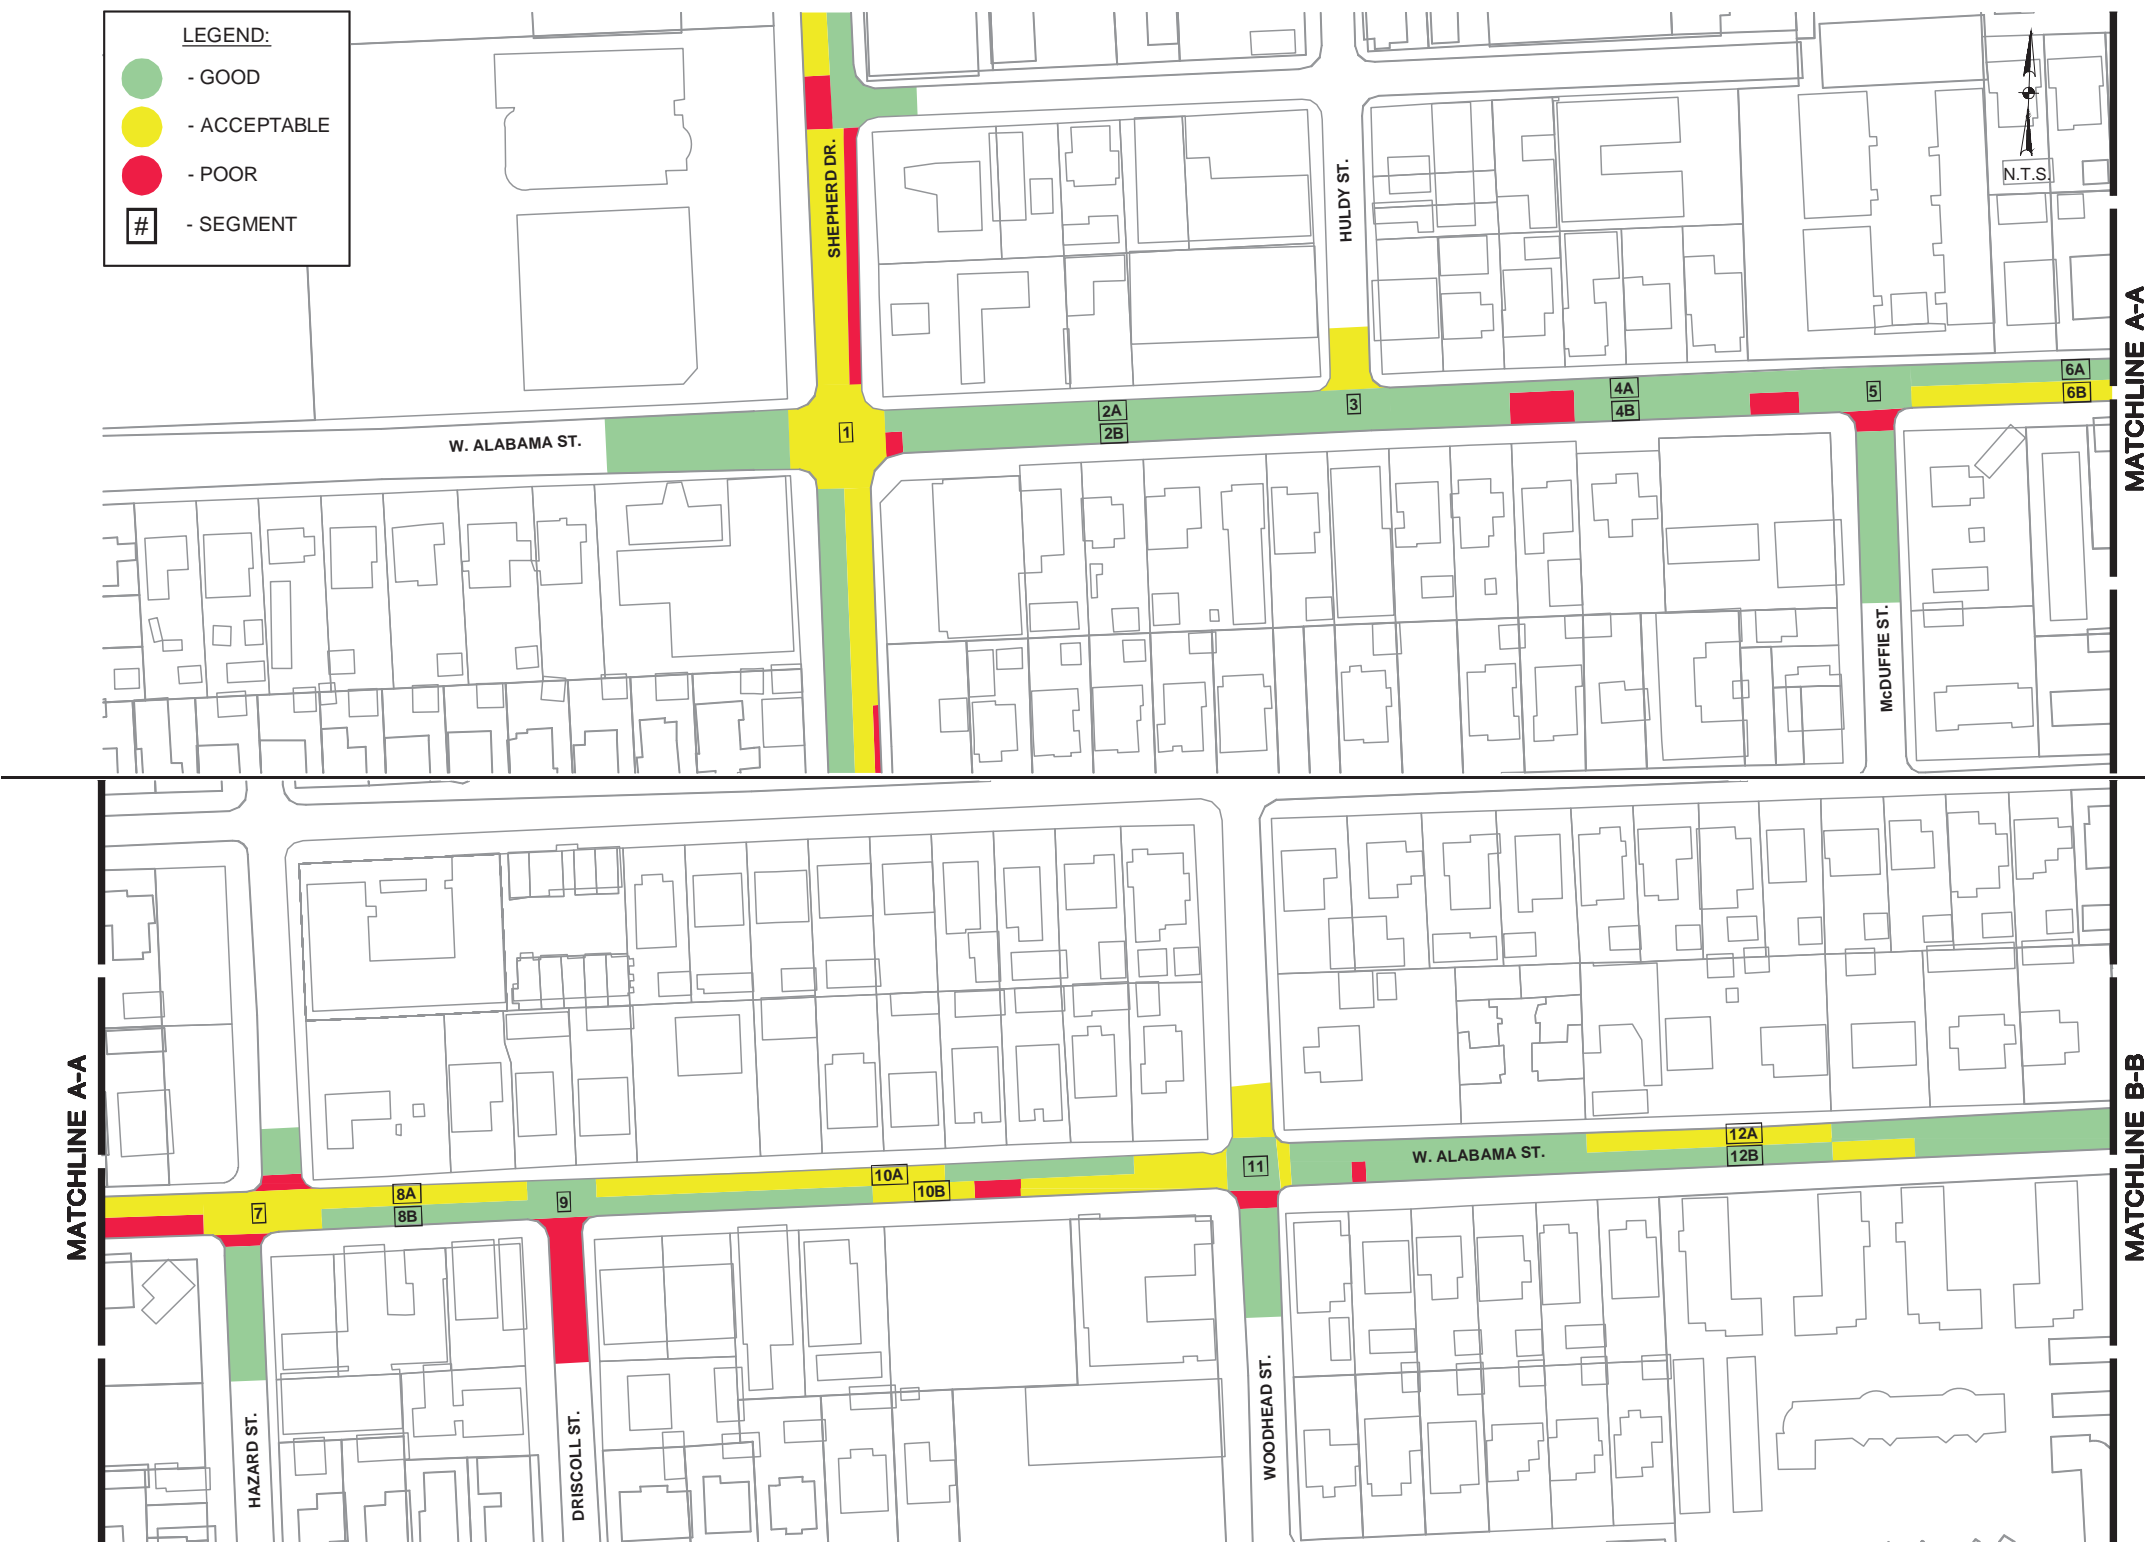
Photo 6-4, Segment 12B
W. Alabama between Woodhead and Dunlavy
A section of the roadway has sunken, creating a pothole.

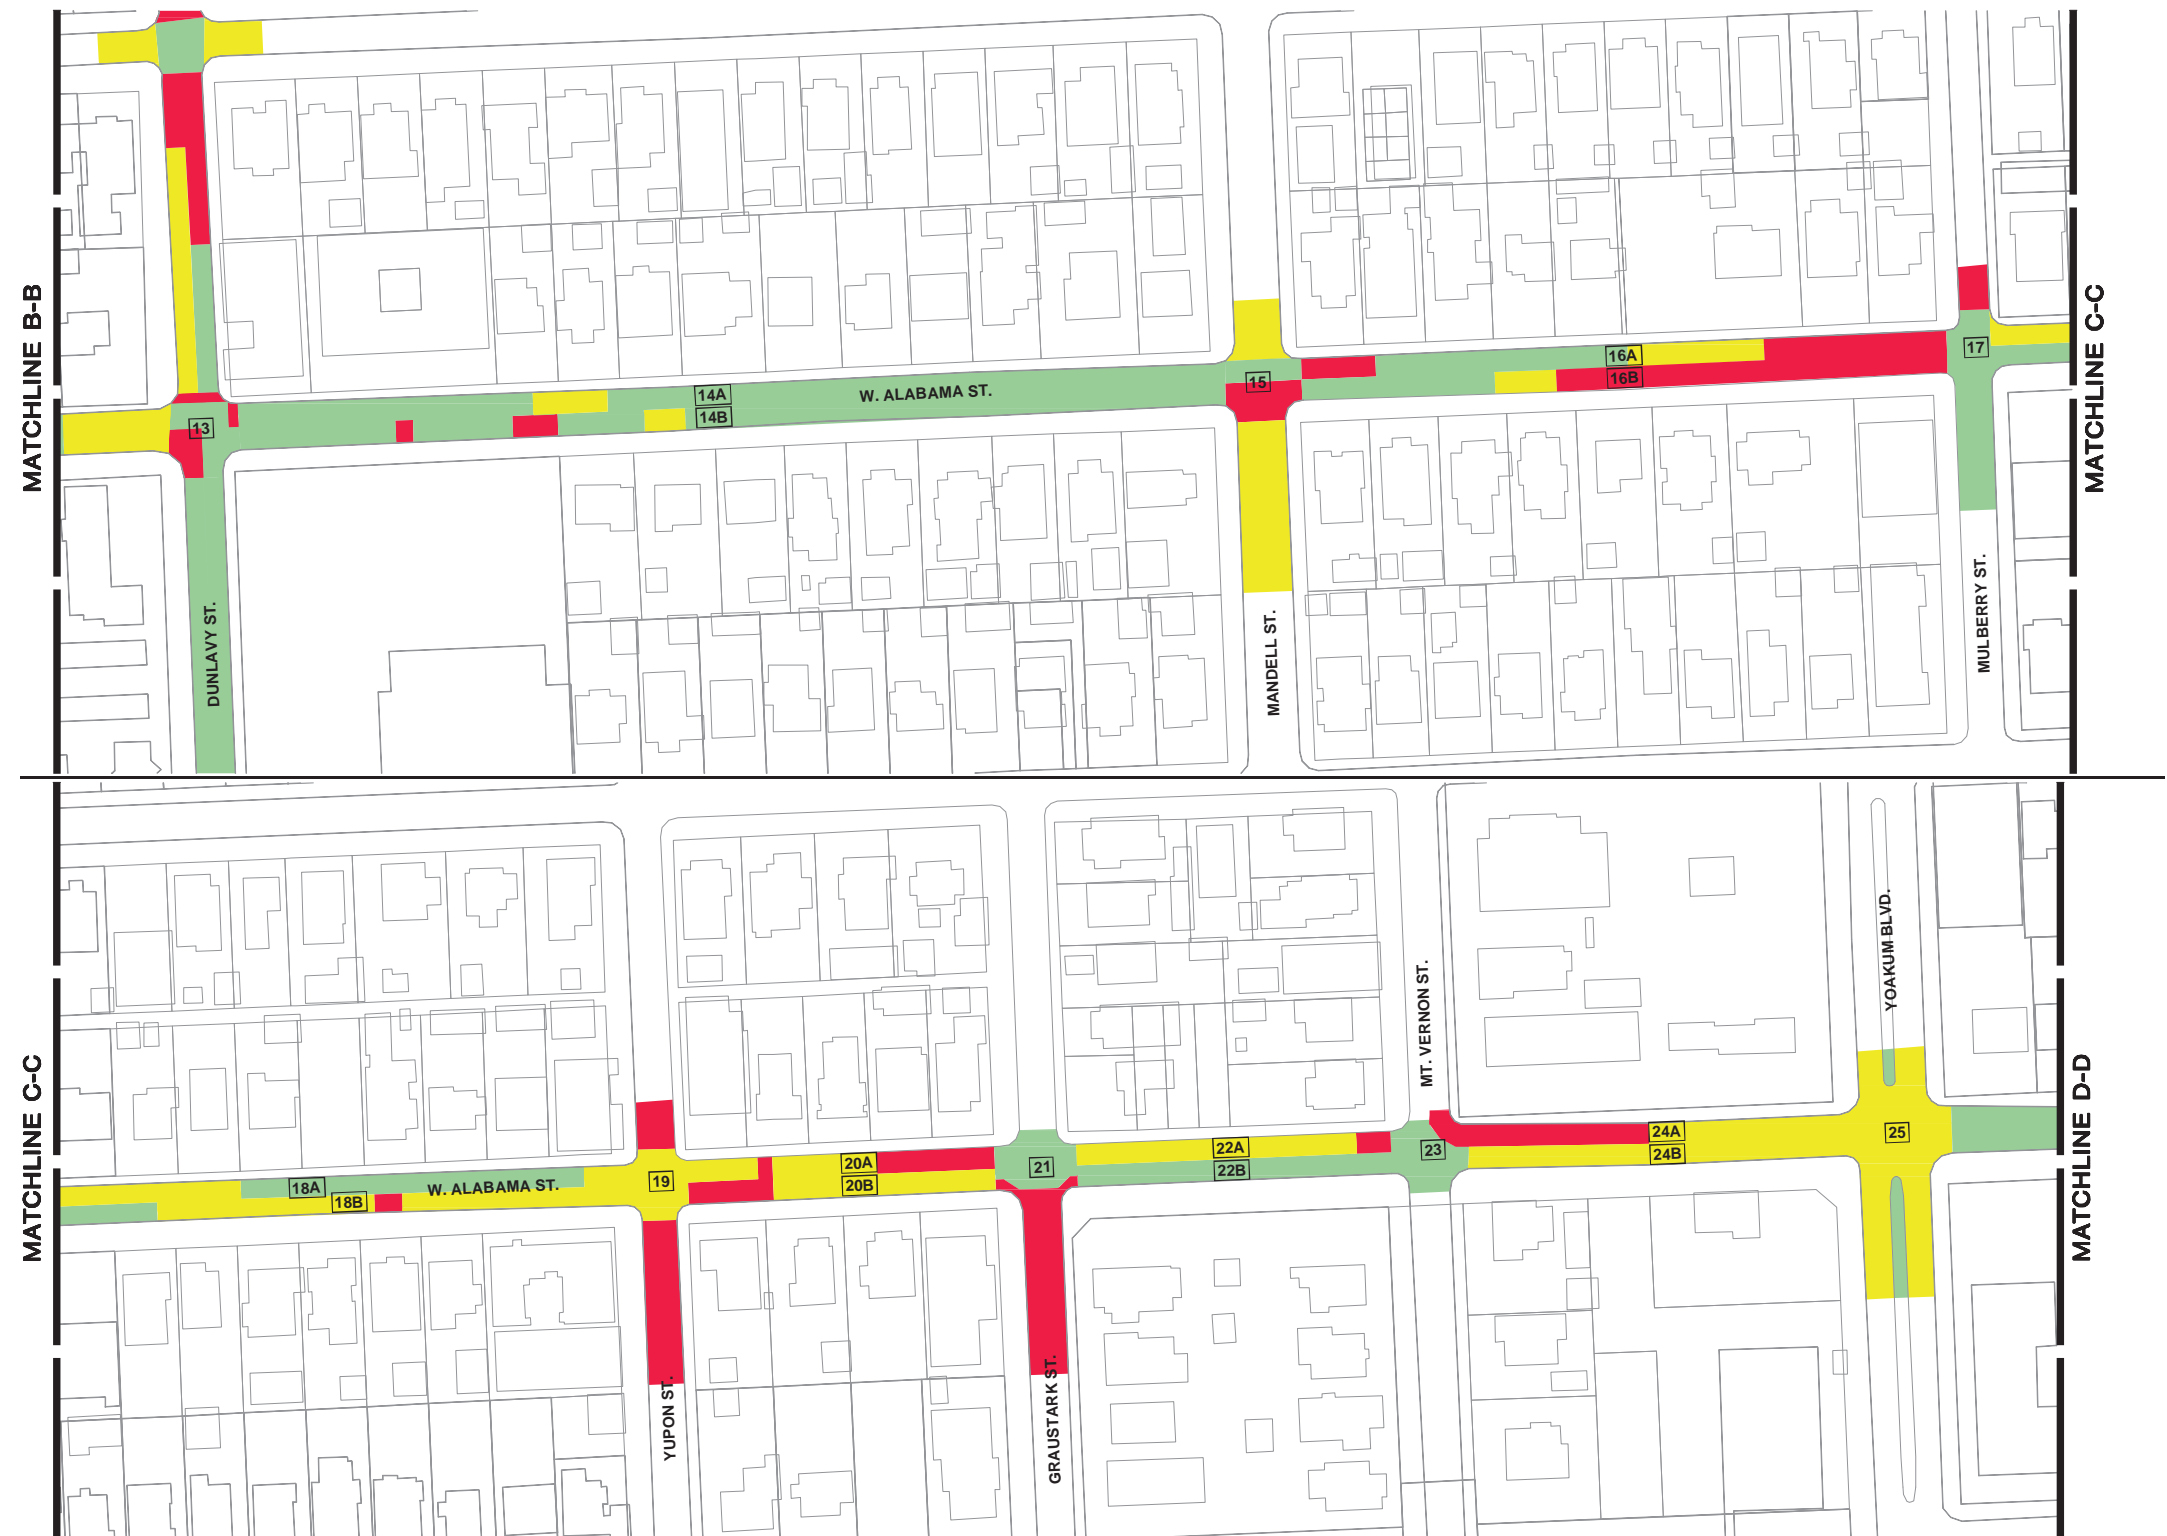
Photo 6-6, Segment 16A
W. Alabama between Mandell and Mulberry
 There is a drop in the elevation of the pavement near the curb. The pavement is also cracking from the related stress.

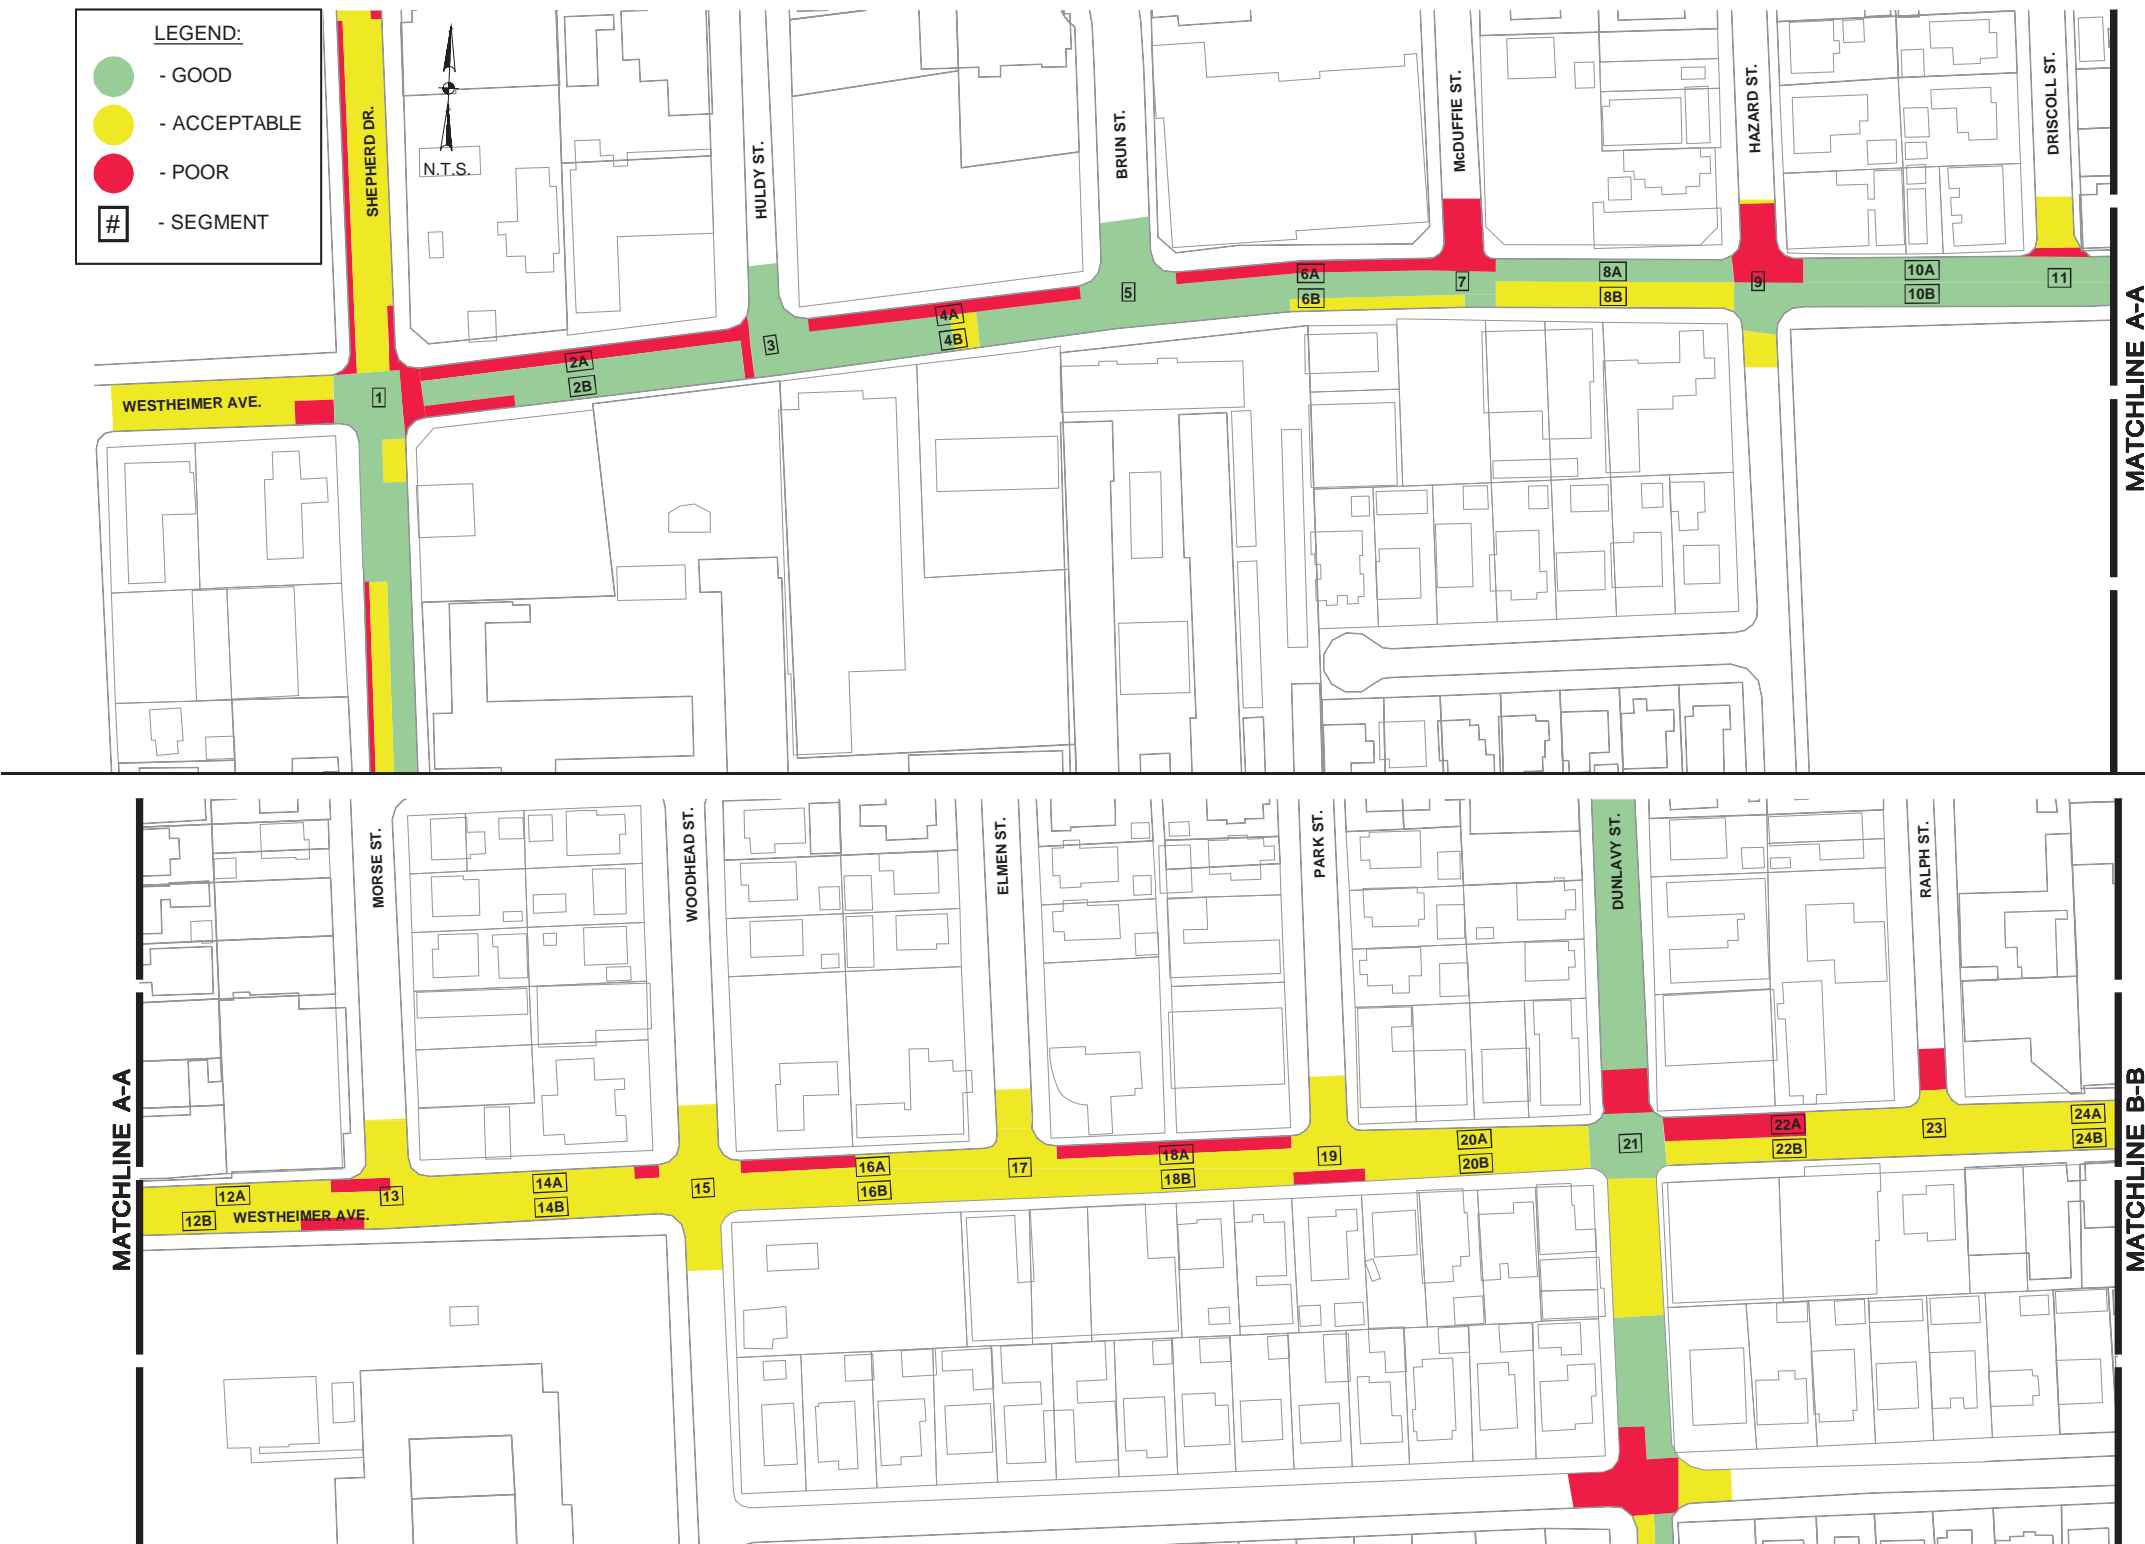
Photo 7-1, Segment 4B
Westheimer between Huldy and Brun
Patched pavement has settled close to the curb and created an uneven riding surface.

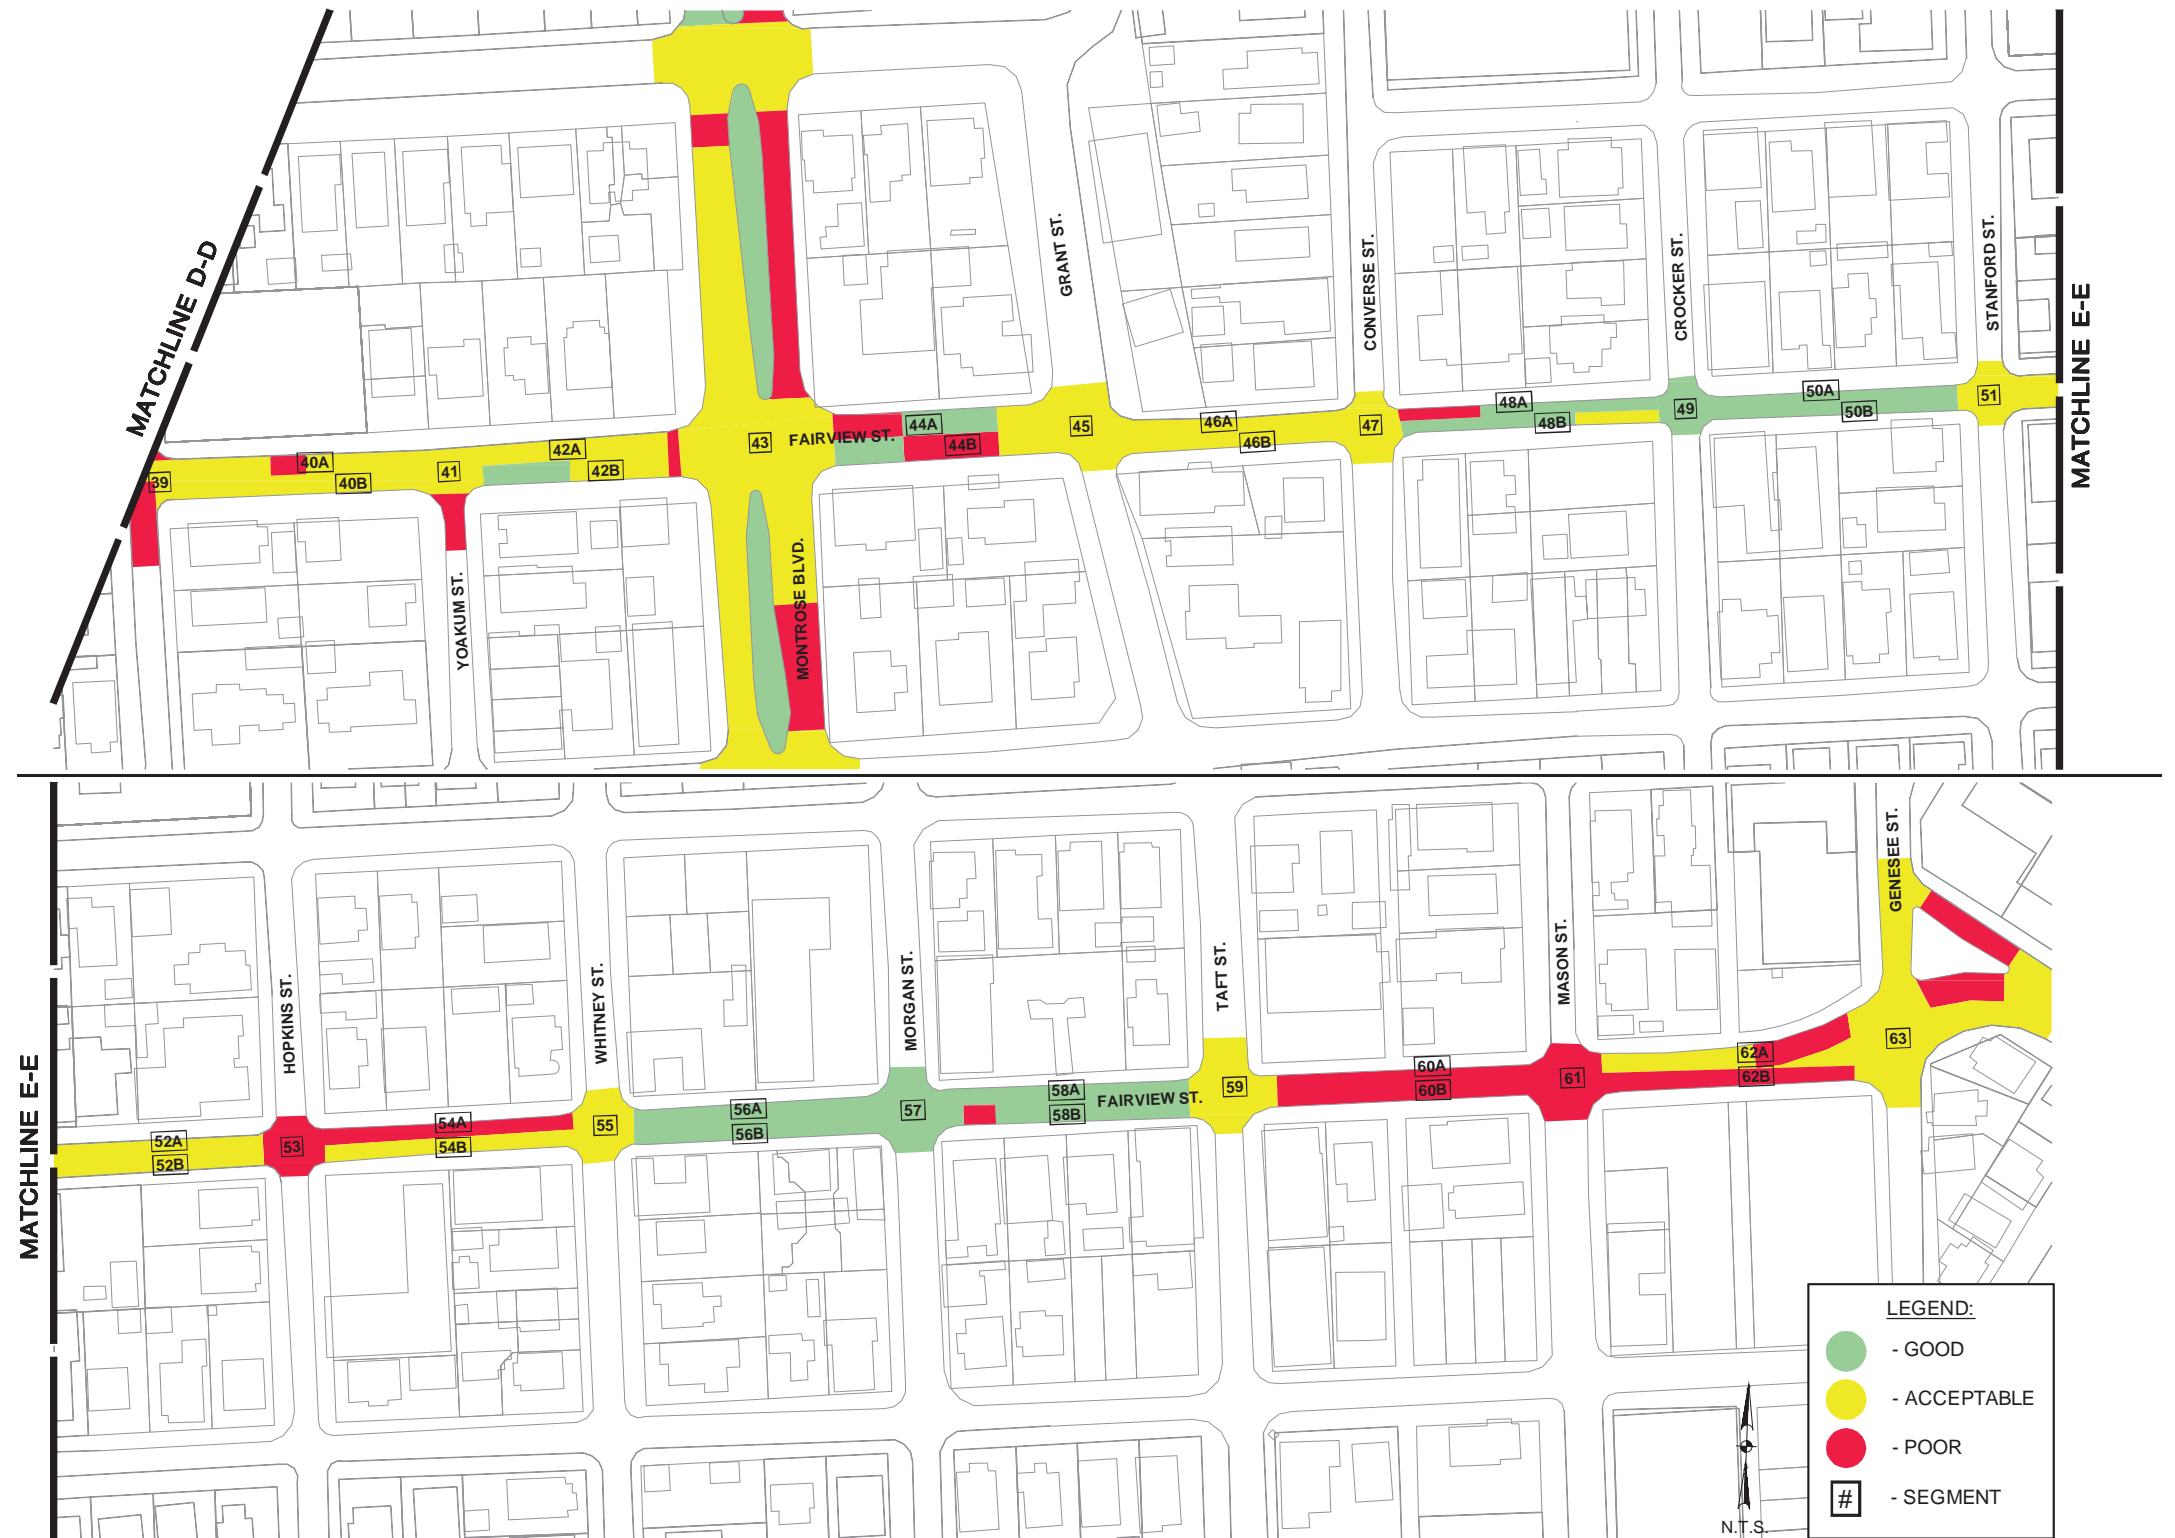
Photo 8-7, Segment 42B
Fairview between Yoakum and Montrose
 Roadway settling that has been previously patched is uneven with remaining roadway.

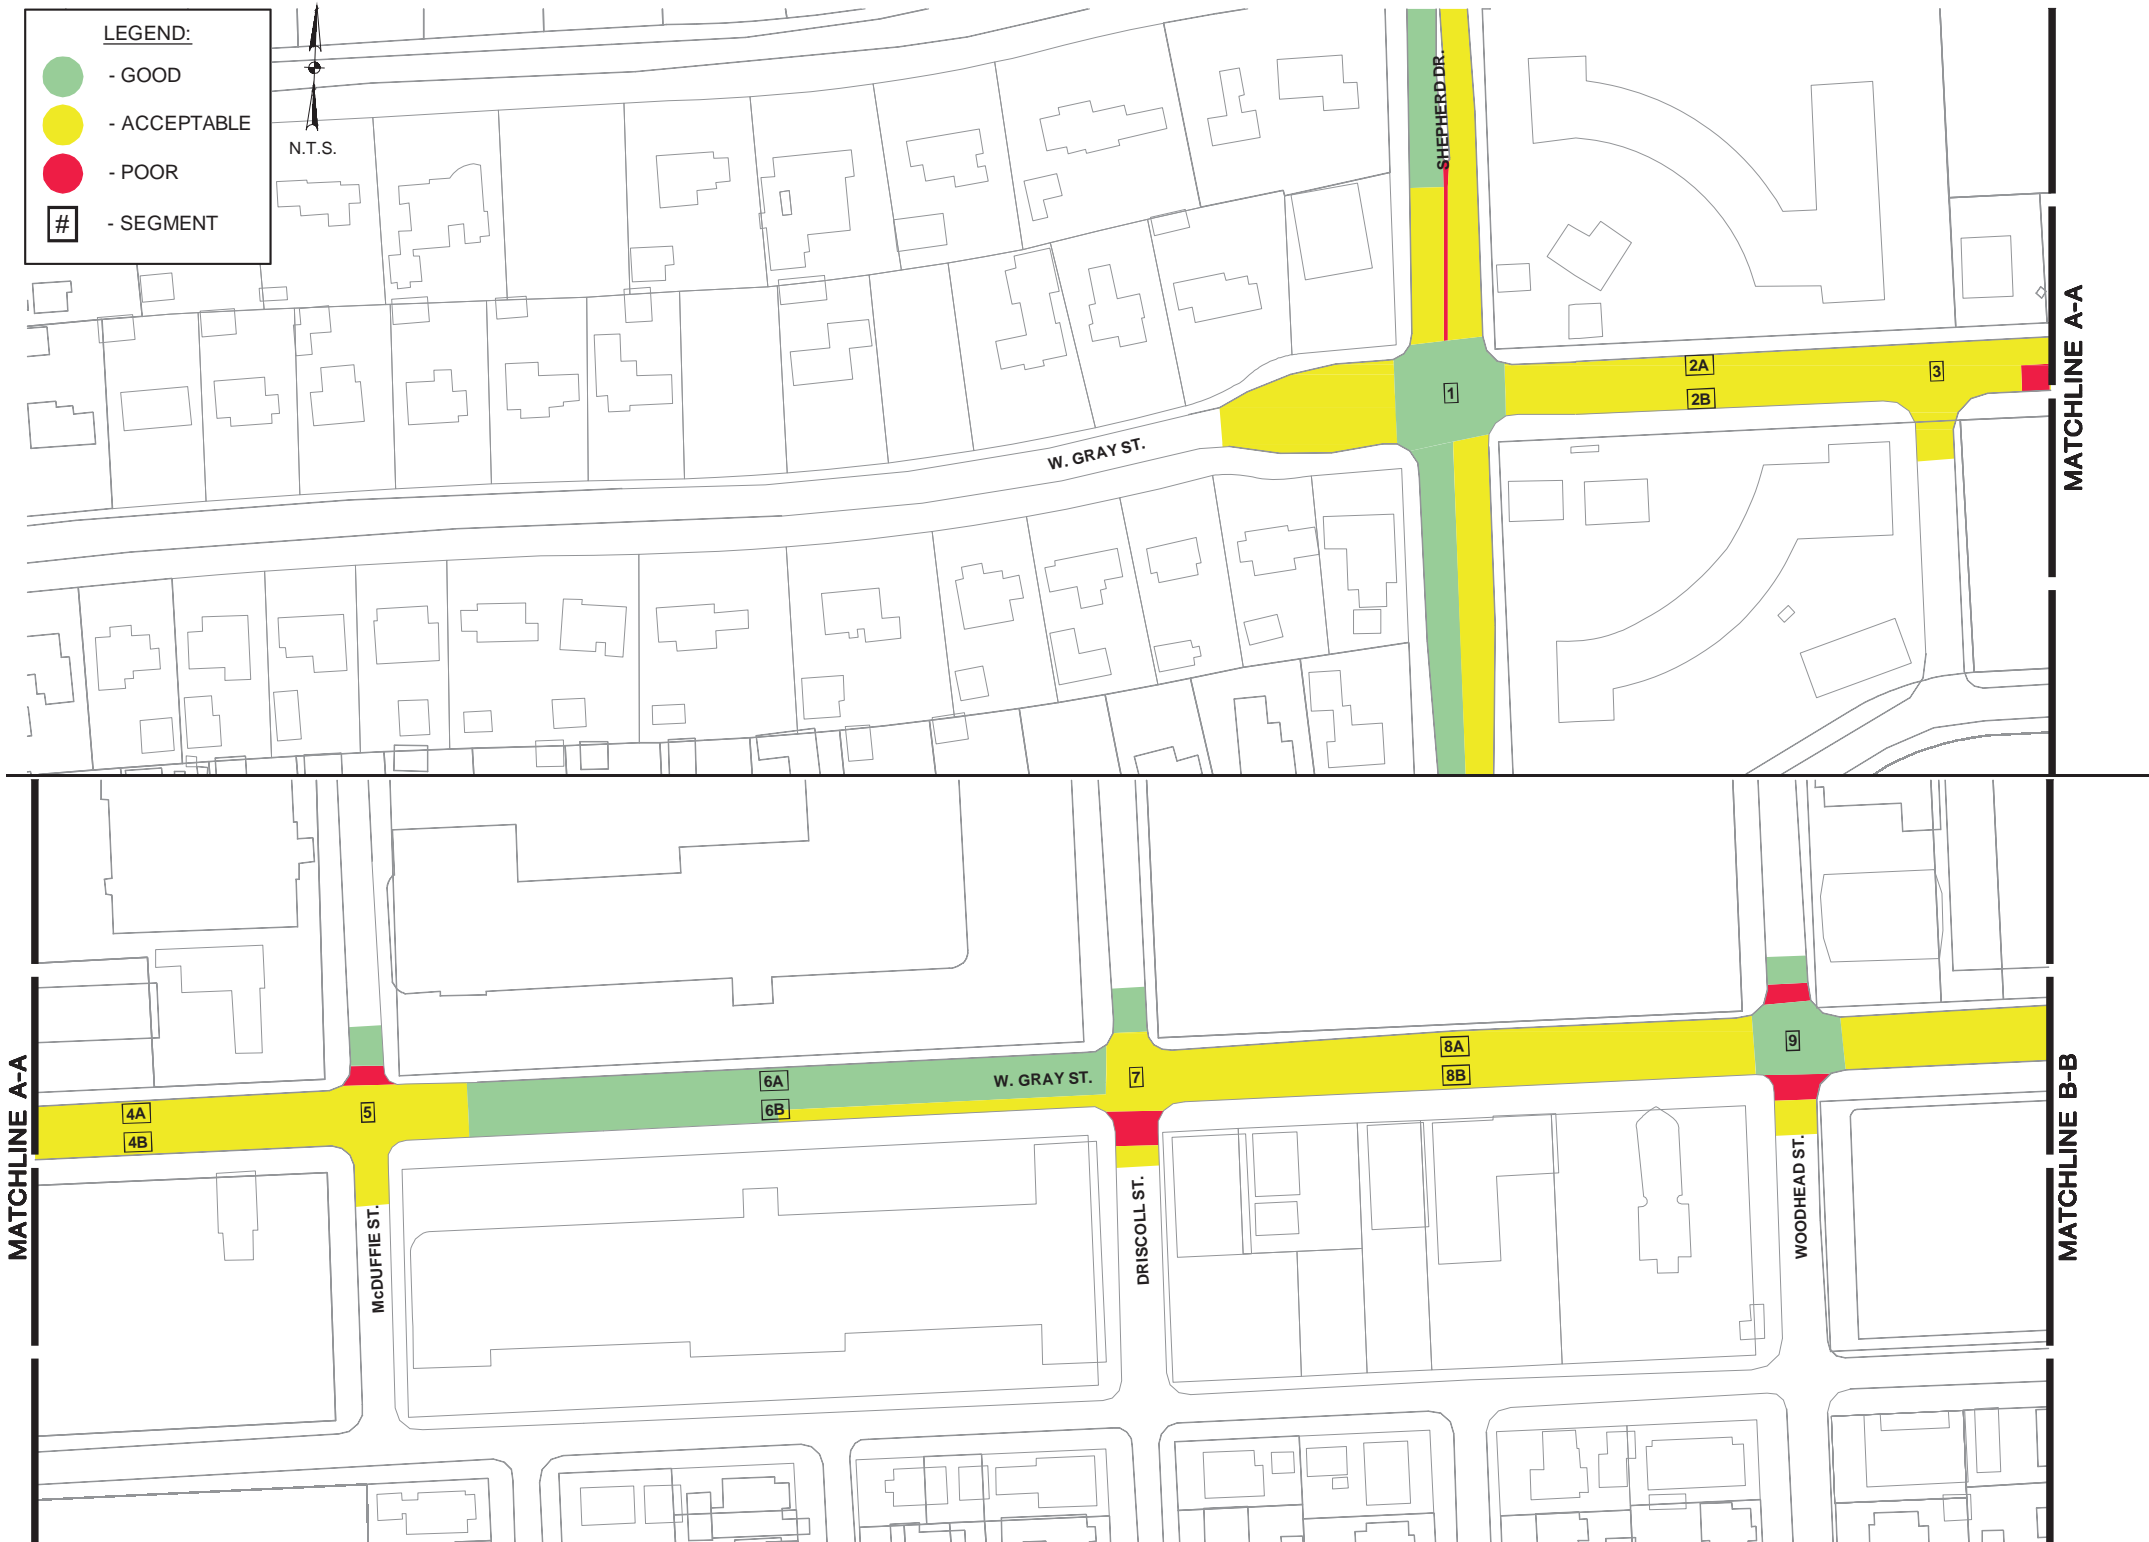
Photo 9-1, Segment 4B
W. Gray between Driveway and McDuffie
Pavement settling has created an uneven riding surface.

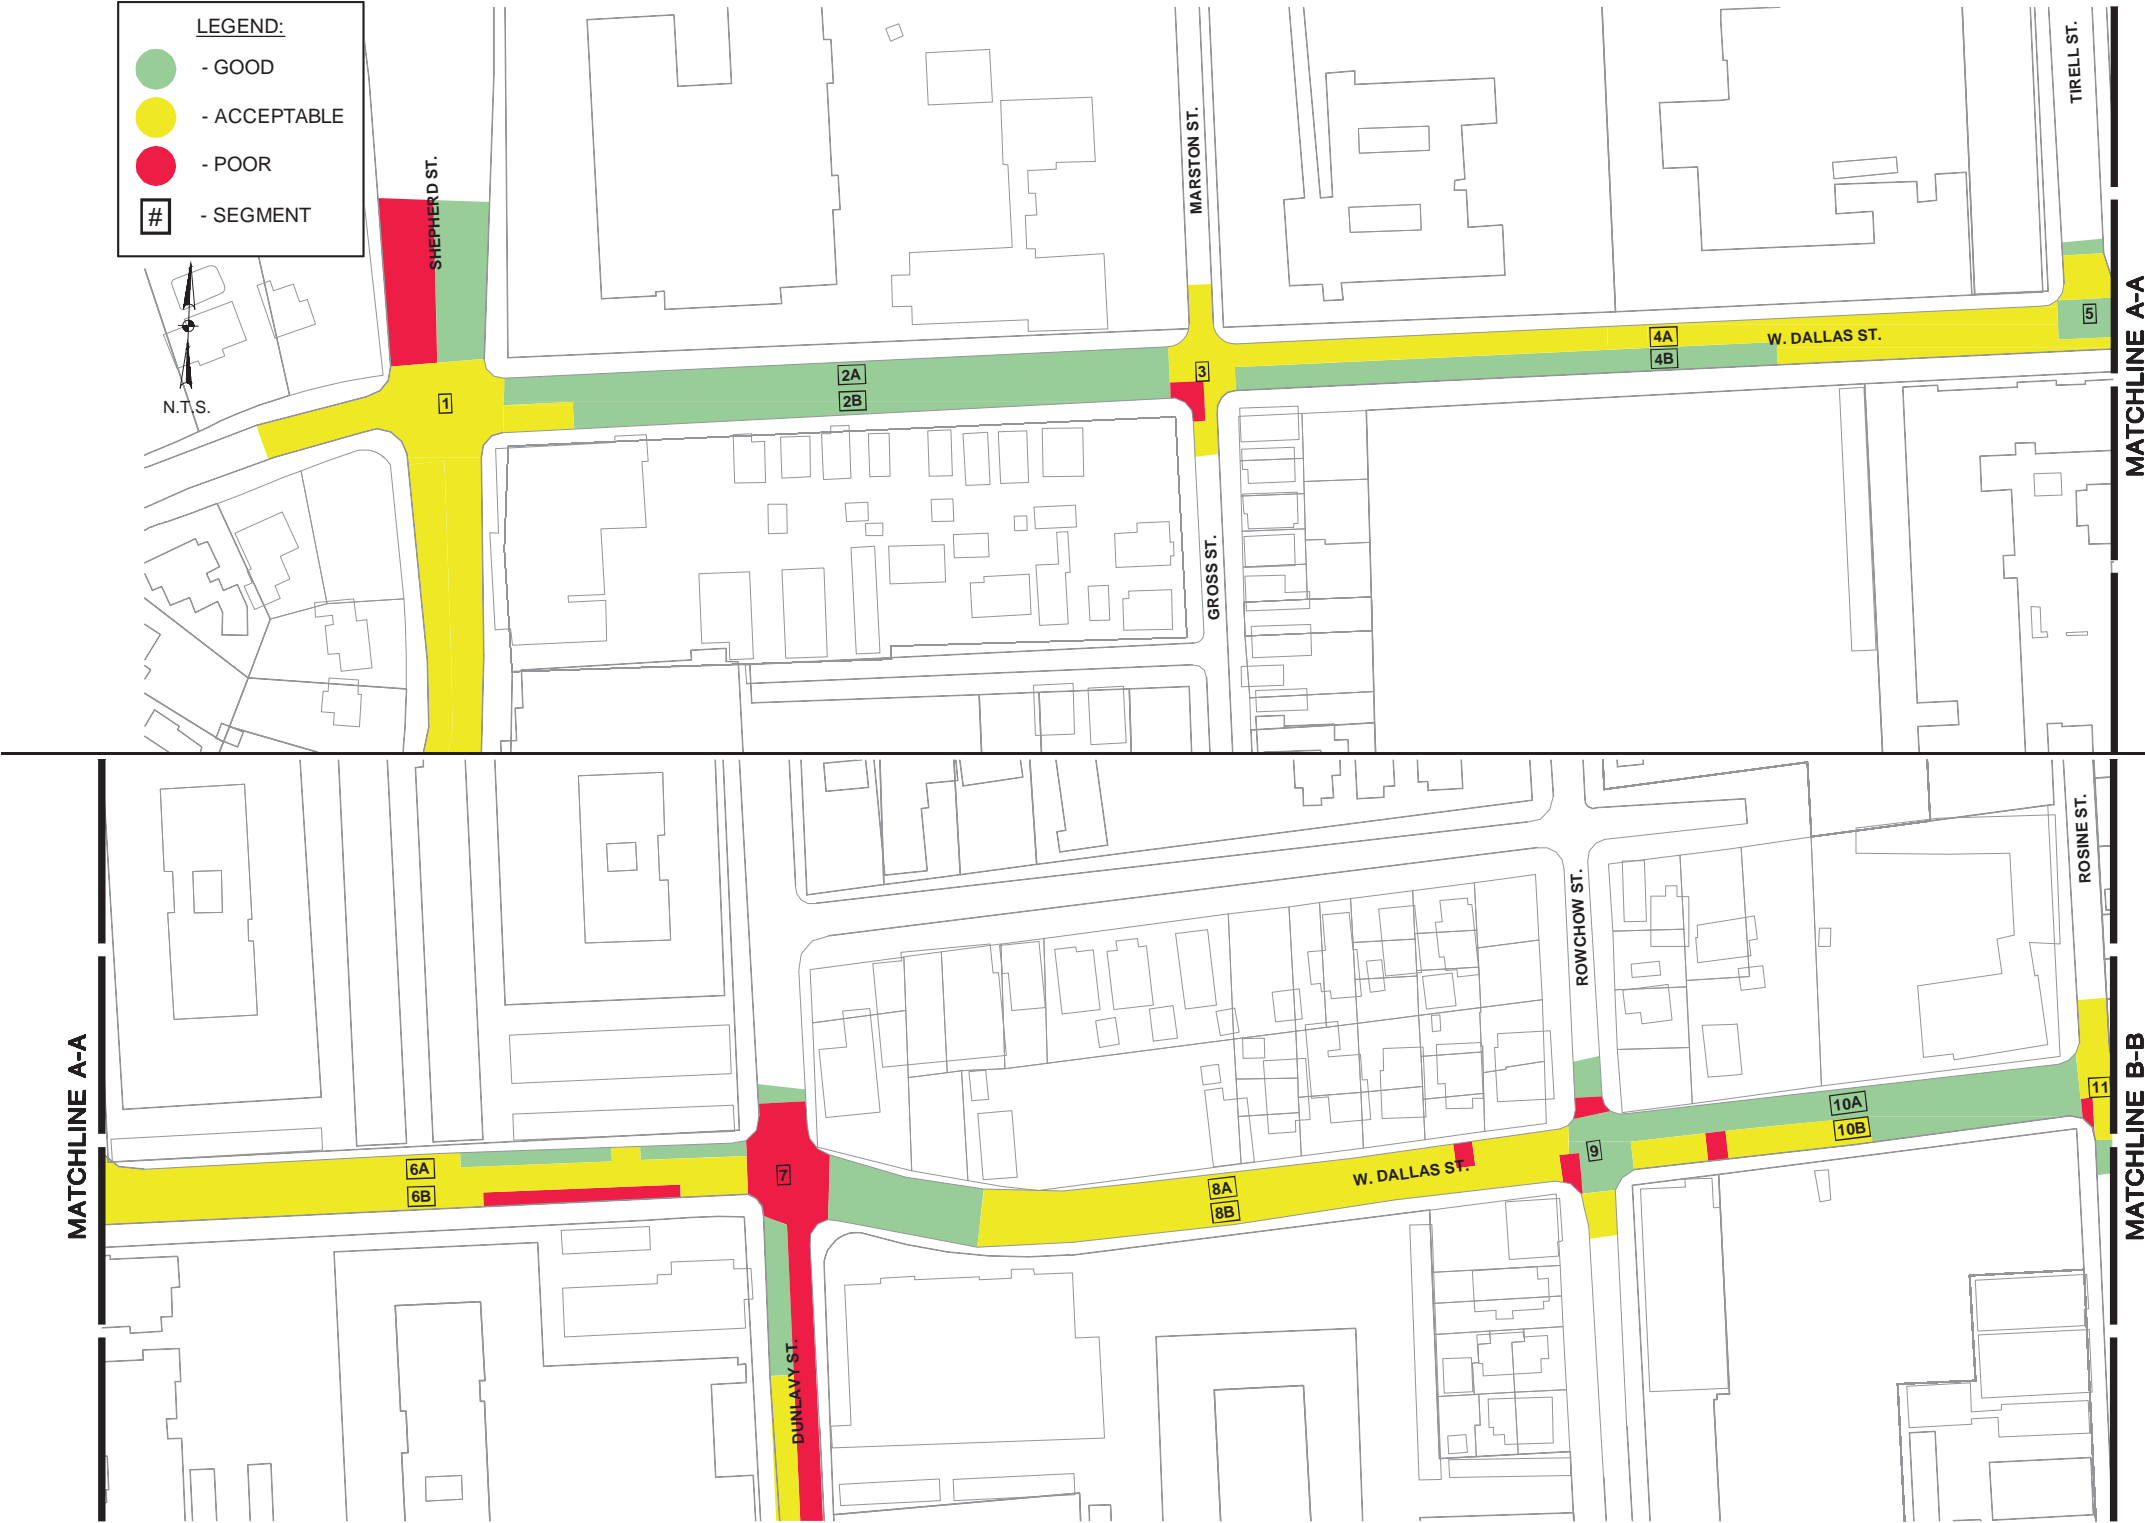
Photo 10-1, Segment 2A
W. Dallas between Shepherd and Gross
Pavement separation at joints

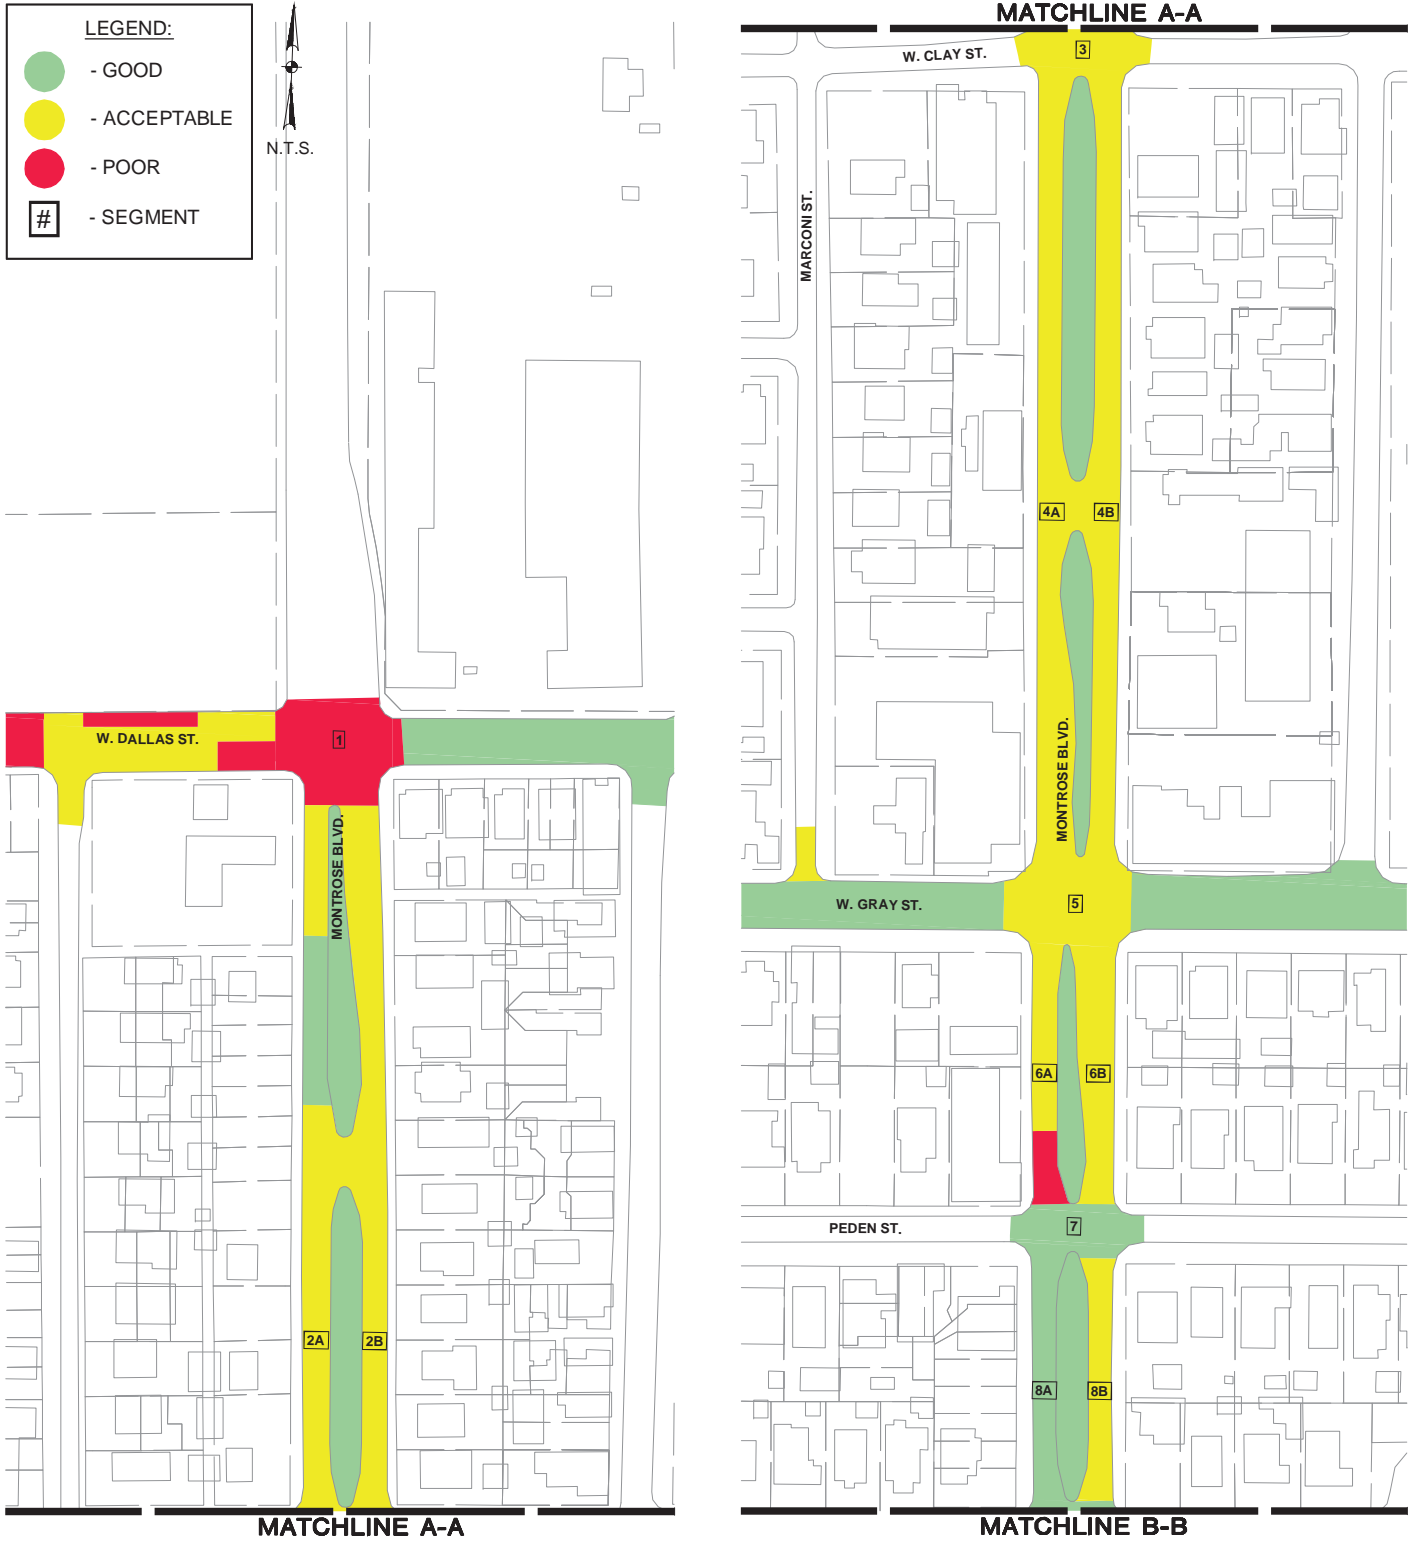
Photo 11-1, Segment 6A
Montrose between W. Gray and Peden
The concrete joint sealant has come out, there are cracks in the pavement, and patching is worn, creating an uneven riding surface.
