COMPREHENSIVE DISTRICT-WIDE MOBILITY STUDY

*An evaluation of pavement condition, pedestrian accessibility,
cut-through traffic, and markings within the Montrose District*

WALTER P MOORE

February 2012

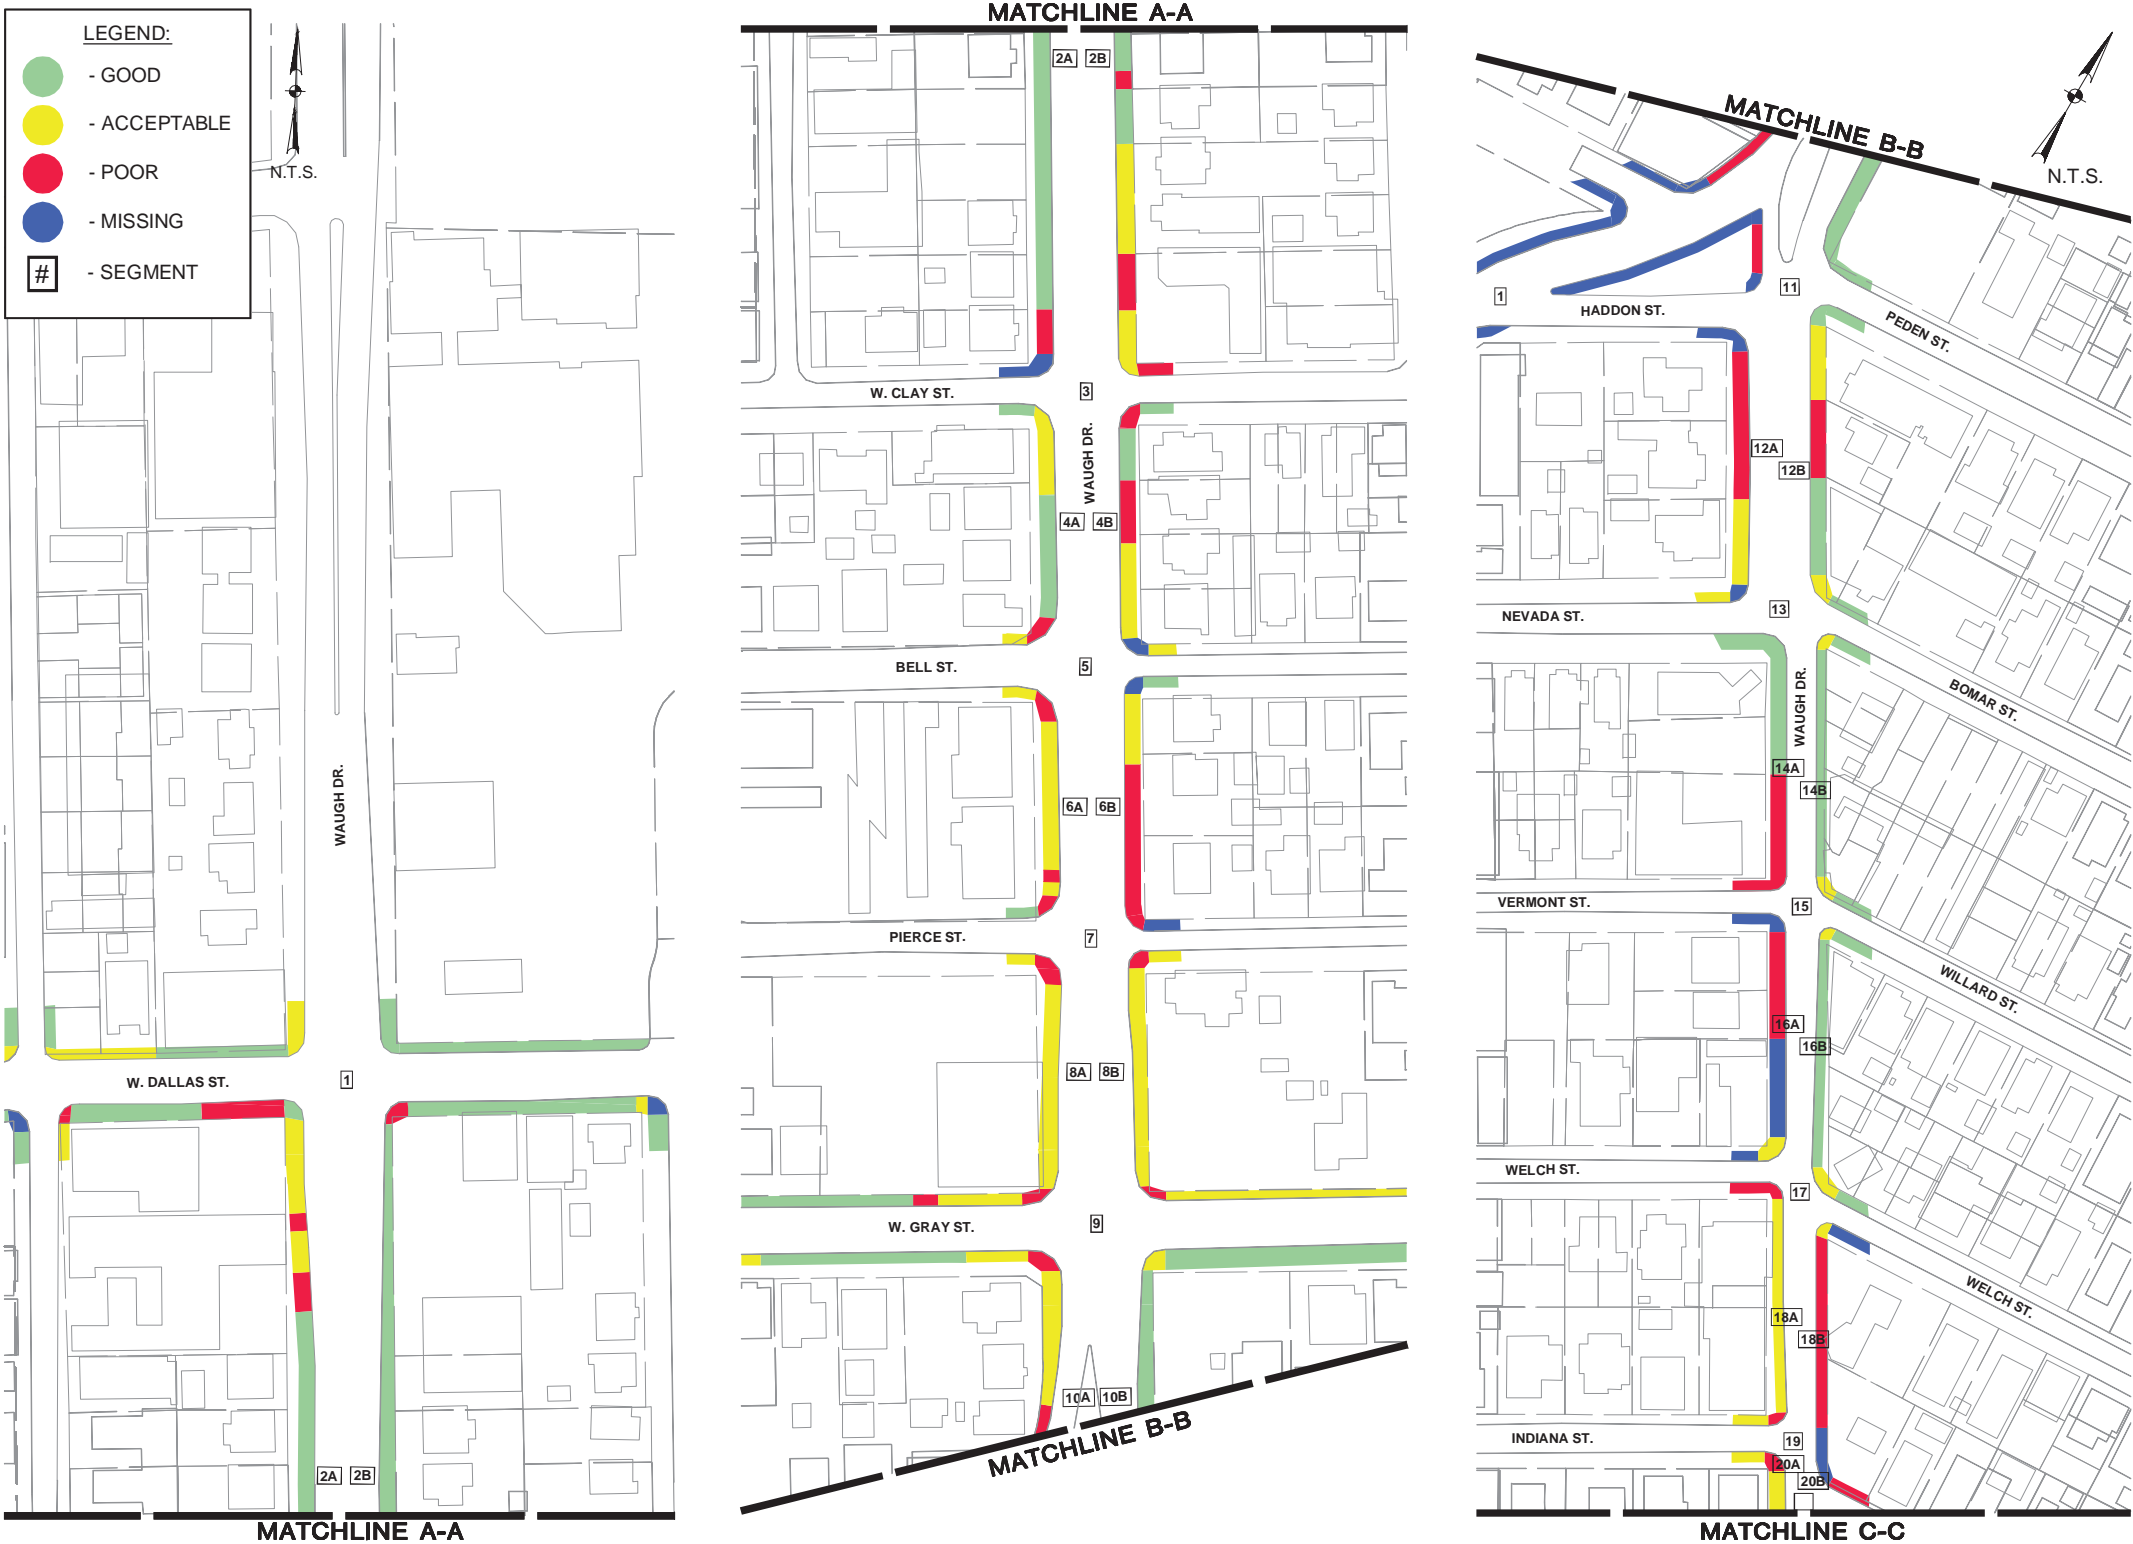
Photo 12-11, Segment 9
Waugh at W. Gray
 Broken ramp was patched with a steep grade. A section of pavement is missing

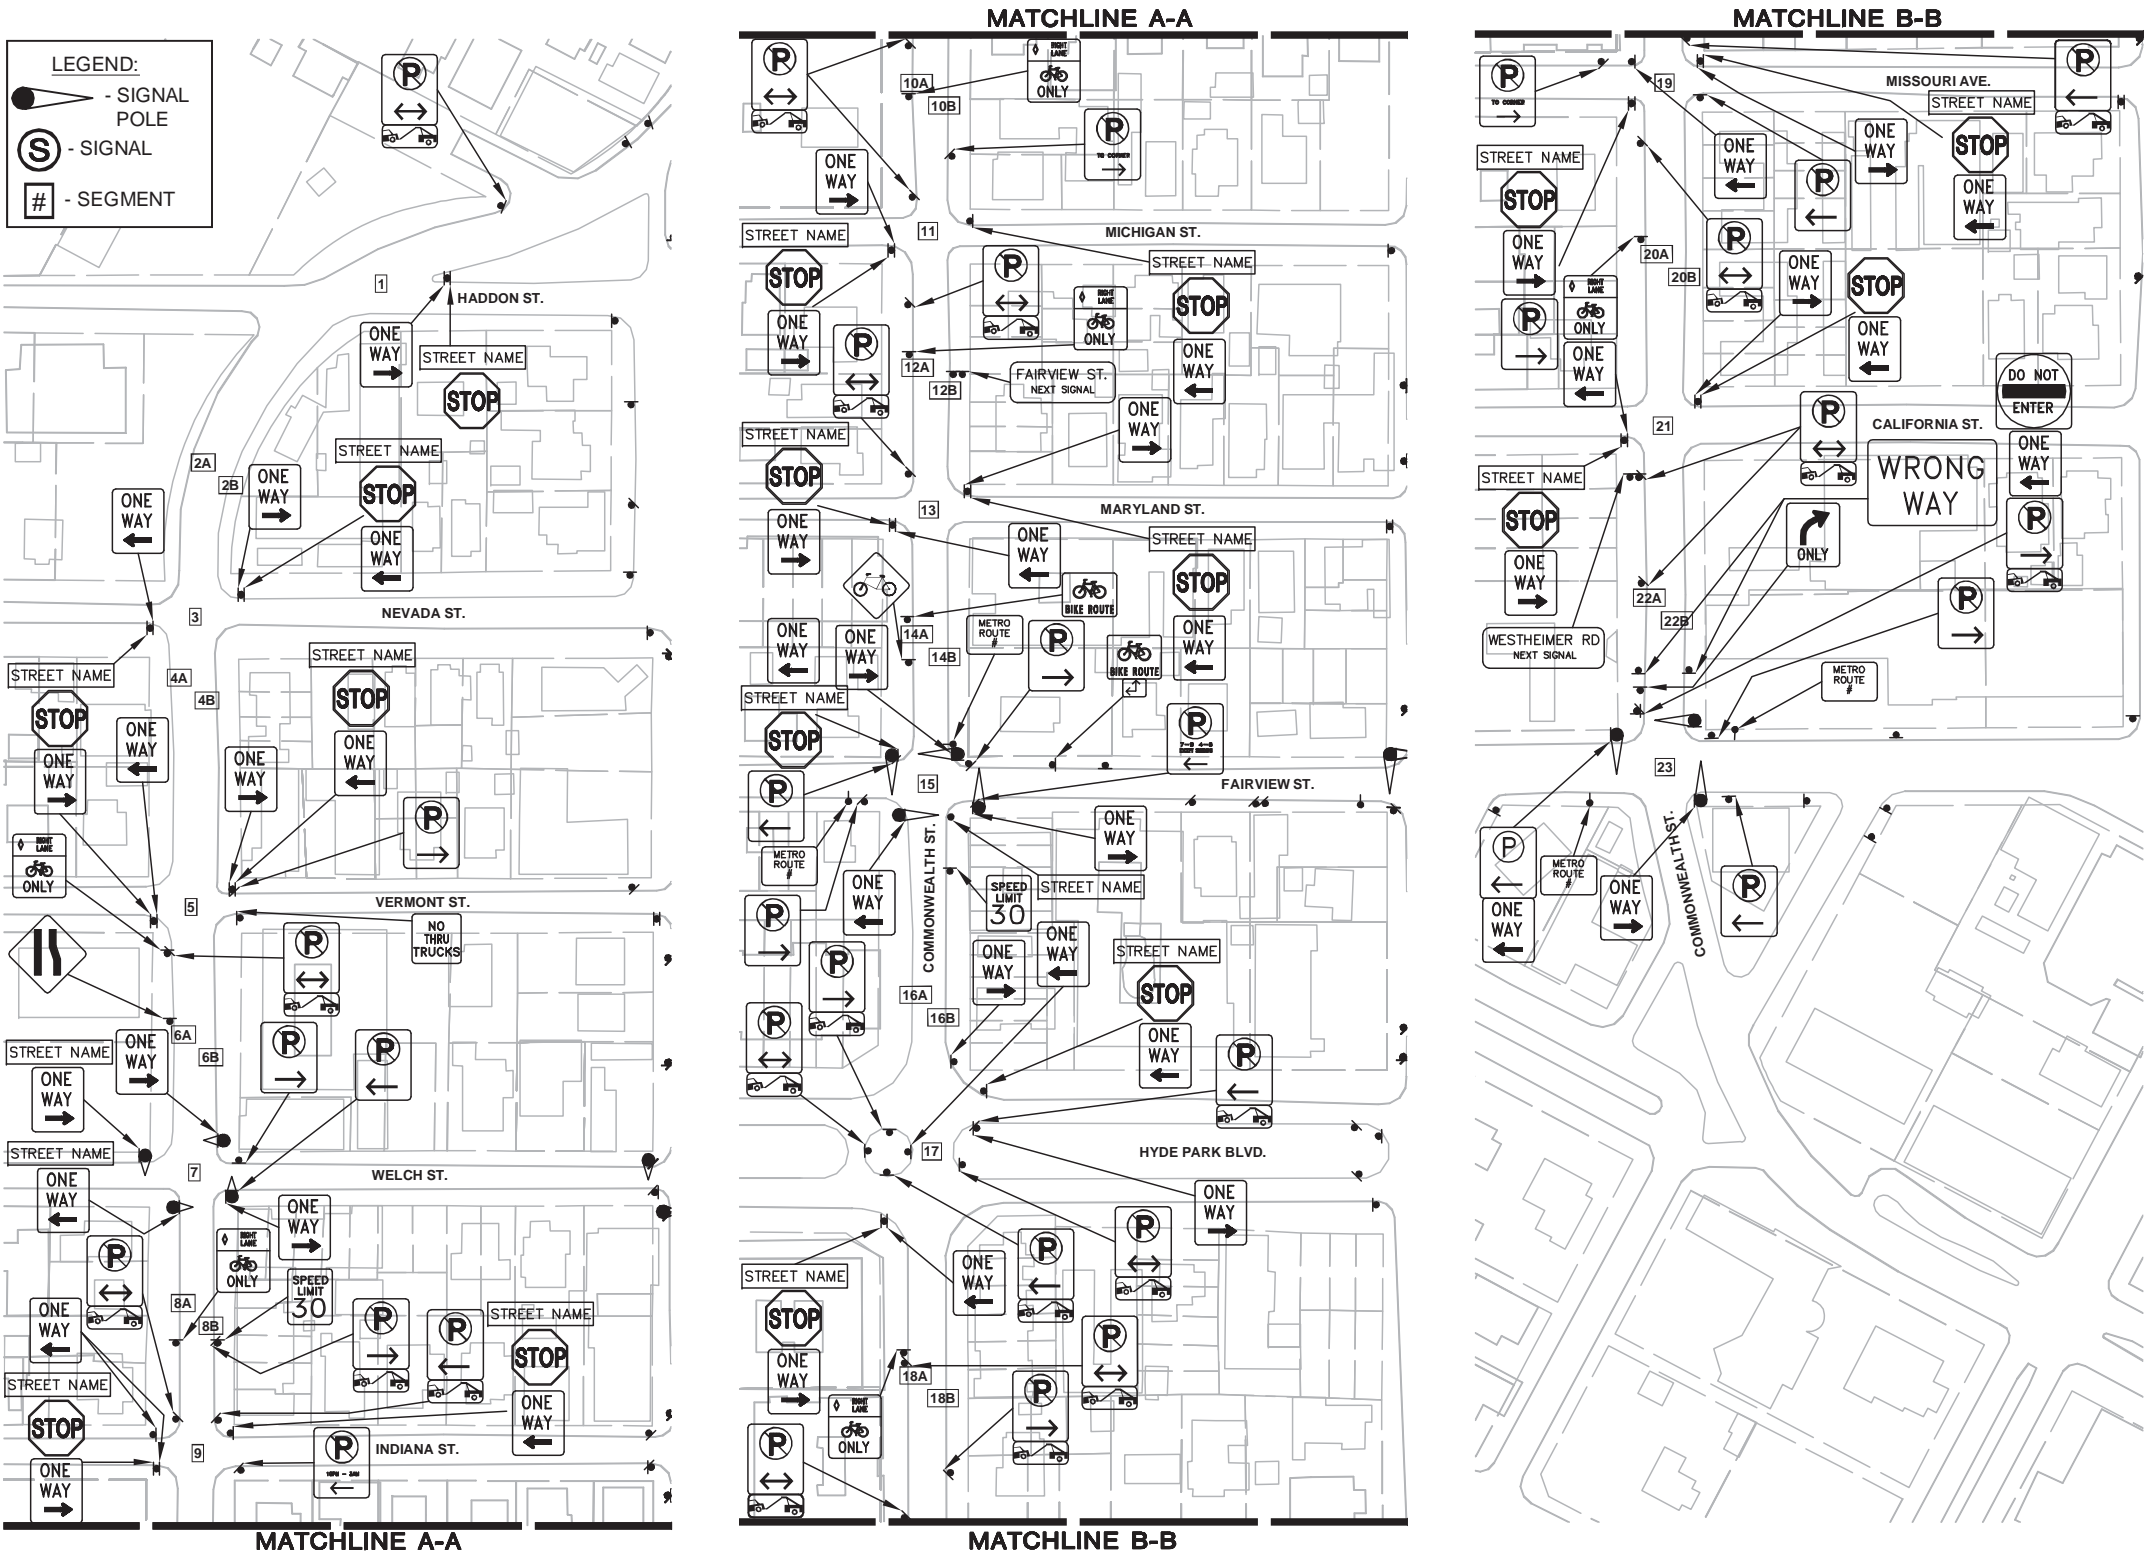
Photo 13-9, Segment 8B
Commonwealth between Welch and Indiana
Sidewalk section has shifted, creating both a slant and a tripping hazard.

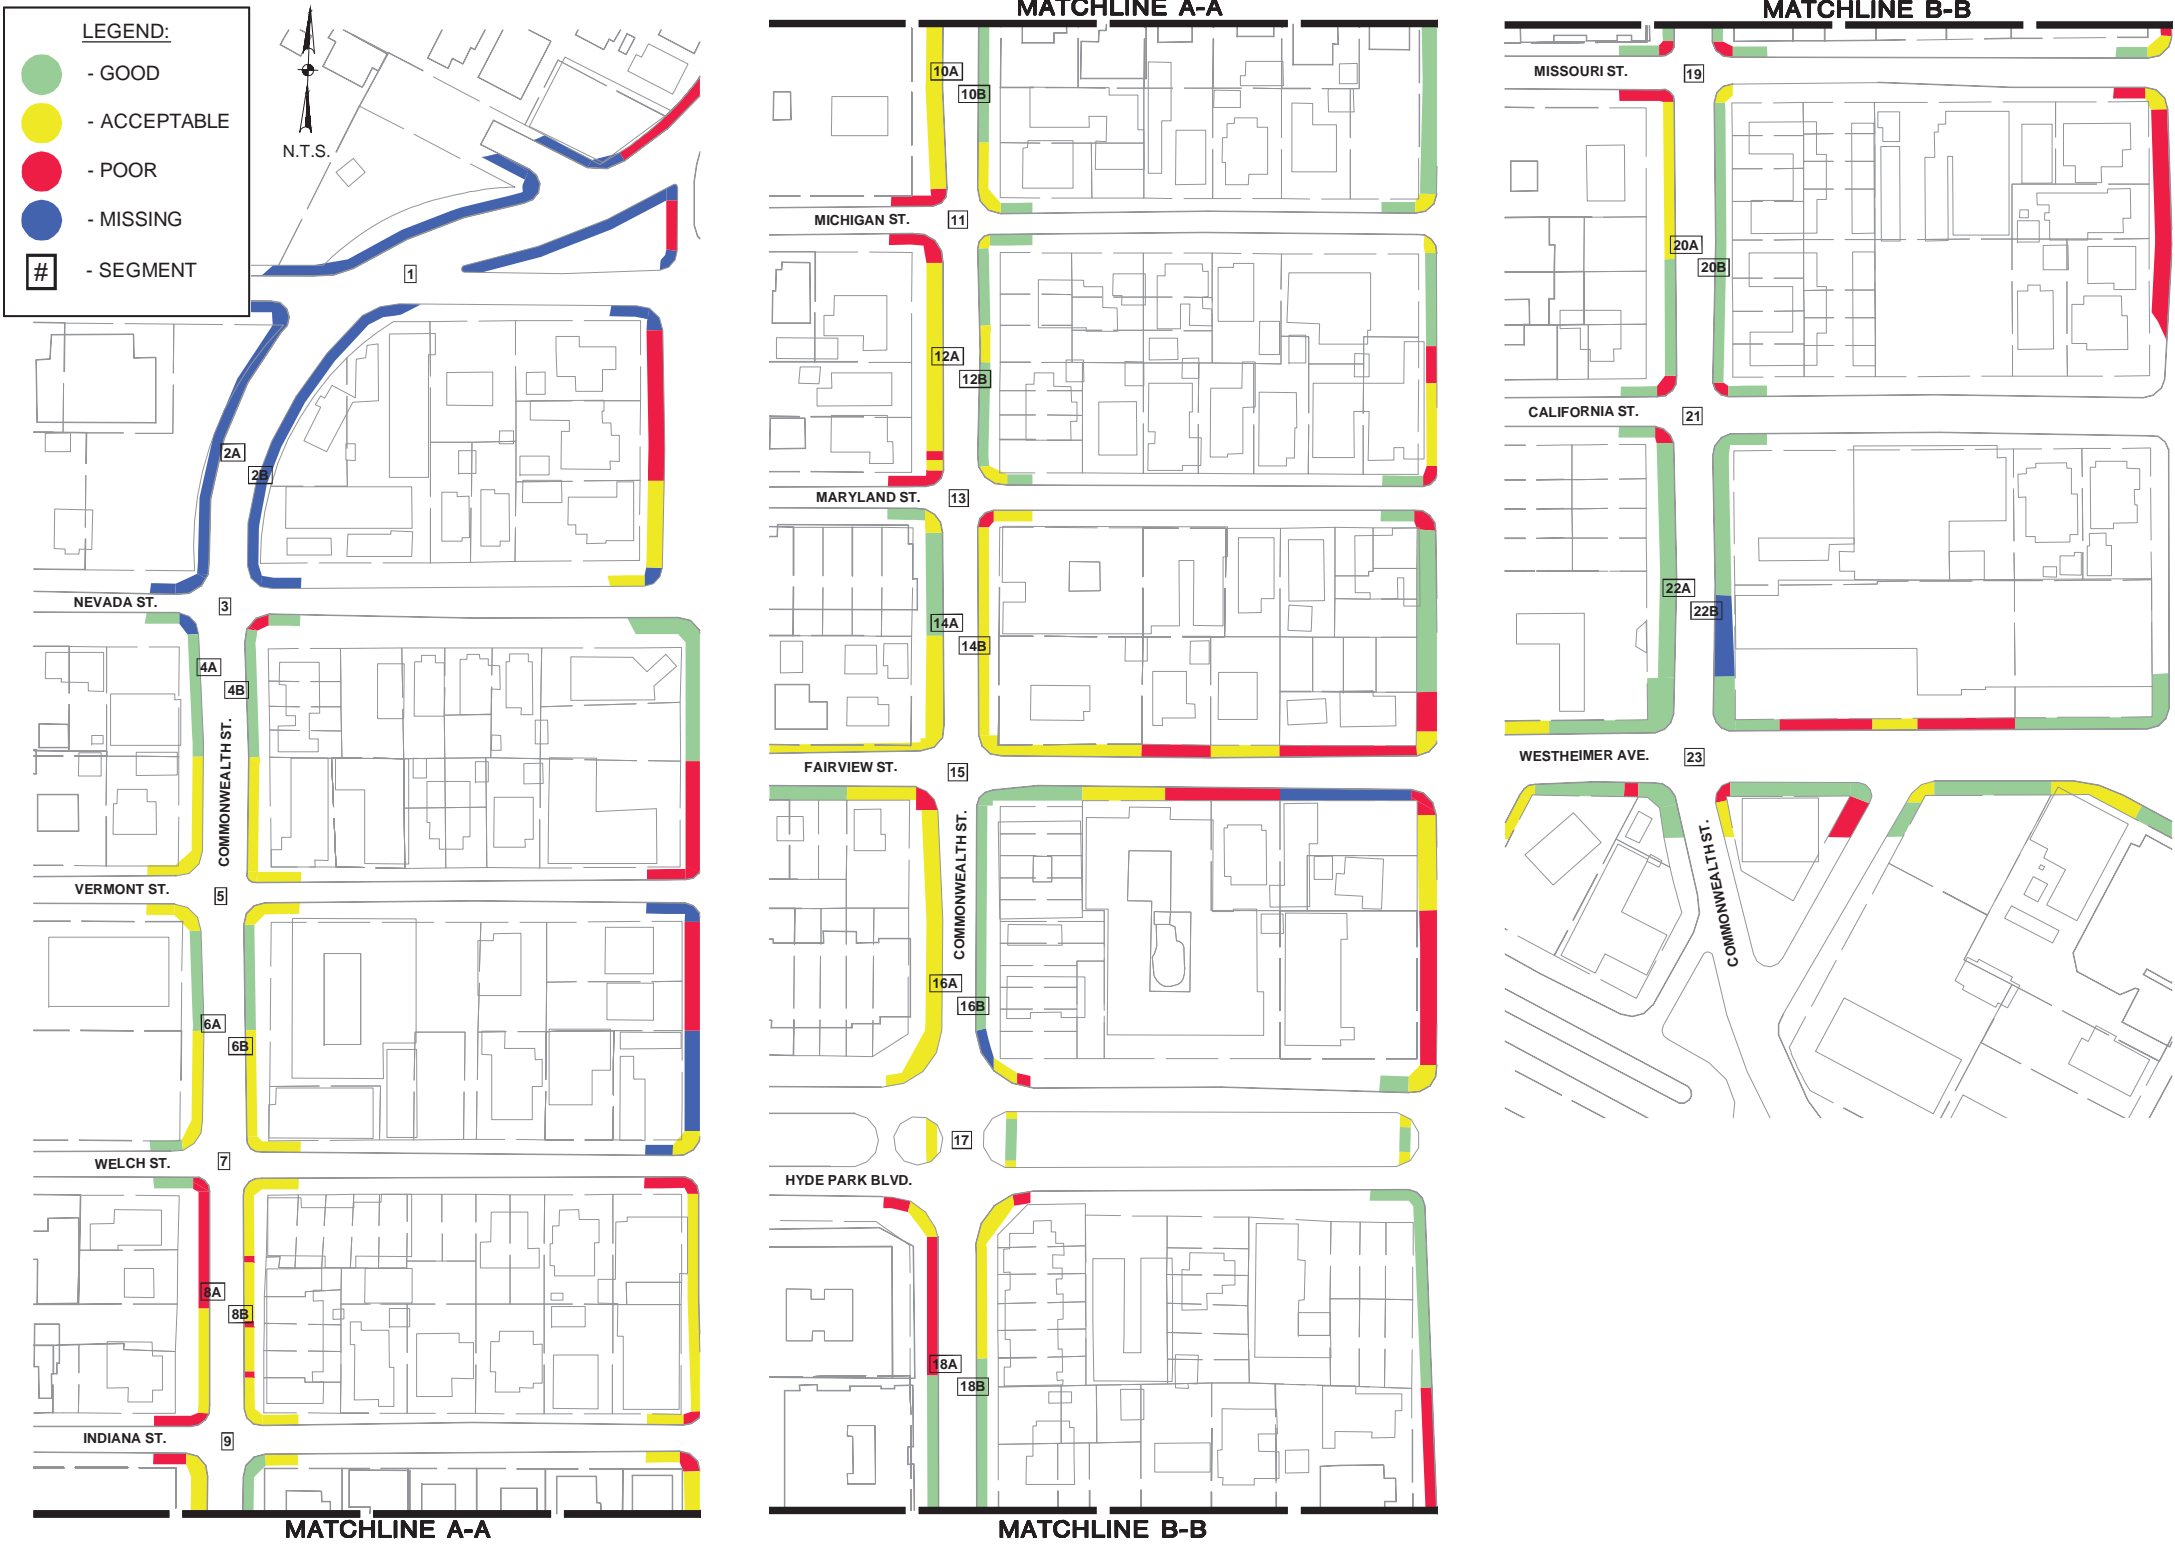
Photo 13-10, Segment 12A
Commonwealth between Michigan and Maryland
 Path to a house has settled in comparison to the adjacent sidewalk, creating of tripping hazards.

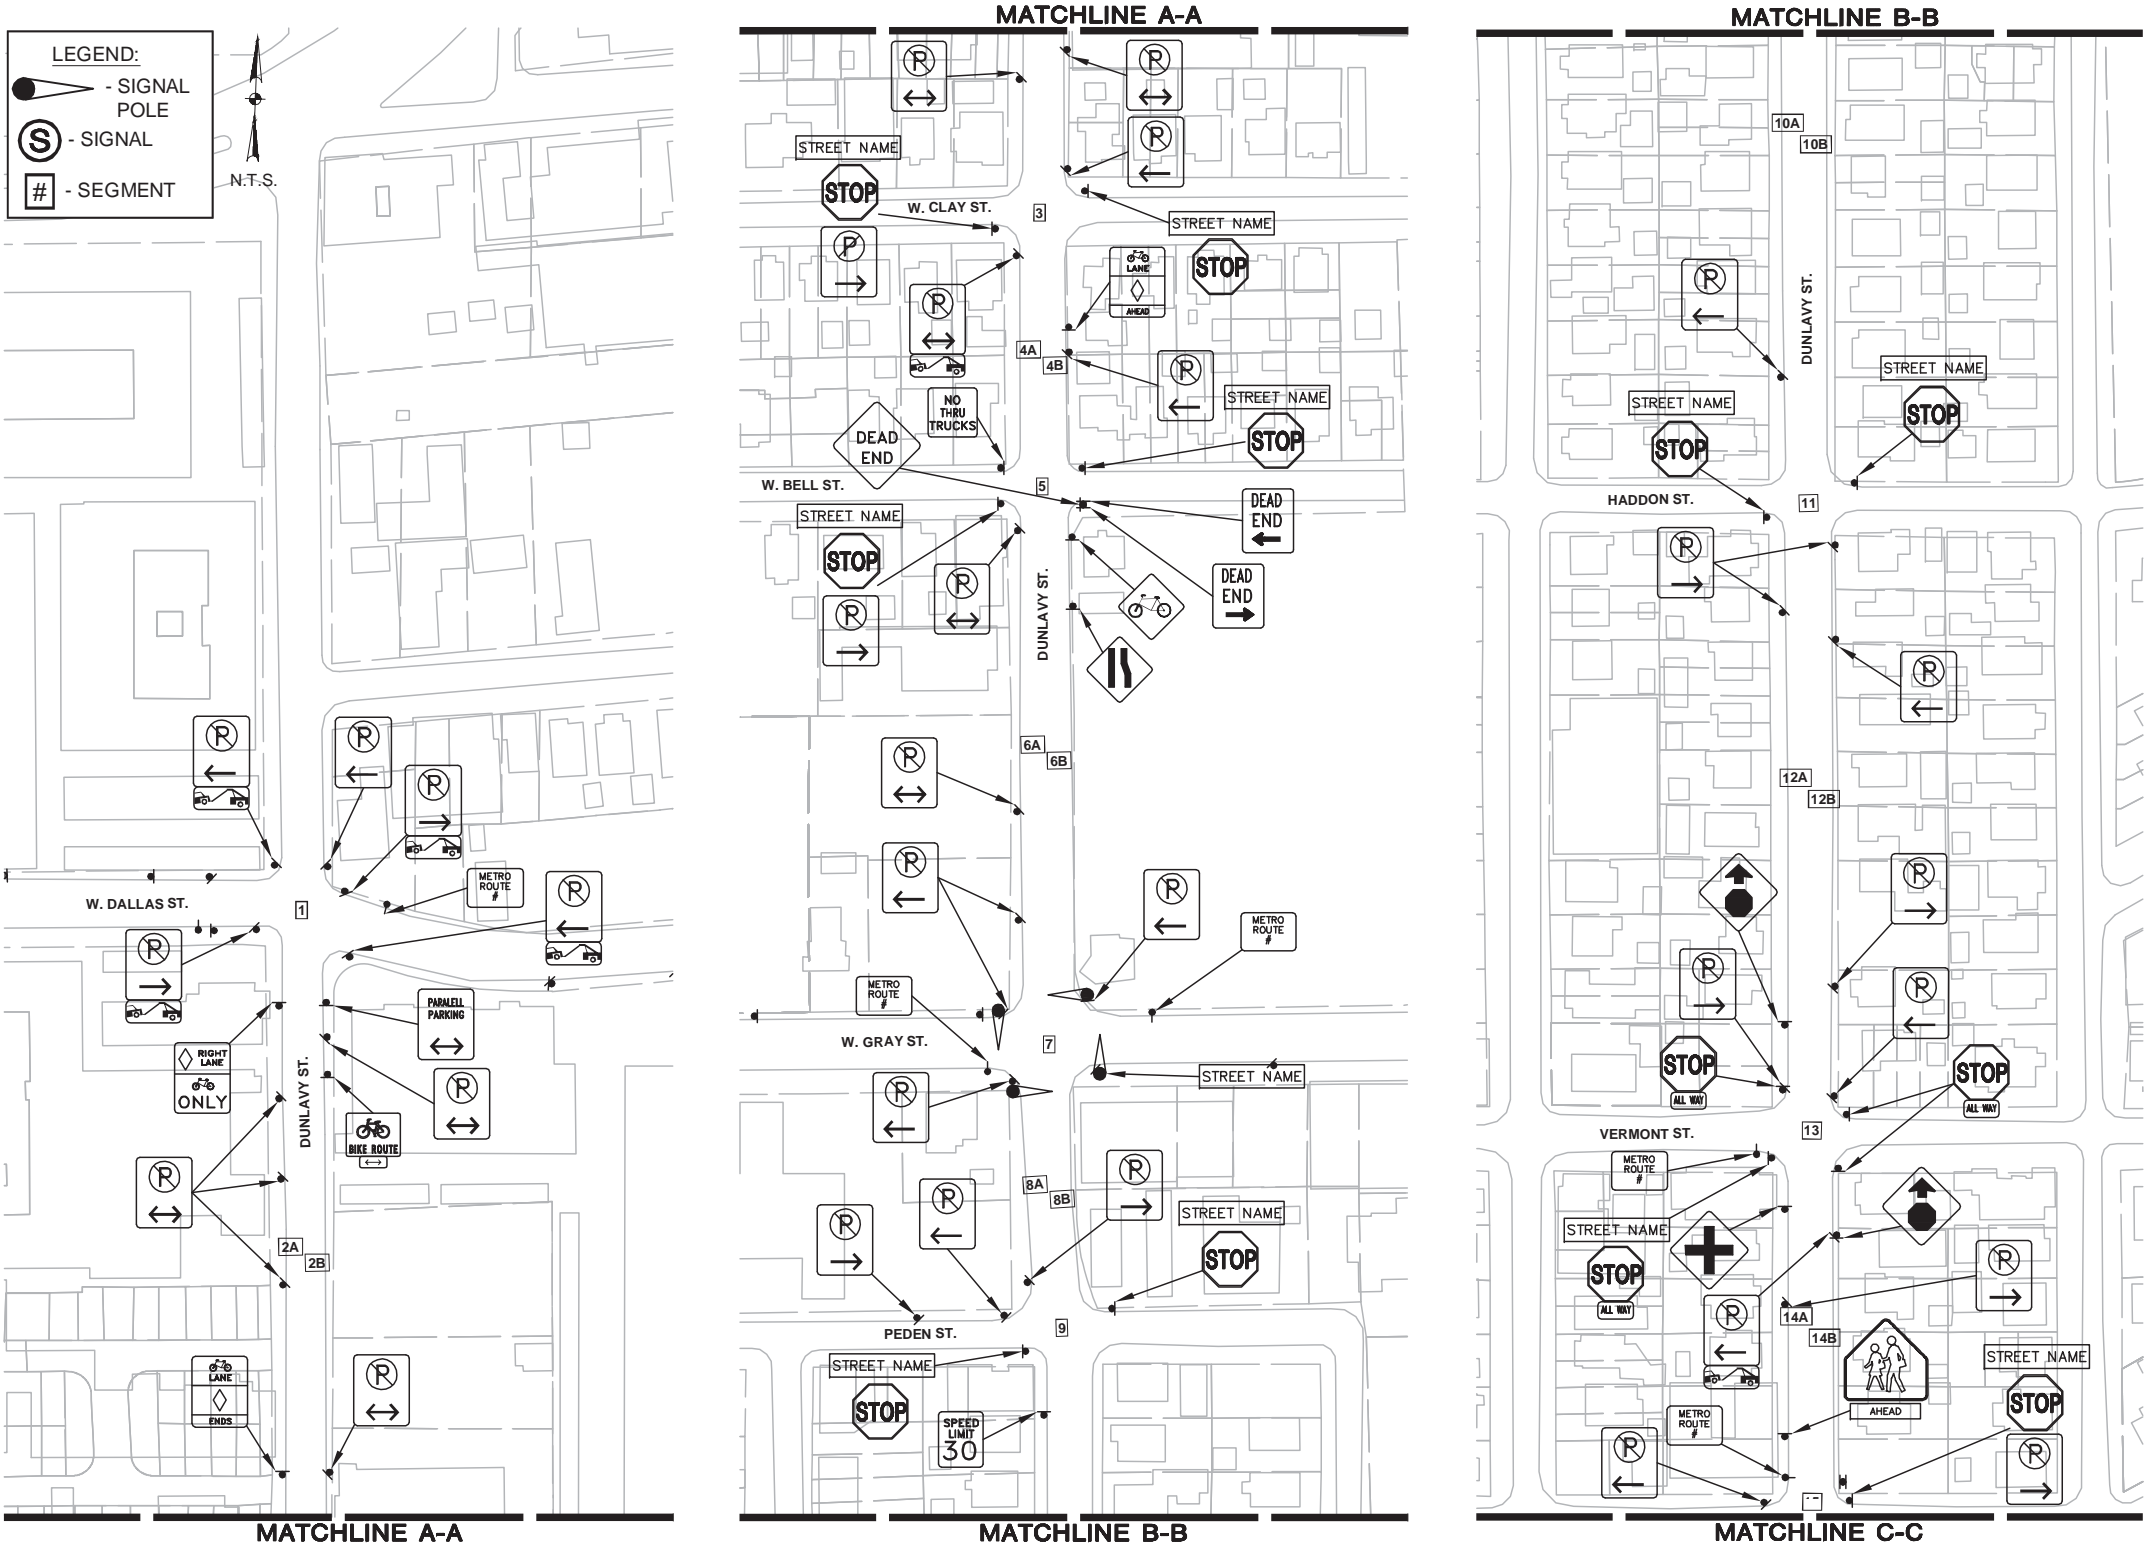
Photo 14-12, Segment 41
Dunlavy at Colquitt
Cracking in the intersection and numerous previous patches
