COMPREHENSIVE DISTRICT-WIDE MOBILITY STUDY

*An evaluation of pavement condition, pedestrian accessibility,
cut-through traffic, and markings within the Montrose District*

WALTER P MOORE

February 2012

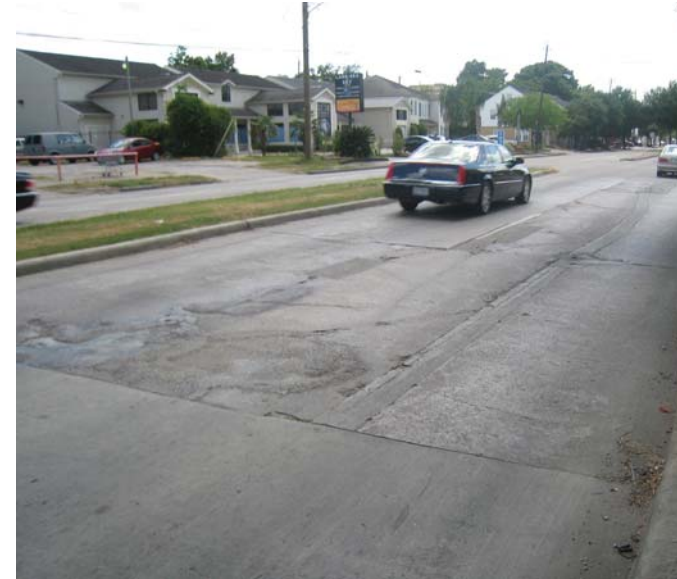
**Photo 5-1, Segment 4A
Richmond between McDuffie and Hazard**
Shows cracks and general deterioration which create an uneven riding surface

Table 5-2 summarizes the results of the pavement and median review. **Figure 5-3** graphically depicts the pavement conditions observed along Richmond. **Photos 5-1** through **5-9** illustrate some of the poor pavement segments which suggest immediate repair/replacement.

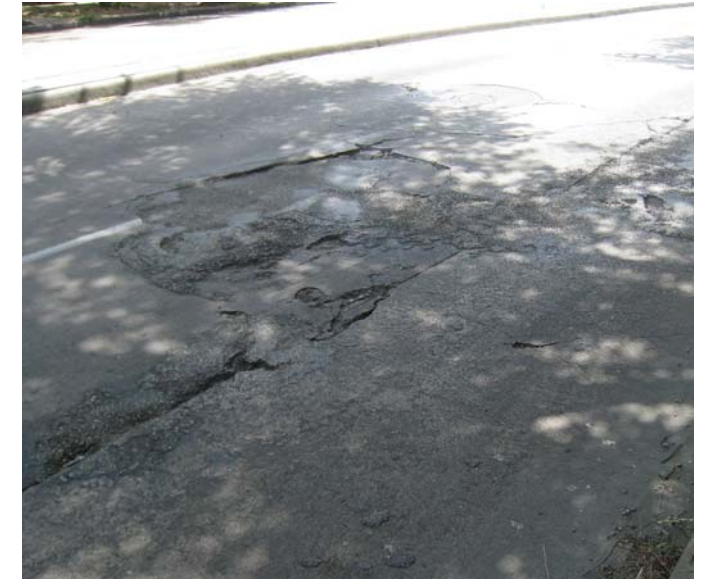
**Photo 5-2, Segment 4A
Richmond between McDuffie and Hazard**
Shows a close up of the cracks and general deterioration which create an uneven riding surface

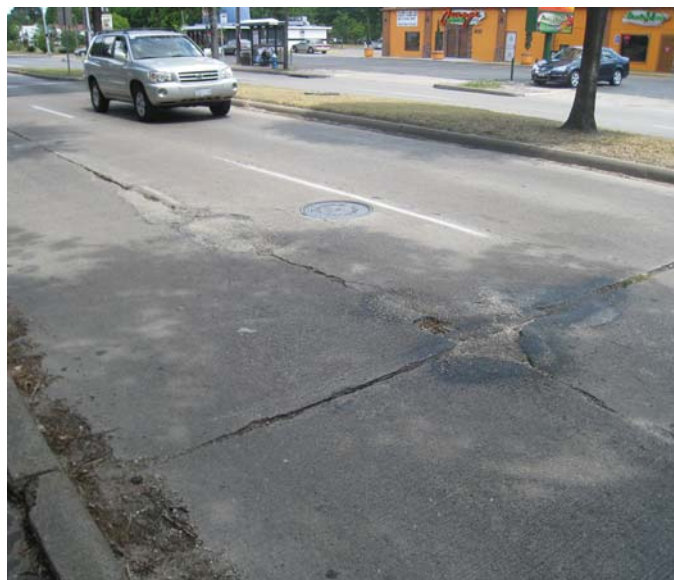
Photo 5-3, Segment 12A
Richmond between Dunlavy and Mandell

There is a section of the road that is raised similar to a speed bump or road hump due to what appears to be natural causes.

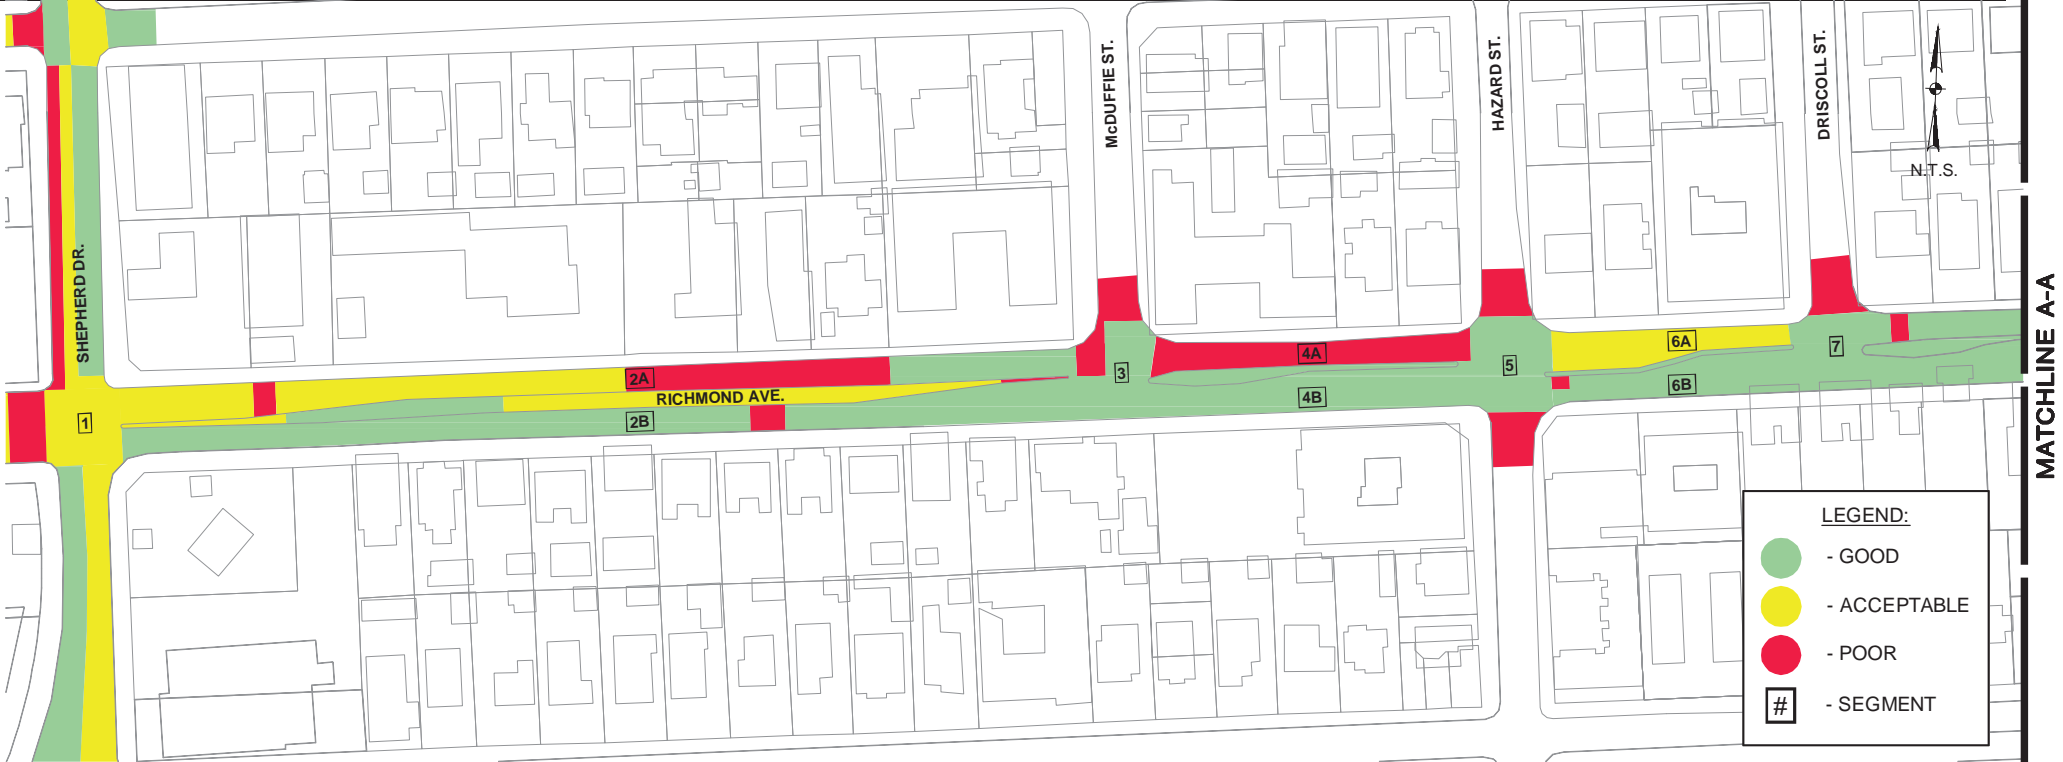
Figure 5-3
Richmond Avenue Pavement Conditions

Within the study area, Richmond has two lanes in each direction, divided by a median. The pavement is concrete with curb and gutter, and the medians are concrete with landscaping in some areas. Richmond pavement conditions between Shepherd and Spur 527 were studied by means of visual observations and photos. In general, the pavement conditions along Richmond were found to be good to acceptable with a few exceptions.

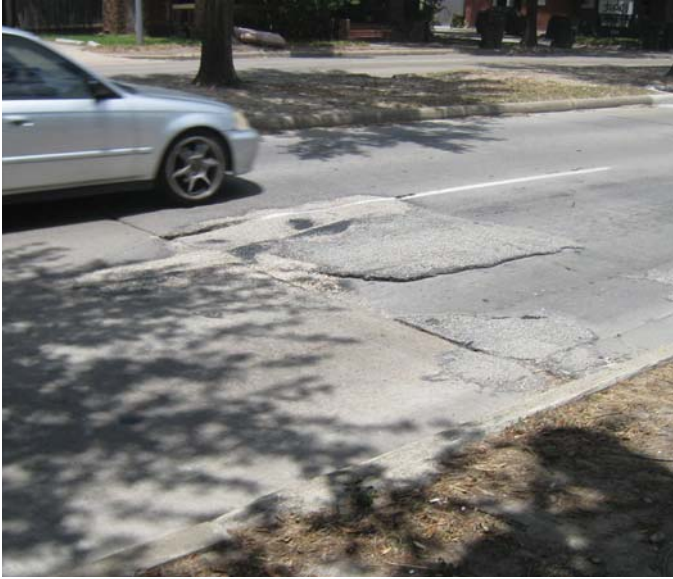
Photo 5-4, Segment 12B
Richmond between Dunlavy and Mandell
 This section of the road appears to have been previously patched, but the patch is no longer flush with the road and there are sections missing.

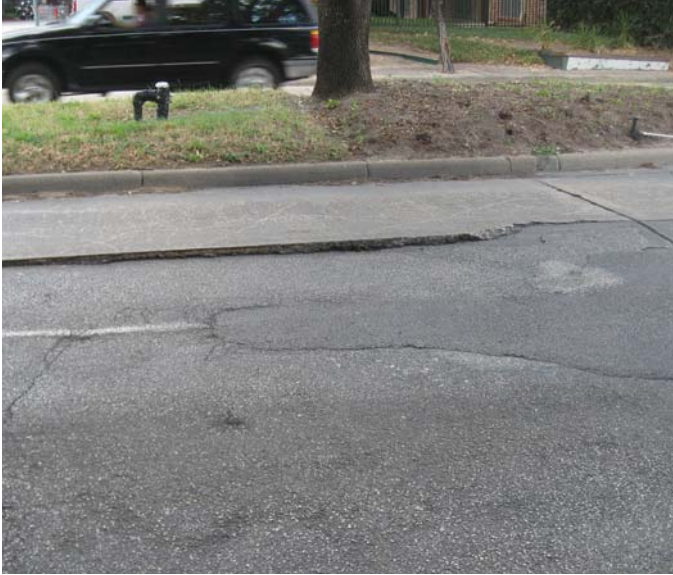
Photo 5-5, Segment 16B
Richmond between Loretto and Yupon
 Pavement separation

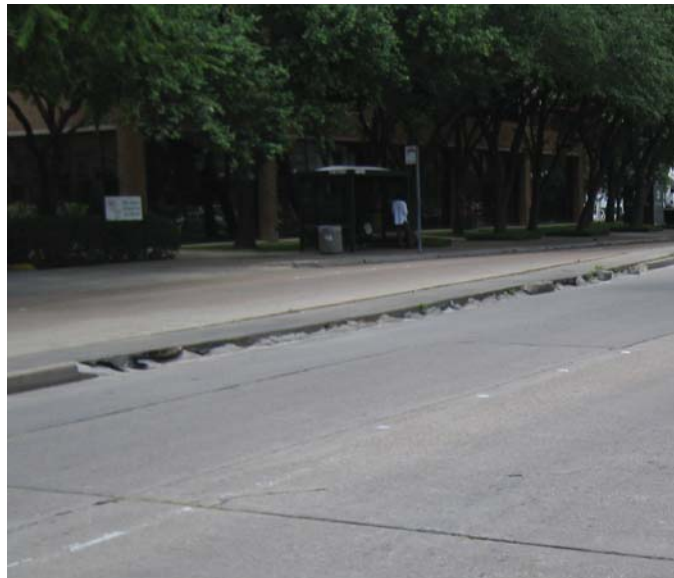
Photo 5-6, Segment 24A & 24B
Richmond between Yoakum and Montrose
 Median damage

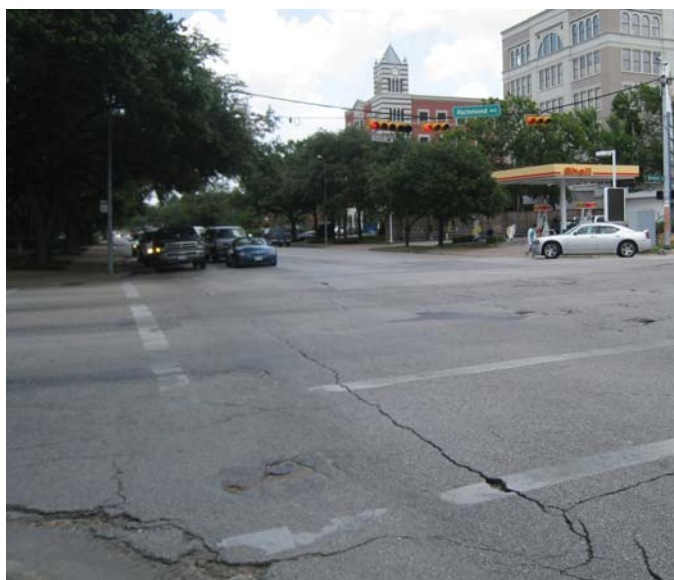
Photo 5-7, Segment 25
Richmond at Montrose
 Cracks, potholes, and patching creates an uneven riding surface.

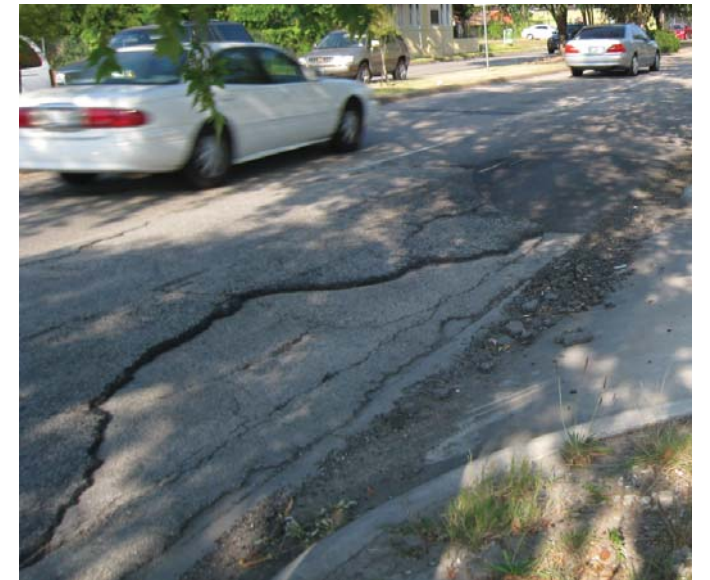
Photo 5-8, Segment 36A
WB Richmond near Milam
Asphalt surface overlay is worn and needs repair/
replacement.

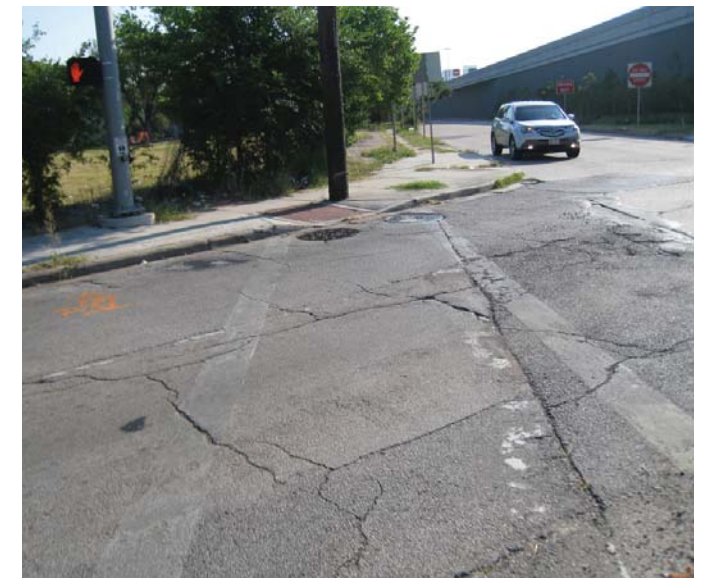
Photo 5-9, Segment 37
Richmond at Milam
Multiple cracks , poor riding experience

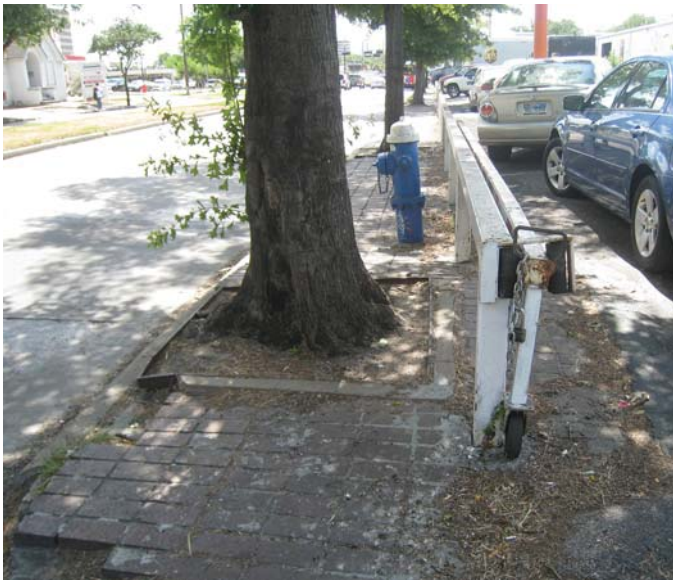
Photo 5-10, Segment 2B
Between Richmond and McDuffie
 Trees block pedestrian path.

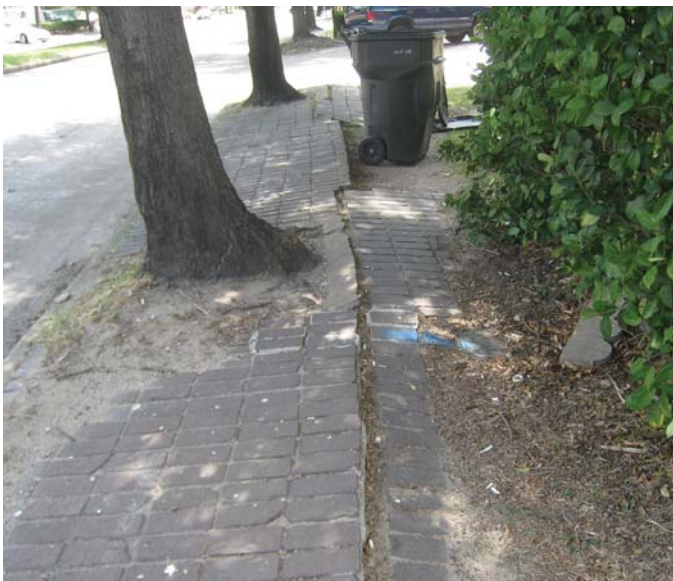
Photo 5-11, Segment 8A
Between Driscoll and Woodhead
 Pavers are uneven and create tripping hazards.

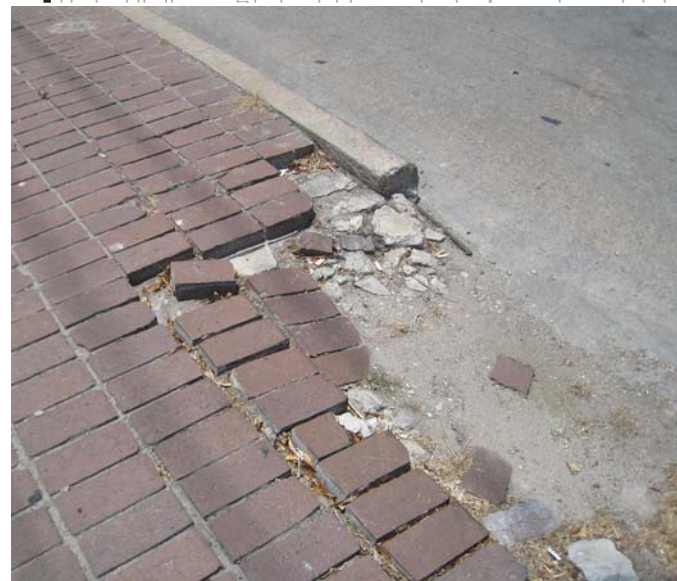
Photo 5-12, Segment 10B
Between Woodhead and Dunlavy
 Pavers and curb are missing or broken creating a tripping hazard .

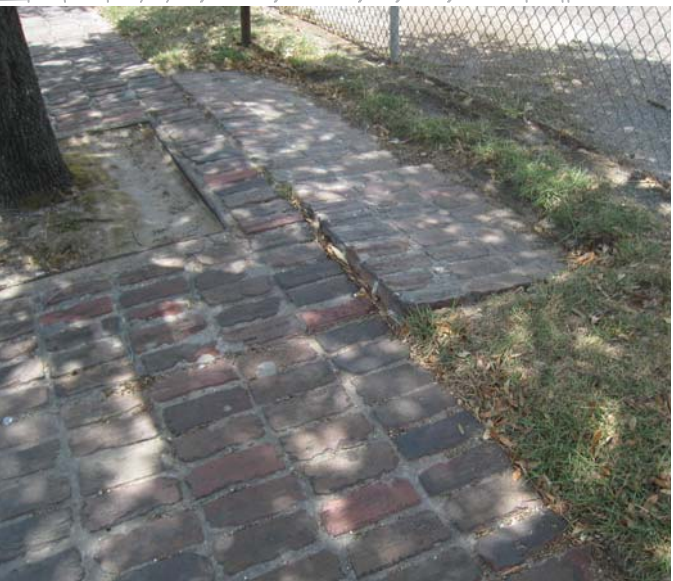
Photo 5-13, Segment 14A
Between Mandell and Loretto
 Pavers are uneven and create tripping hazards. Passage widths are too narrow.

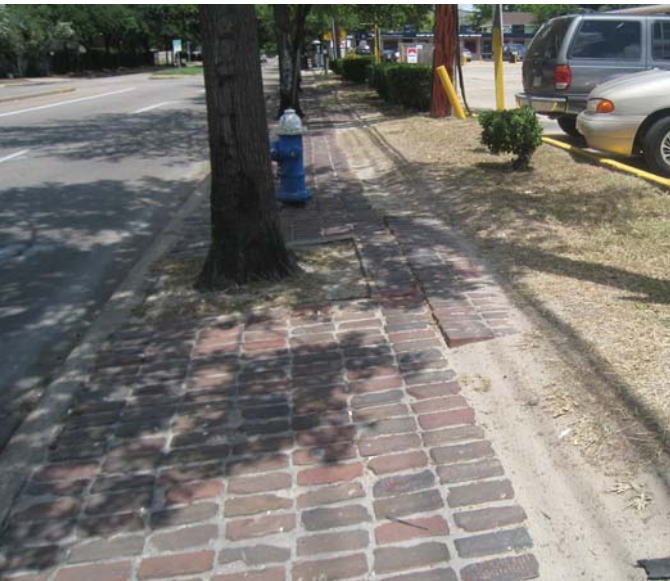
Photo 5-14, Segment 14B
Between Mandell and Loretto
Narrow width as well as path obstruction inhibit pedestrian activity.

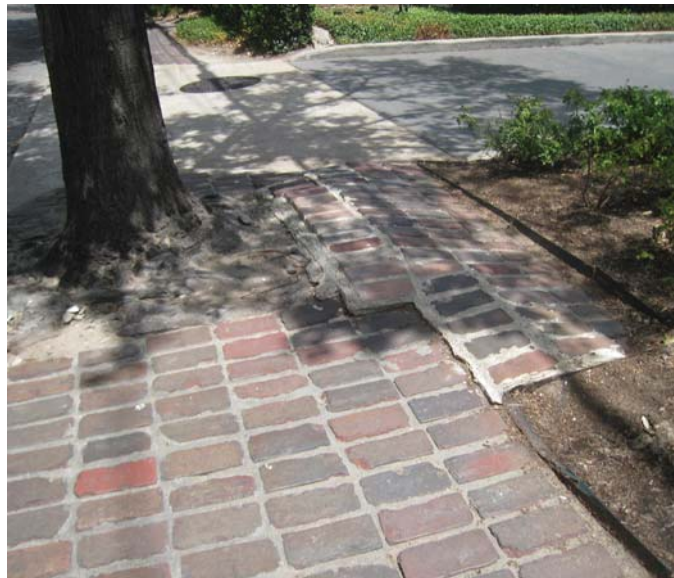
**Photo 5-15, Segment 16B
Between Loretto and Yupon**

Pavers are uneven and create tripping hazards. Narrow passage does not meet current standard.

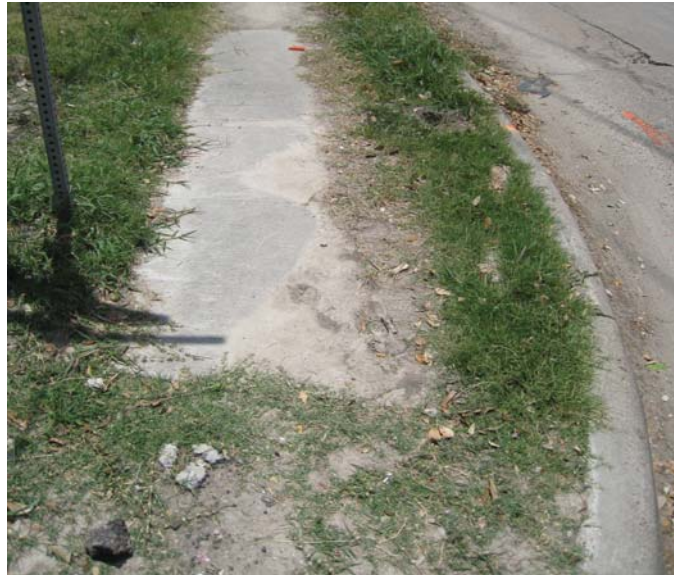
**Photo 5-16, Segment 19
Richmond at Graustark**

The presence of dirt and grass on the sidewalk makes it difficult for pedestrians to access the ramp in the southeast corner of the intersection of Richmond at Graustark.

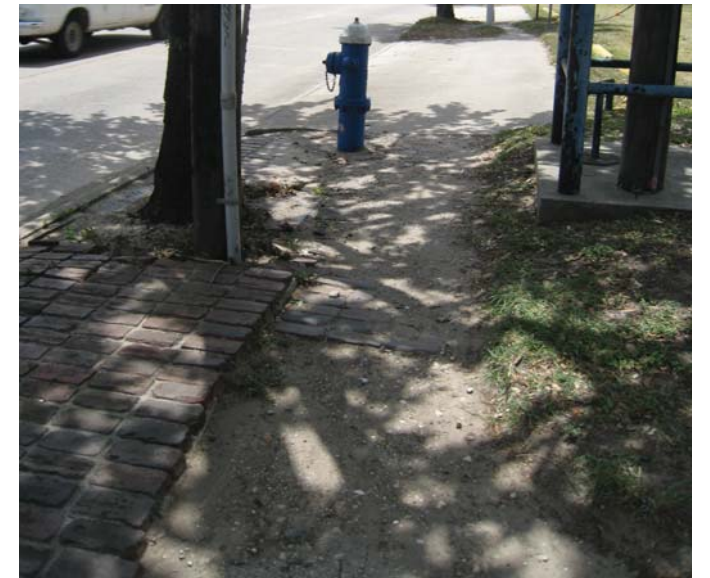
Photo 5-17, Segment 20A
Richmond between Graustark and Mt. Vernon
 Missing pavers create uneven surface. Obstructions in the pedestrian path make it difficult for pedestrians to travel on the sidewalk.

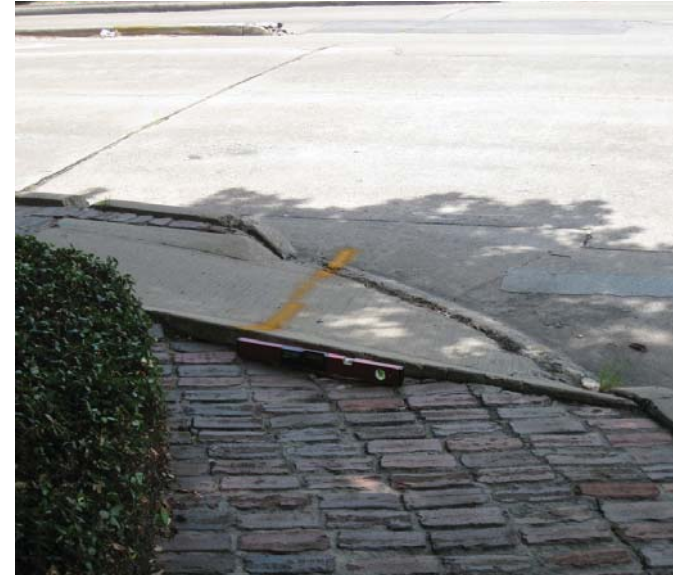
**Photo 5-18, Segment 21
Richmond at Mt. Vernon**

The connection between the northeast ramp and sidewalk is uneven which makes it difficult for pedestrians to access the ramp.

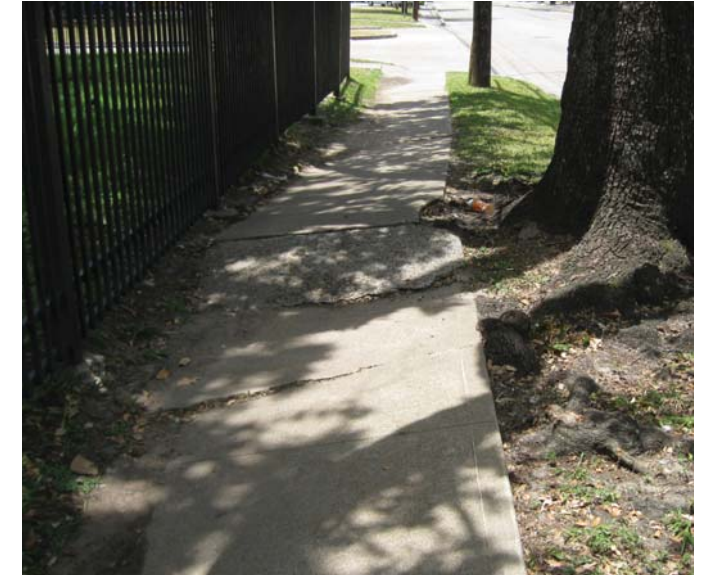
**Photo 5-19, Segment 24B
Richmond between Yoakum and Montrose**

Unevenness of the sidewalk makes it difficult for pedestrians to travel on the sidewalk.

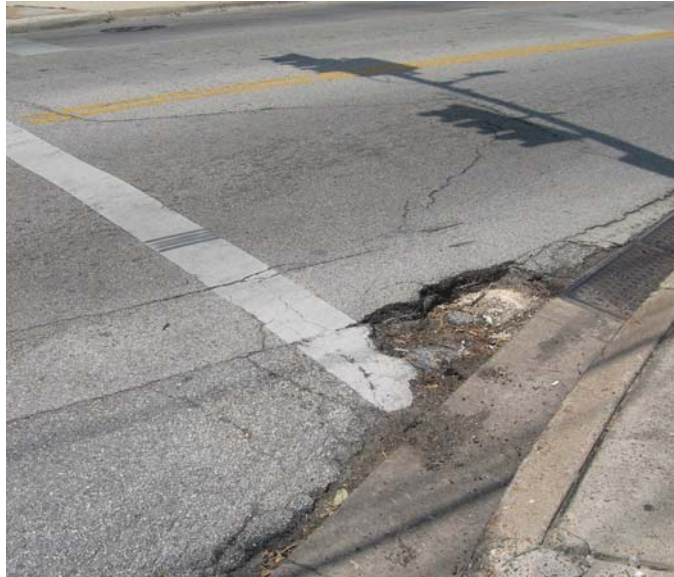
Photo 6-1, Segment 2B
W. Alabama between Shepherd and Huldy
 A section of the asphalt is missing near the Shepherd intersection.

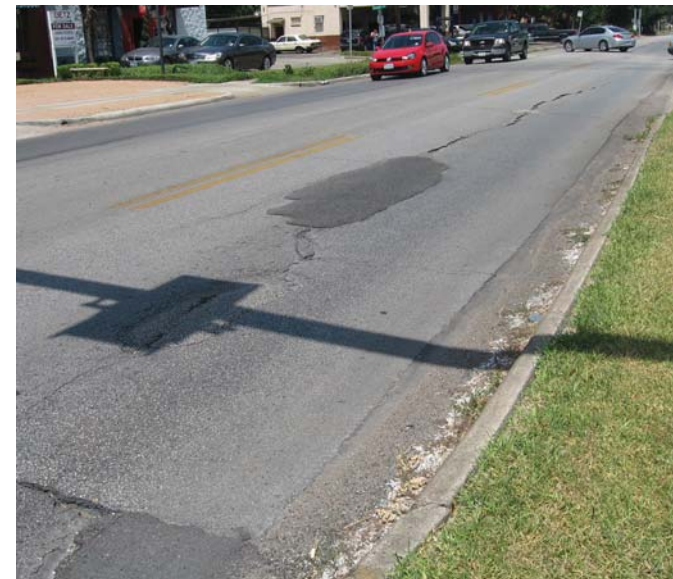
**Photo 6-2, Segment 6B
W. Alabama between McDuffie and Hazard**

There is a large crack down the middle of the eastbound lane. It appears to have been patched in the past.

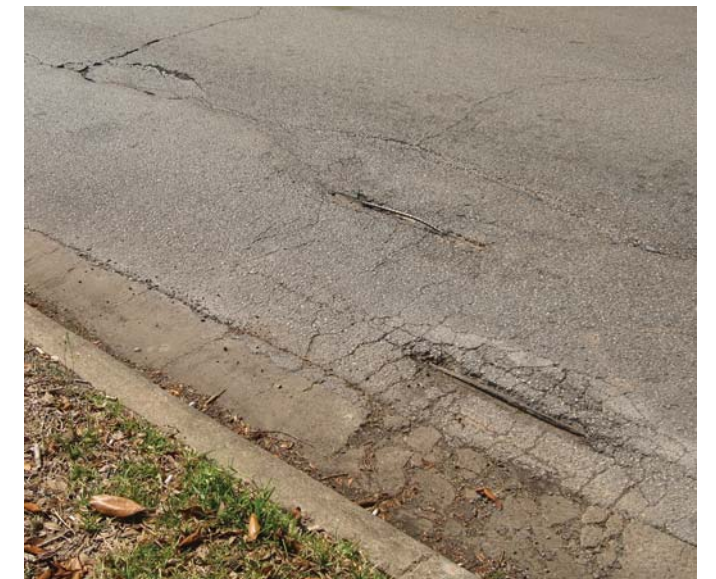
**Photo 6-3, Segment 12B
W. Alabama between Woodhead and Dunlavy**
Near the intersection with Dunlavy, there is exposed rebar.

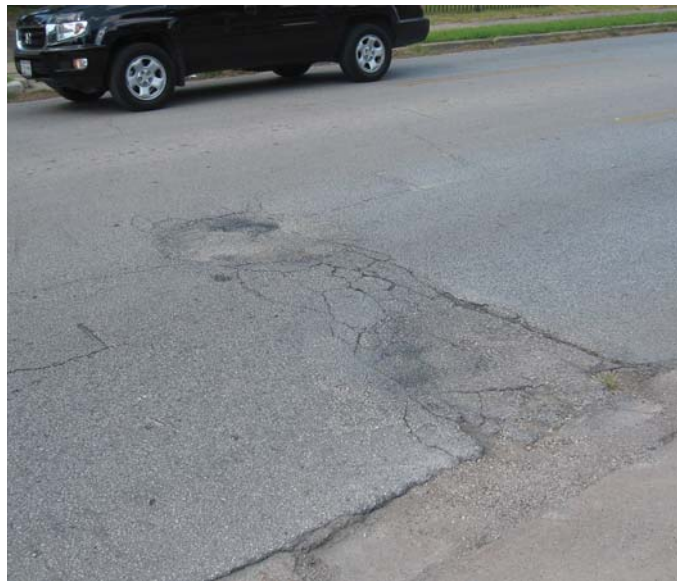
Photo 6-4, Segment 12B
W. Alabama between Woodhead and Dunlavy
A section of the roadway has sunken, creating a pothole.

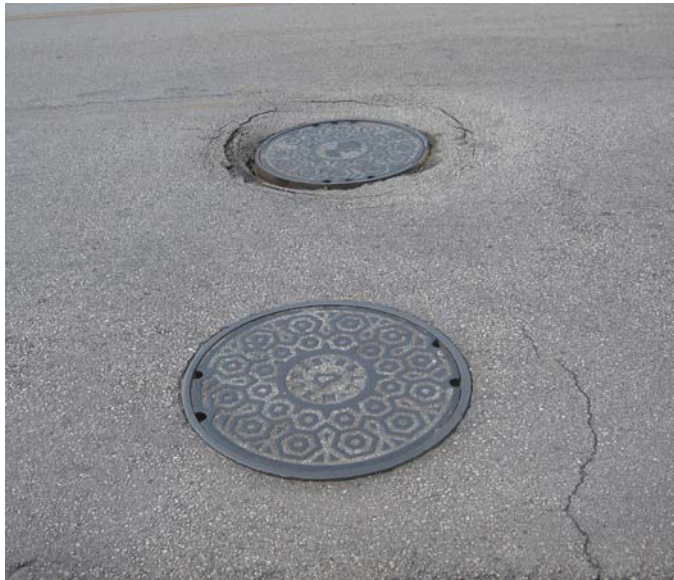
Photo 6-5, Segment 14B
W. Alabama between Dunlavy and Mandell
 One of the manholes is significantly lower in relation to both the roadway and the other manhole.

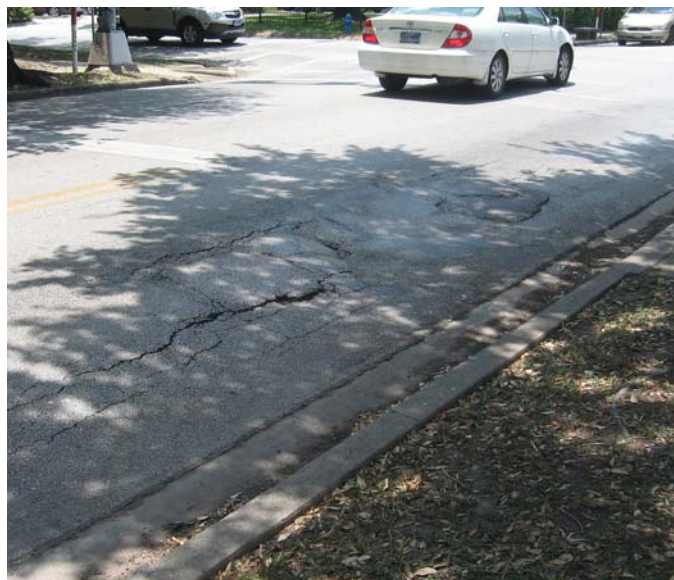
Photo 6-6, Segment 16A
W. Alabama between Mandell and Mulberry
 There is a drop in the elevation of the pavement near the curb. The pavement is also cracking from the related stress.

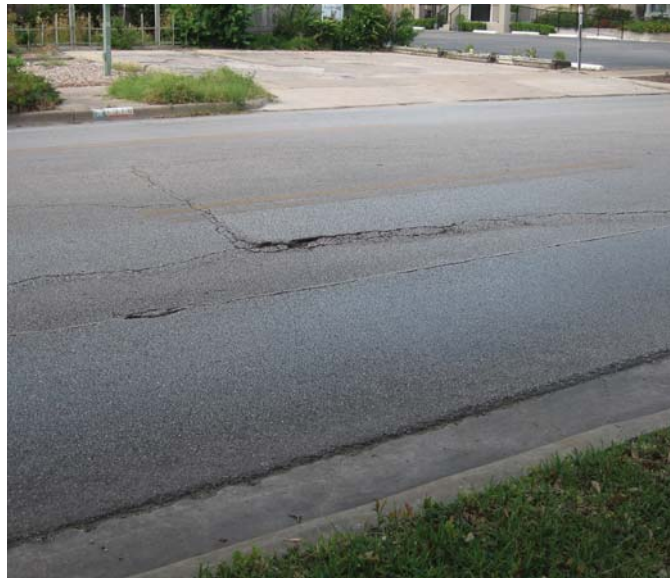
Photo 6-7, Segment 16B
W. Alabama between Mandell and Mulberry
 The pavement has settled unevenly, creating a small drop off or fault in the center of the lane.

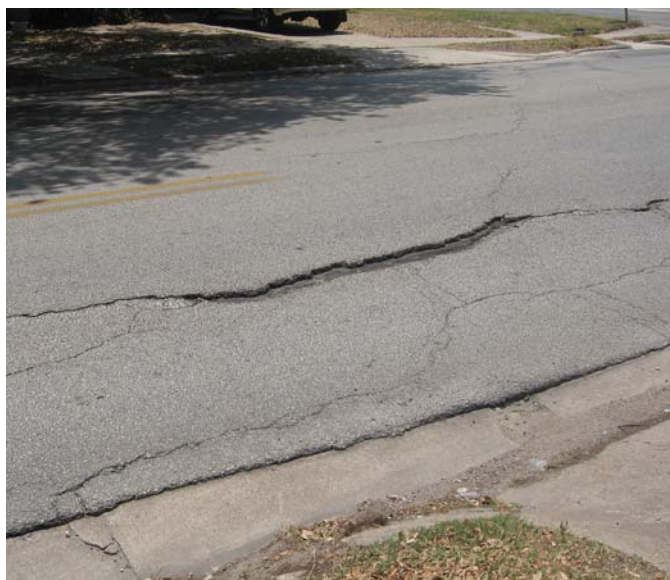
Photo 6-8, Segment 20A
W. Alabama between Yupon and Graustark
 The pavement has settled unevenly, creating a small drop off or fault in the center of the lane.

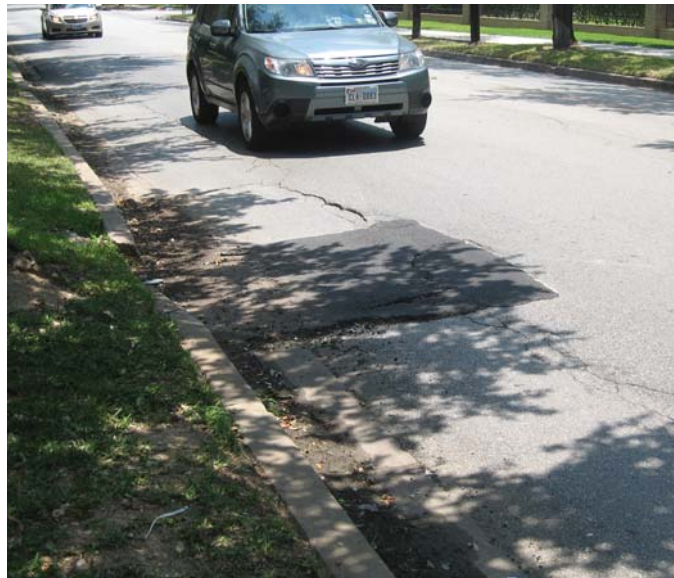
Photo 6-9, Segment 24A

The pavement has settled unevenly, creating an uneven riding surface. It appears to have been patched, but the patch is not even with the existing road and is chipping off.

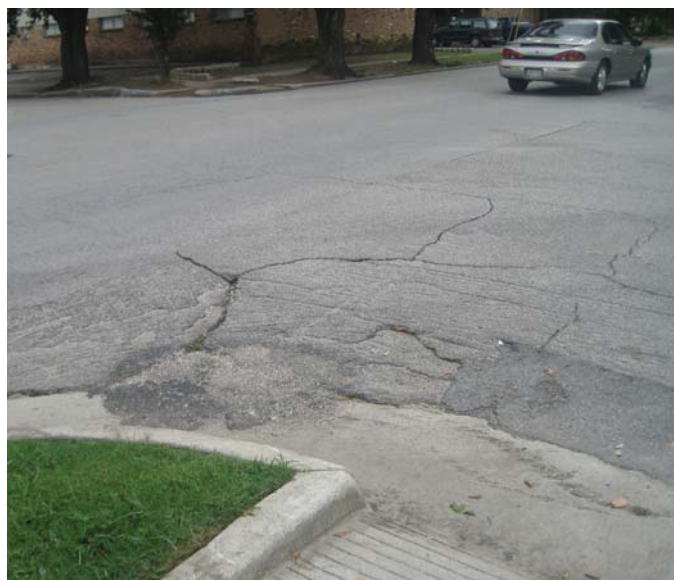
Photo 6-10, Segment 29

There are cracks and patching at the southwest corner of the intersection which creates an uneven riding surface.

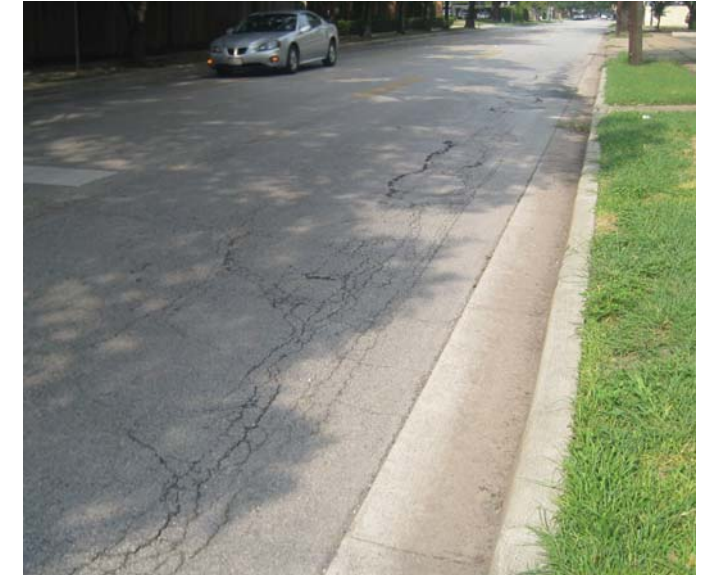
Photo 6-11, Segment 30A
W. Alabama between Roseland and Stanford
The cracking creates an uneven riding surface and may widen or propagate creating additional problems.

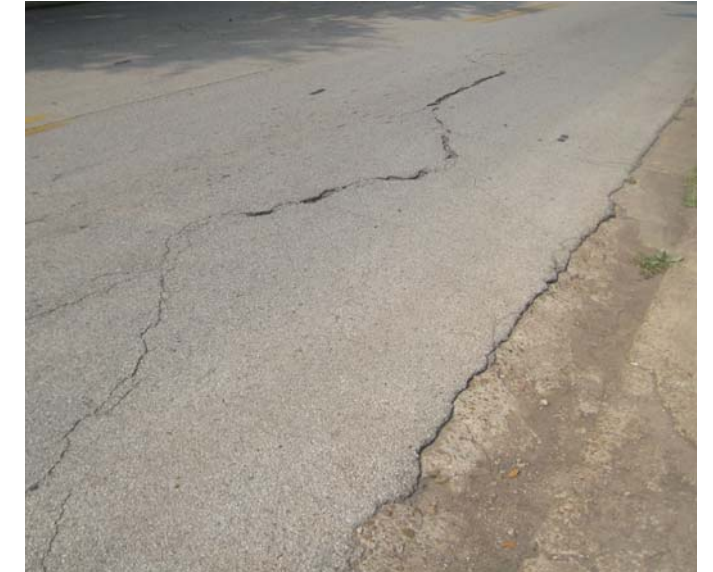
Photo 6-12, Segment 30A
W. Alabama between Roseland and Stanford
The cracking creates an uneven riding surface and may widen or propagate creating additional problems.

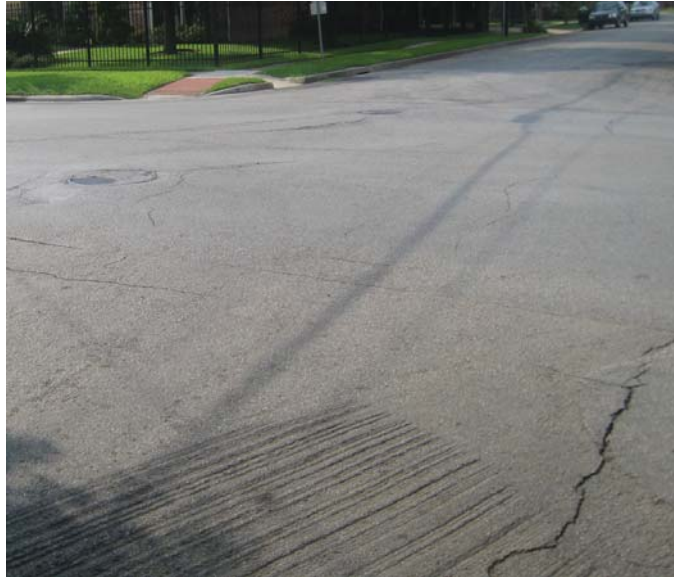
Photo 6-13, Segment 39
W. Alabama at Garrett

The cracks , grooves, and upheaval seen in the photo creates a poor riding experience.

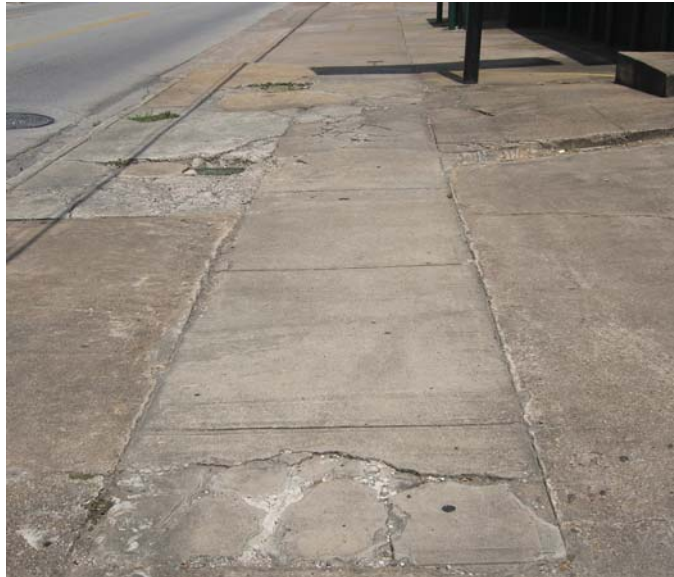
Photo 6-14, Segment 2B
W. Alabama between Shepherd and Huld

Cracking and uneven settling along pedestrian path.

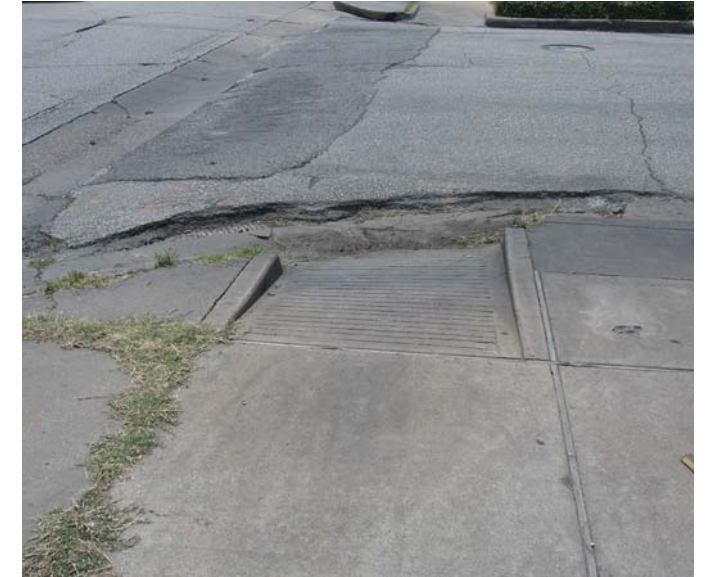
Photo 6-15, Segment 7
W. Alabama at Hazard
Road resurfacing has made ramps difficult to traverse.

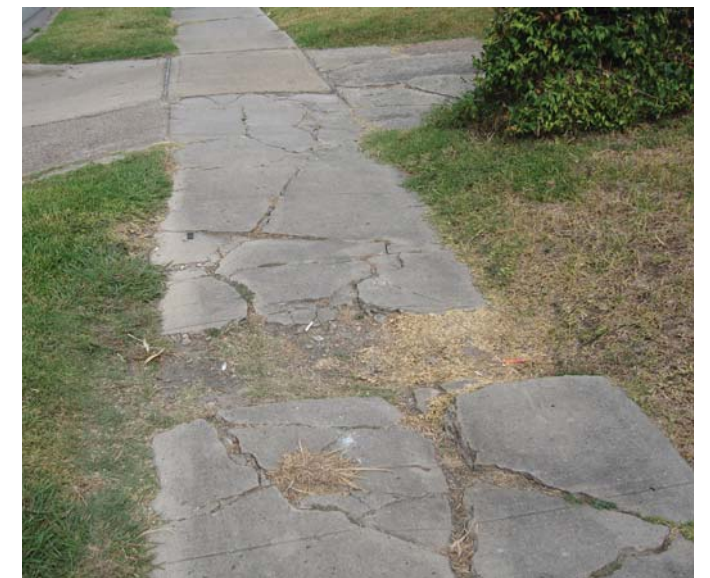
Photo 6-16, Segment 12B
W. Alabama between Woodhead and Dunlavy
Missing sections, cracking, and uneven settling create tripping hazards.

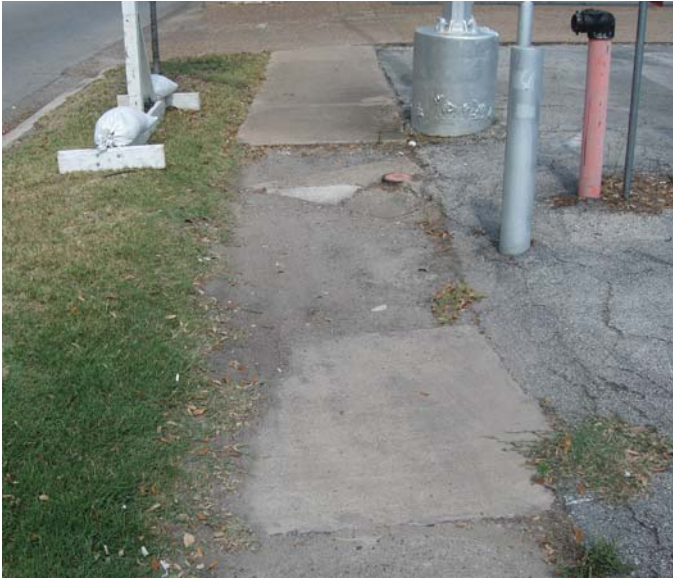
Photo 6-17, Segment 14B
W. Alabama between Dunlavy and Mandell
Untrimmed vegetation and missing section.

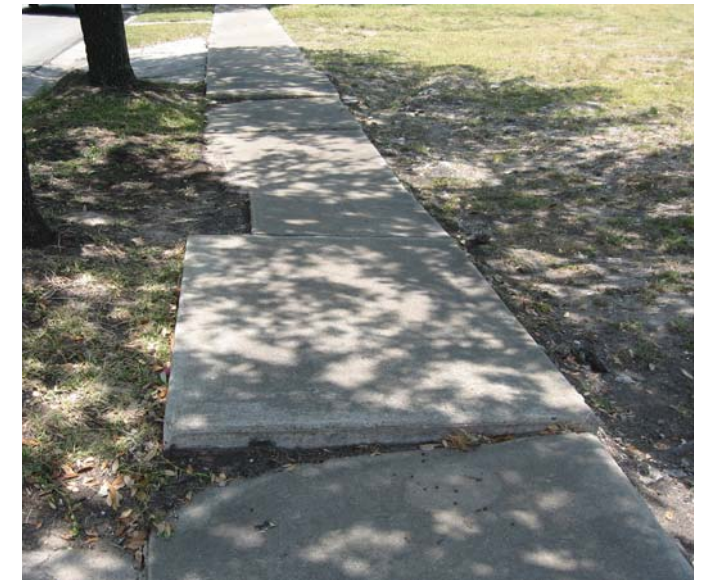
Photo 6-18, Segment 16A
W. Alabama between Mandell and Mulberry
Ground movement has caused whole sidewalk sections to shift, creating tripping hazards.

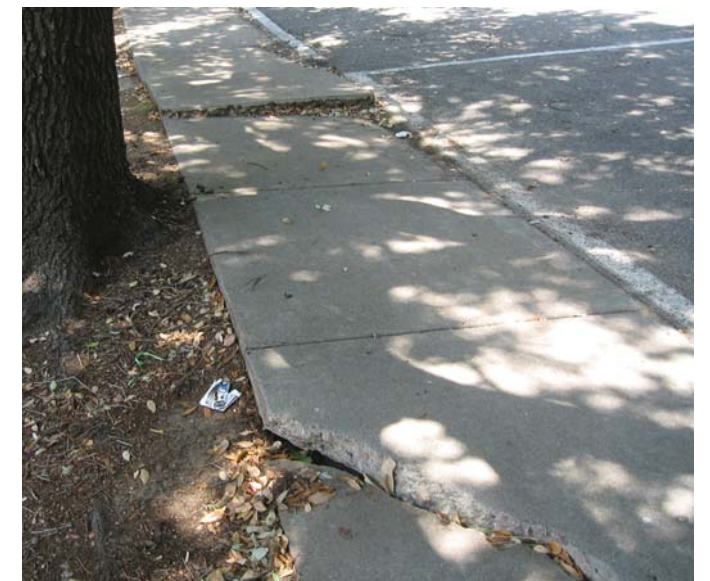
Photo 6-19, Segment 18A
W. Alabama between Mulberry and Yupon
Sections have broken off, creating tripping hazards.

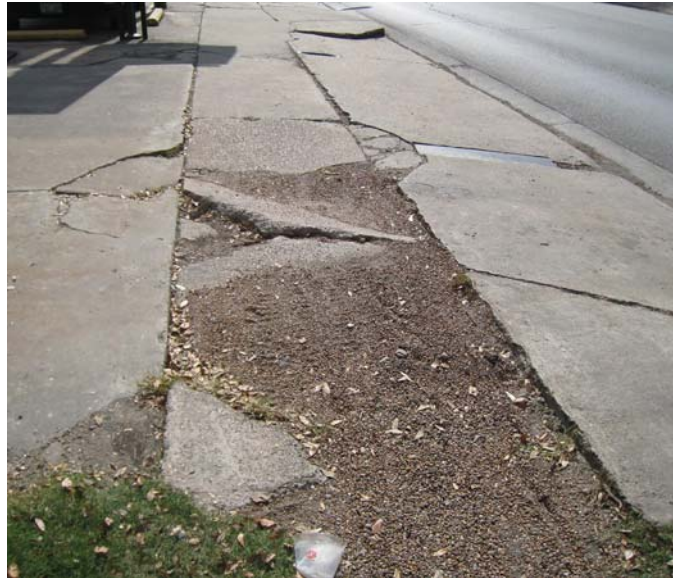
Photo 6-20, Segment 18B
W. Alabama between Mulberry and Yupon
 Sidewalk is cracked, missing, and covered in dirt, making it difficult to traverse.

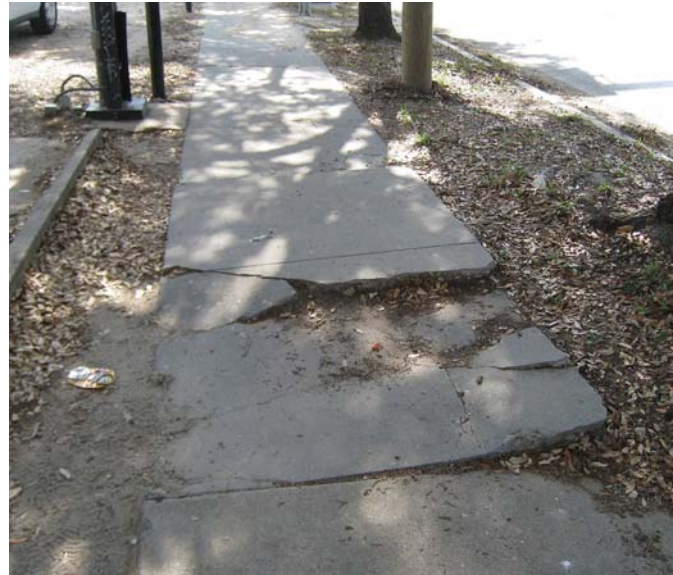
Photo 6-21, Segment 20B
W. Alabama between Yupon and Graustark
 Broken pieces of the sidewalk create tripping hazards.

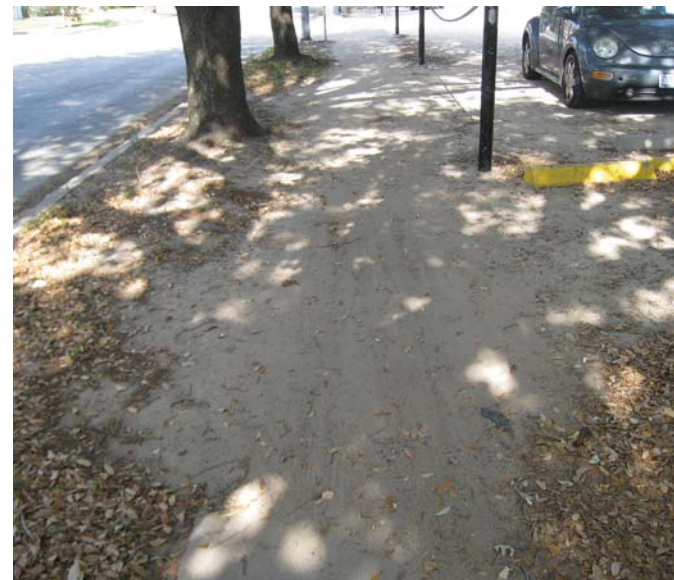
Photo 6-22, Segment 20A
W. Alabama between Yupon and Graustark
Missing and/or buried sidewalk.

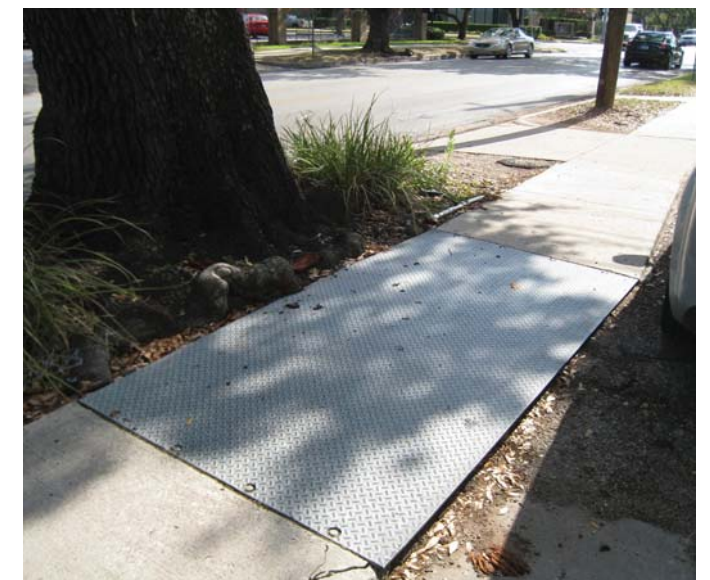
Photo 6-23, Segment 26A
W. Alabama between Yoakum and Montrose
This section is suitable for now, but should be monitored to make sure future tree root growth does not displace metal plate and create tripping hazard.

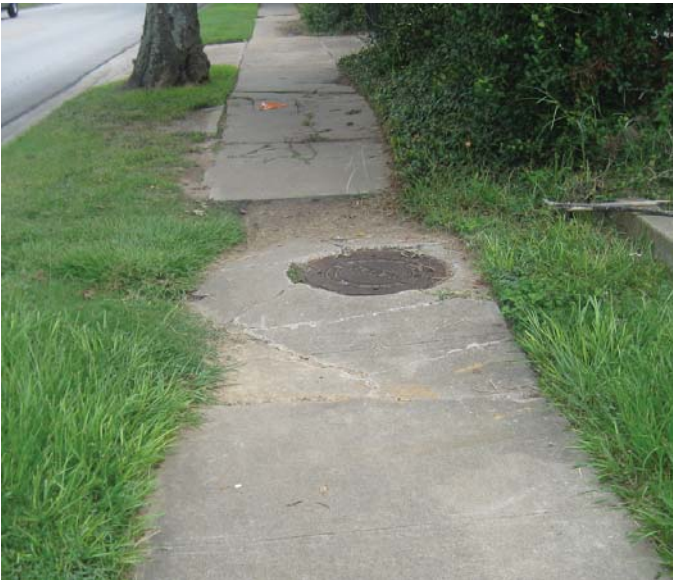
Photo 6-23, Segment 28B
W. Alabama between Montrose and Roseland
 Portions of the sidewalk have cracks and upheaval, and some portion is missing.

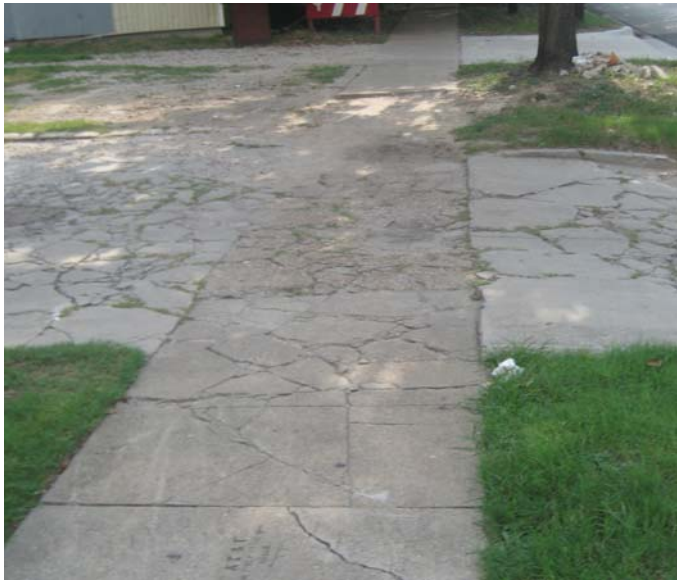
Photo 6-25, Segment 38A
W. Alabama between Audubon and Garrott
 There is substantial cracking.

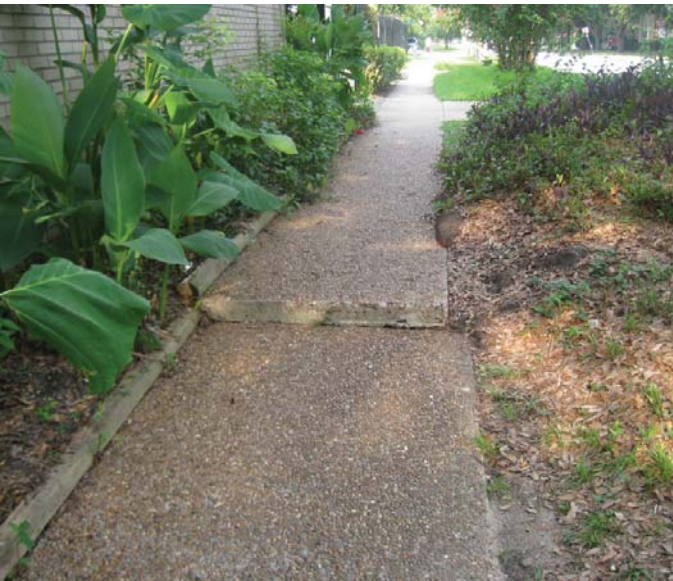
Photo 6-24, Segment 40B
W. Alabama Between Garrott and Bute
 There is substantial upheaval at the sidewalk joint.

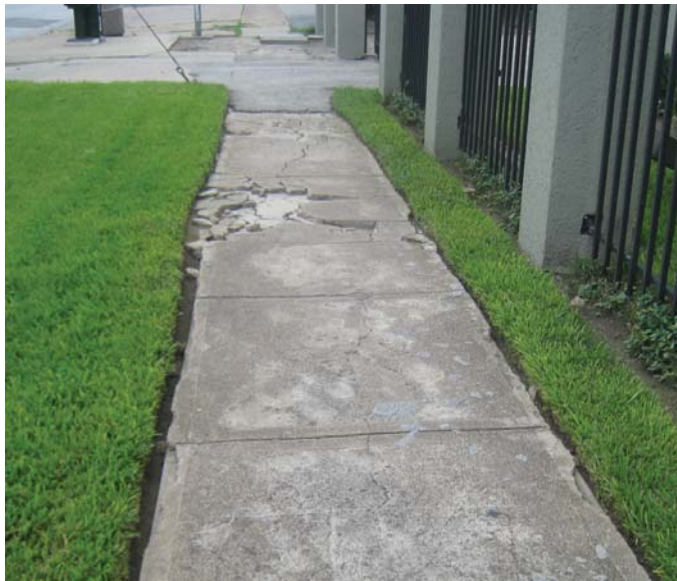
Photo 6-26, Segment 42B
W. Alabama between Bute and Flora
 A section of the sidewalk has broken pieces which might create tripping hazards.

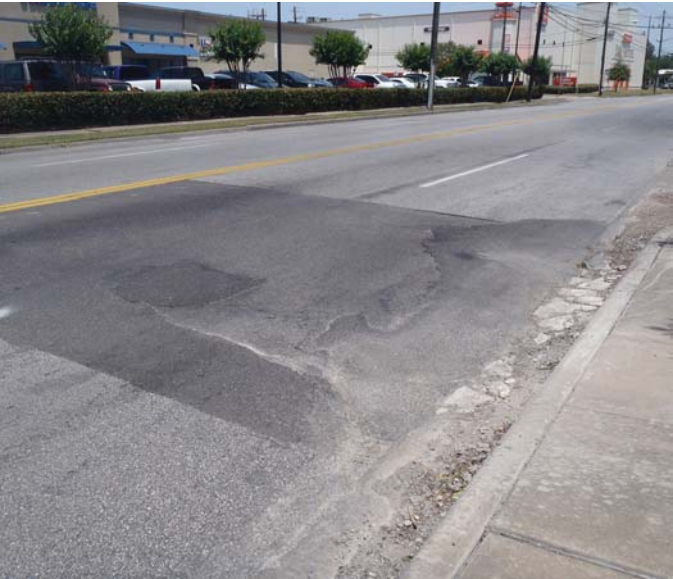
Photo 7-1, Segment 4B
Westheimer between Huldy and Brun
Patched pavement has settled close to the curb and created an uneven riding surface.

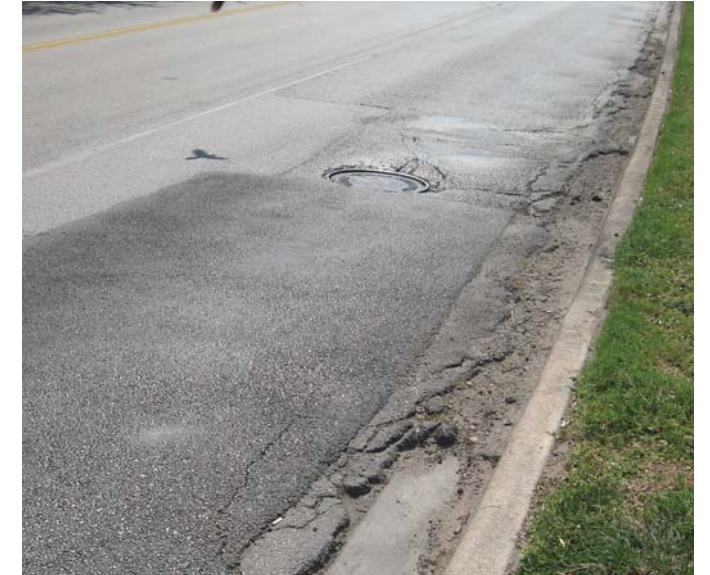
Photo 7-2, Segment 6A
Westheimer between Brun and McDuffie
 Pavement around the patch is crumbling and coming up, additionally the roadway is uneven and has visible ruts where tires traditionally travel.

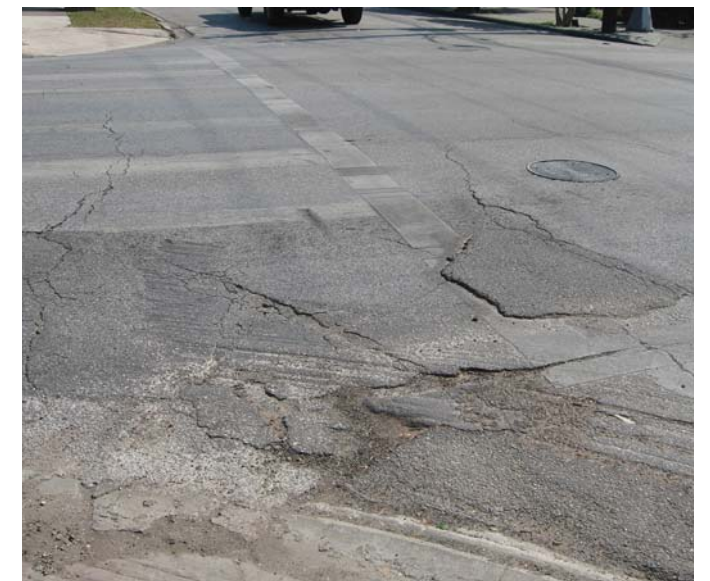
Photo 7-3, Segment 9
Westheimer at Hazard
 Pavement at the corner is cracked and uneven.
