COMPREHENSIVE DISTRICT-WIDE MOBILITY STUDY

*An evaluation of pavement condition, pedestrian accessibility,
cut-through traffic, and markings within the Montrose District*

WALTER P MOORE

February 2012

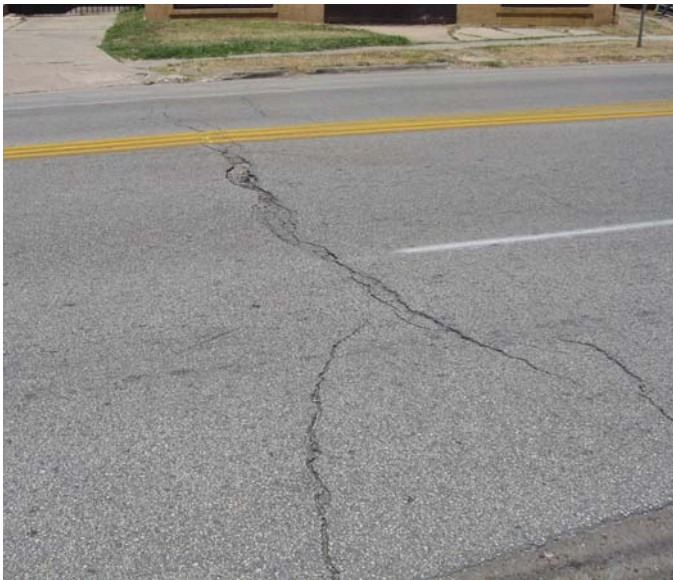
Photo 7-4, Segment 40B
Westheimer between Graustark and Commonwealth
 Large crack across the width of the lanes

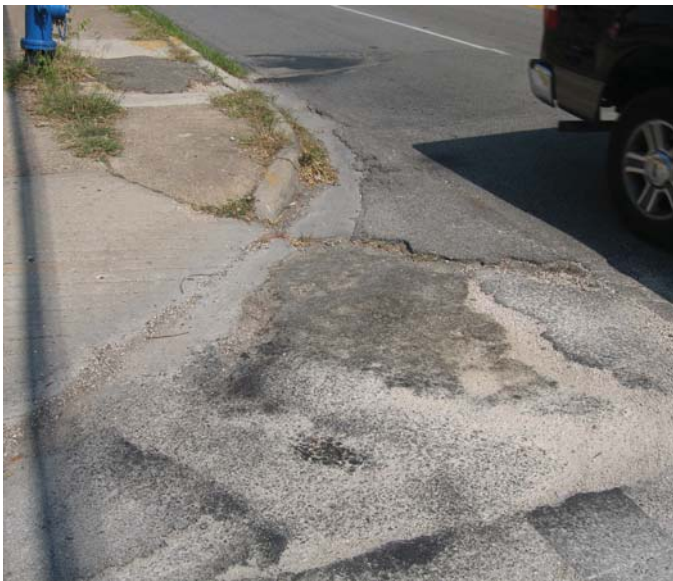
Photo 7-5, Segment 46A
Westheimer between Waughcrest and Waugh
 Missing layer of pavement at corner

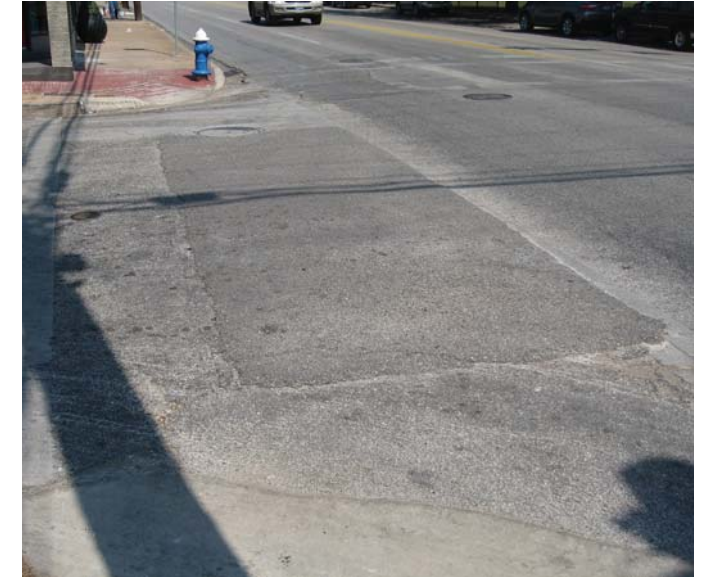
**Photo 7-6, Segment 49
Westheimer at Lincoln**
Pavement patch uneven with the original surface

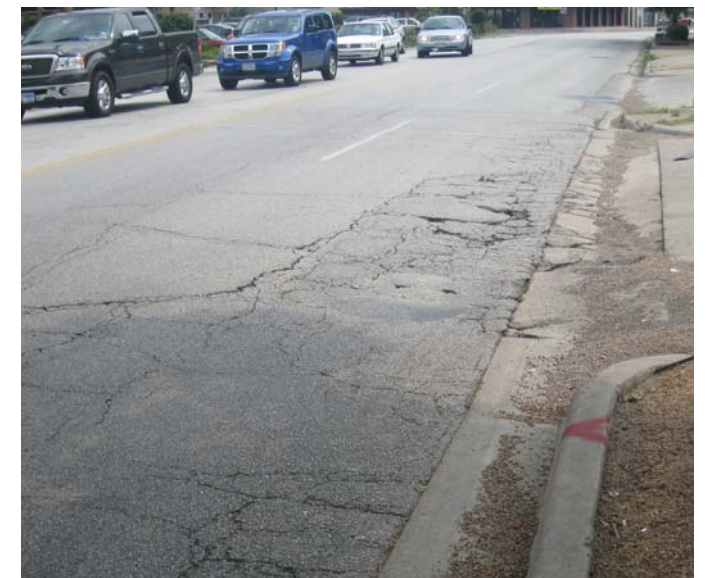
**Photo 7-7, Segment 52B
Westheimer between Montrose and Grant**
Alligator cracks along the outside lane

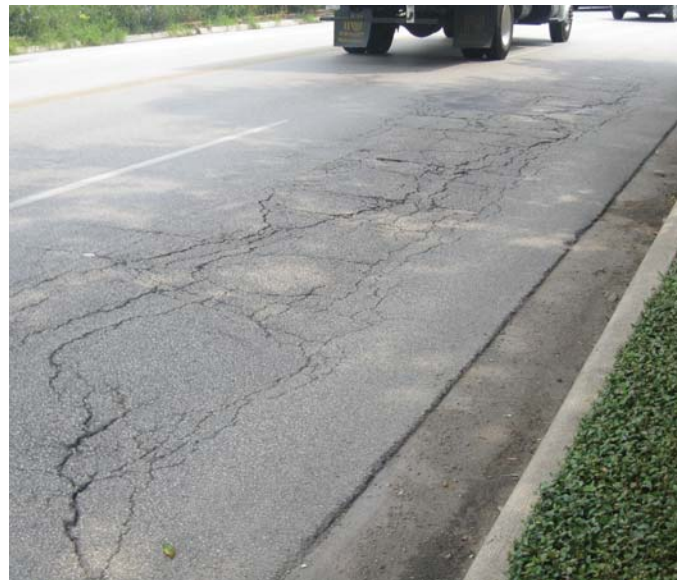
Photo 7-8, Segment 54B
Westheimer between Grant and Crocker
 Alligator cracks along the outside lane

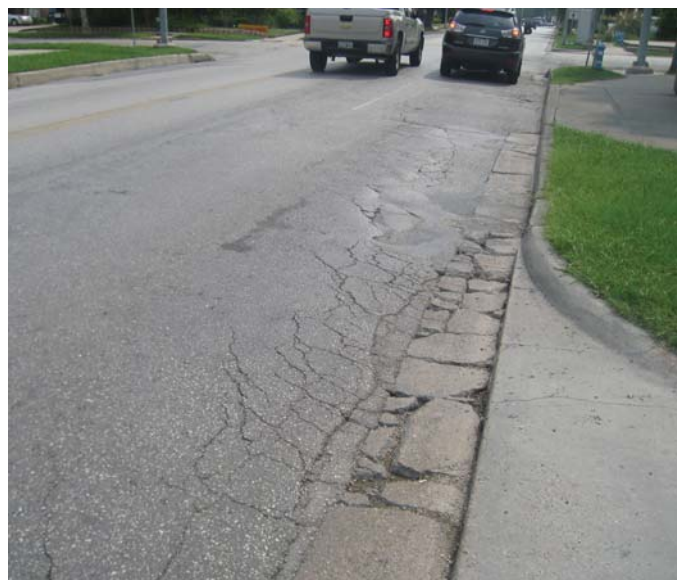
Photo 7-9, Segment 60B
Westheimer between Whitney and Taft
 Severe cracking can be seen in the pavement and gutter sections.

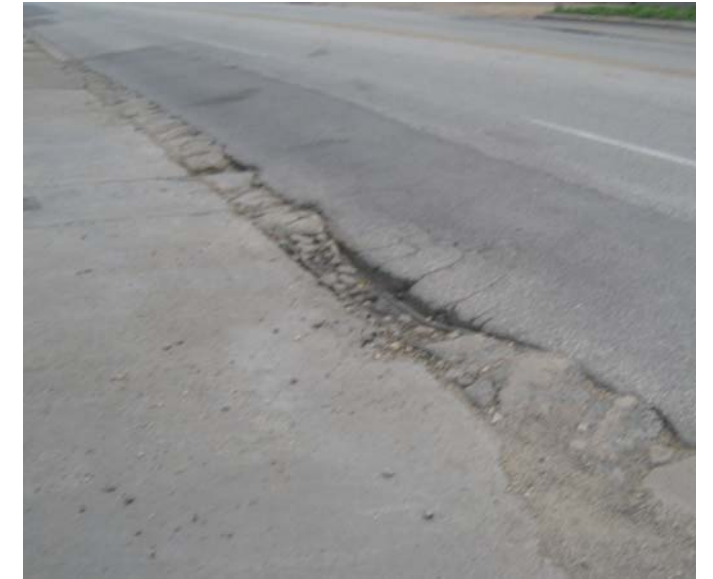
Photo 7-10, Segment 64A
Westheimer between Mason and Helena
Patched pavement section has cracks, and concrete in the gutter section is broken and steel is exposed.

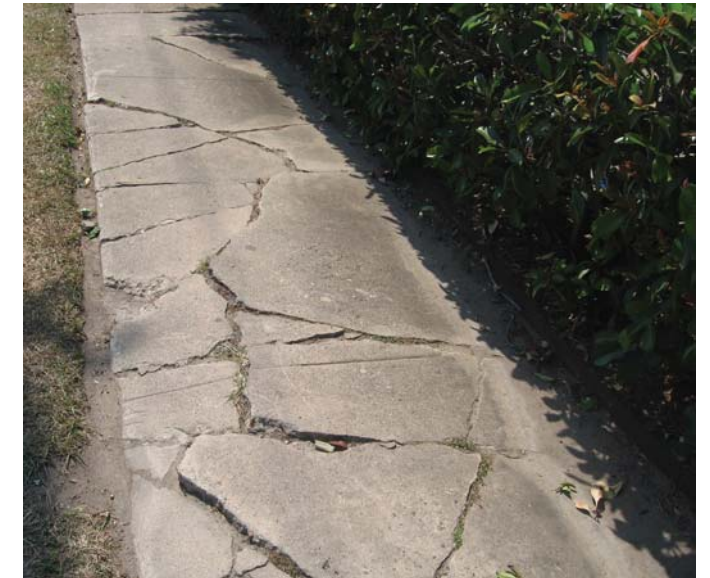
Photo 7-11, Segment 4A
Westheimer between Huldy and Brun
Sidewalk is cracked and has settled, creating tripping hazards.

No marked crosswalks were found across Westheimer at the minor street intersections with Westheimer. Crosswalks at the signalized intersections were generally found to be acceptable. **Photos 7-11** through **7-23** illustrate some of the poor sidewalks and ramps which suggest immediate repair/replacement.

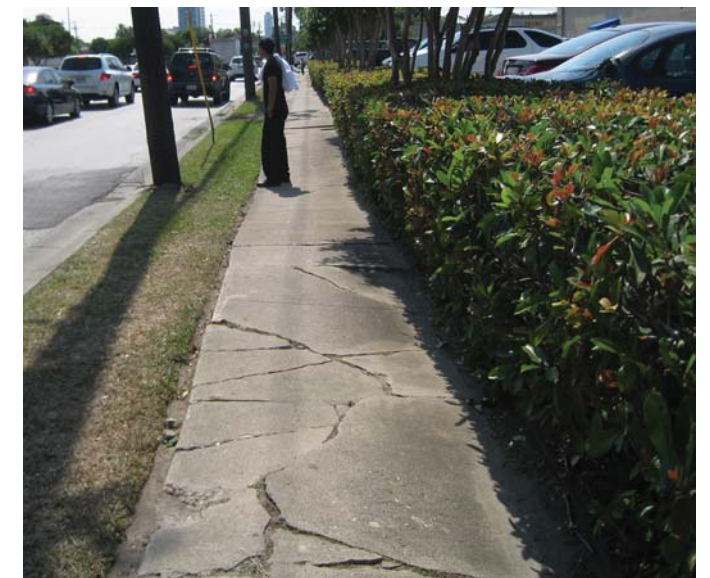
Photo 7-12, Segment 4A
Westheimer between Huldy and Brun
Sidewalk is cracked and has settled, creating tripping hazards.

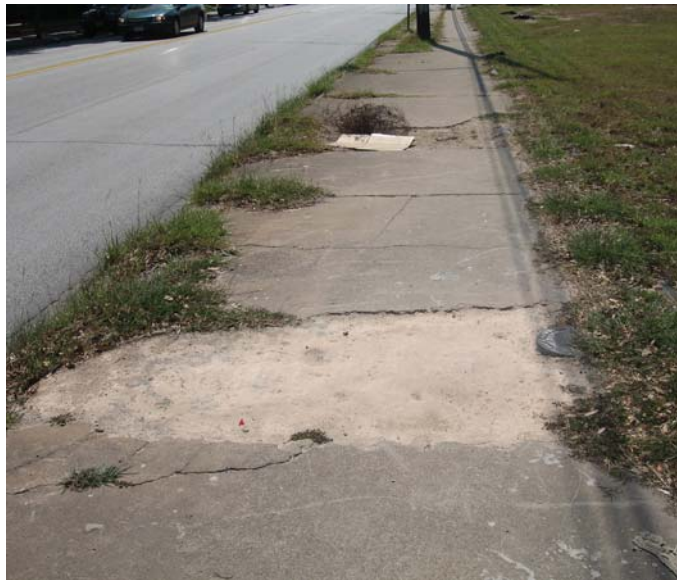
Photo 7-13, Segment 8A
Westheimer between McDuffie and Hazard
 Missing sections of sidewalk periodically through out the block

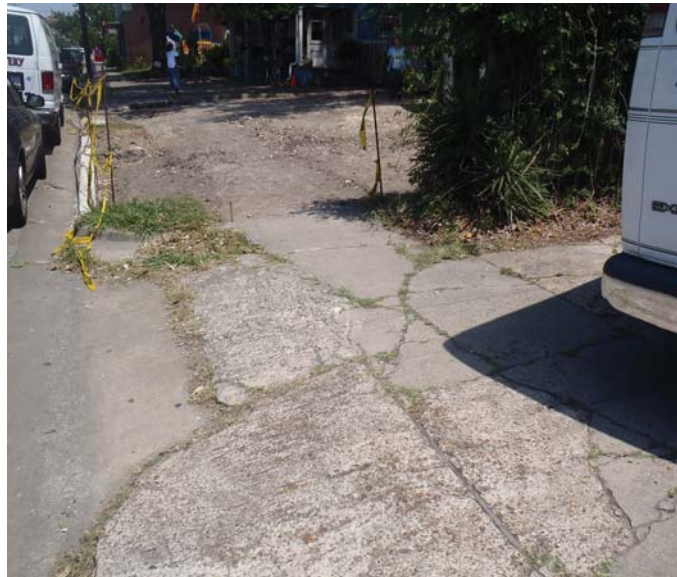
Photo 7-14, Segment 18B
Westheimer between Elmen and Park
 Missing section of sidewalk

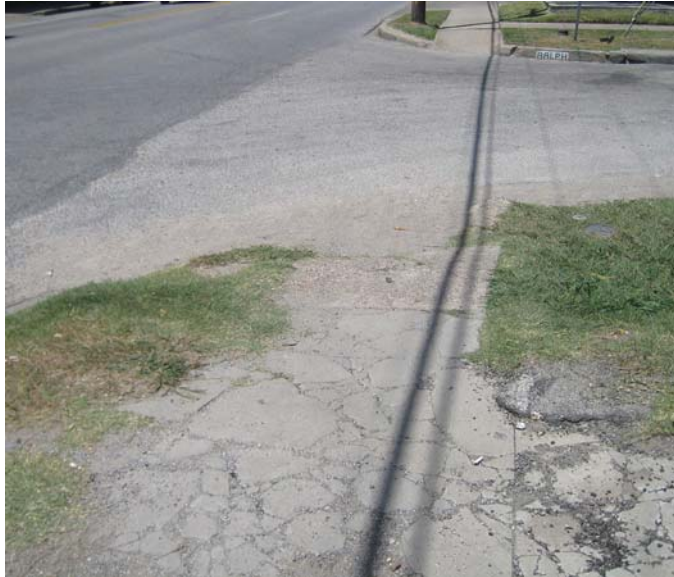
Photo 7-15, Segment 23
Westheimer at Ralph

Sidewalk is cracked and starting to separate.

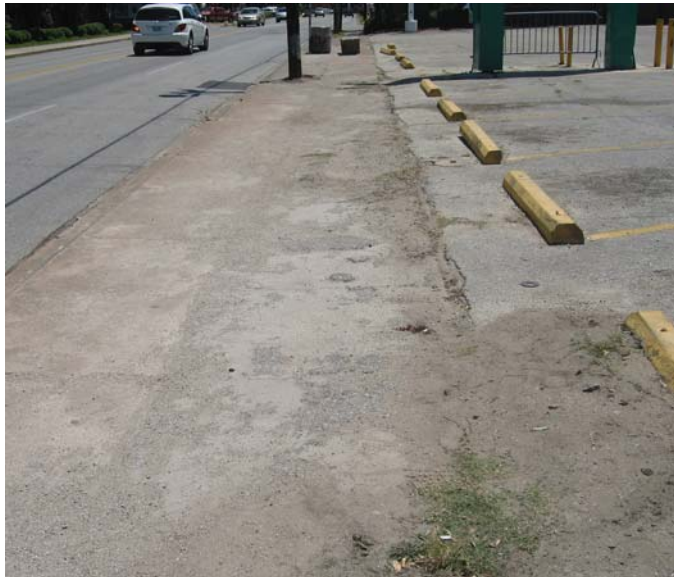
Photo 7-16, Segment 26B
Westheimer between Kuester and Mandell

Sidewalk is covered in so much dust and debris that it is barely discernible. Obstructions block clear path.

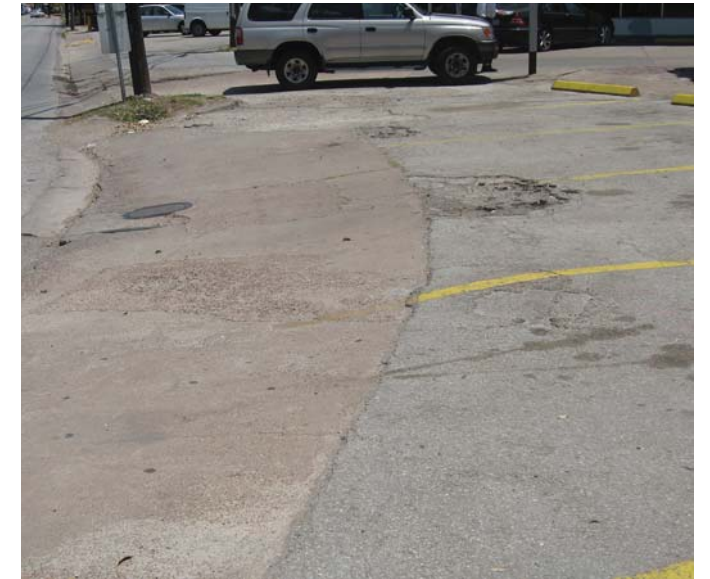
Photo 7-17, Segment 35
Westheimer at Windsor
Sidewalk not well defined and used for parking.

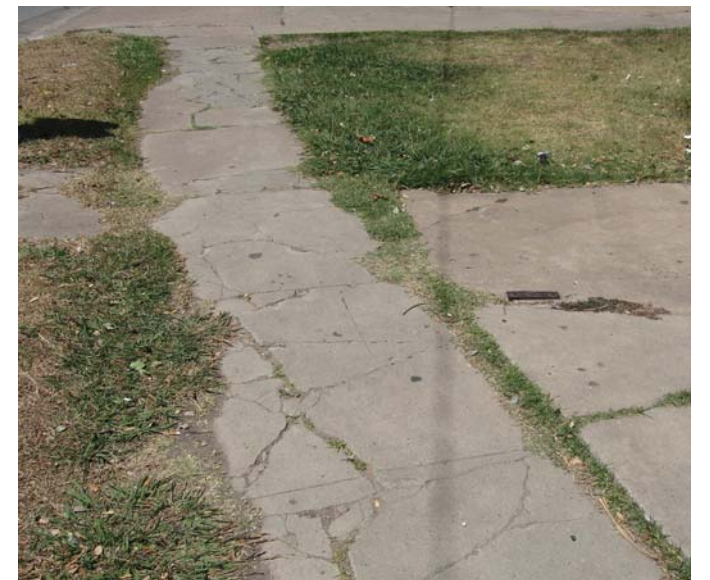
Photo 7-18, Segment 38A
Westheimer between Yupon and Graustark
Sidewalk is broken and edges are starting to settle away from the main walkway.

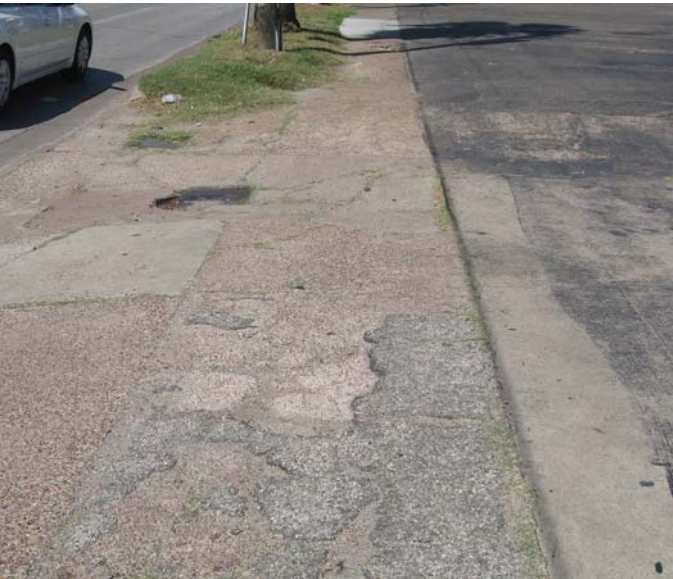
Photo 7-19, Segment 44A
Westheimer between Mt. Vernon and Waughcrest
 Excess asphalt on top of existing sidewalk creates tripping hazards.

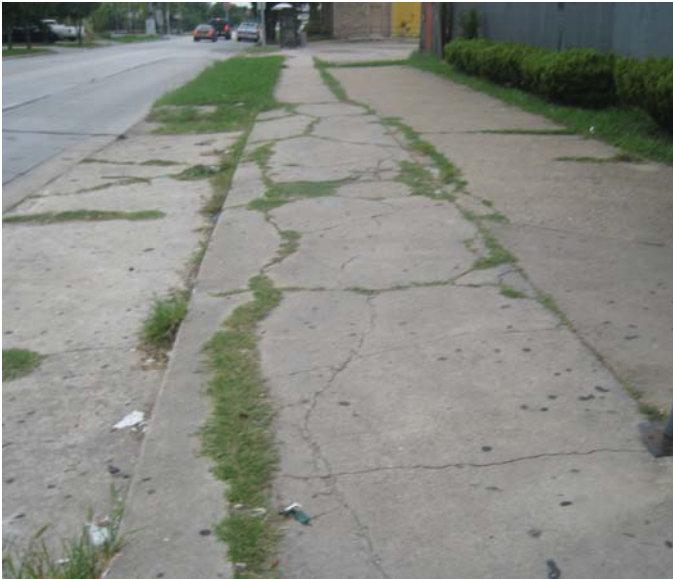
Photo 7-21, Segment 62A
Westheimer between Taft and Mason
 Cracks in the sidewalk and grass growth in the cracks

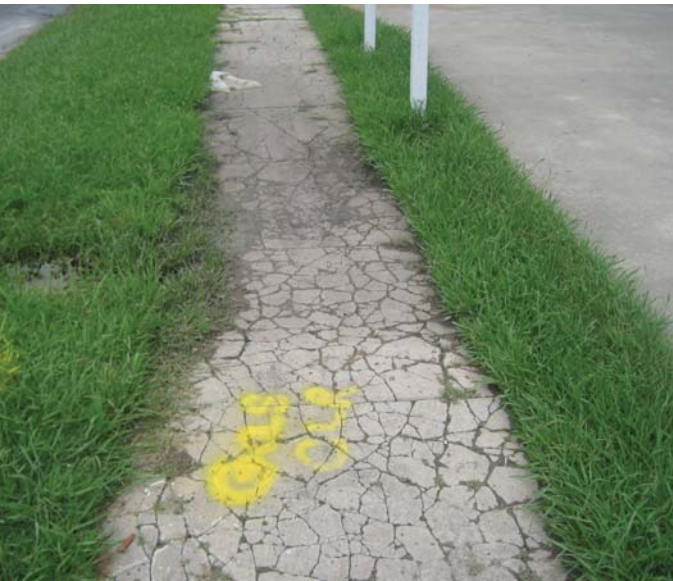
Photo 7-20, Segment 60A
Westheimer between Whitney and Taft
 Severe cracks have formed in the sidewalk.

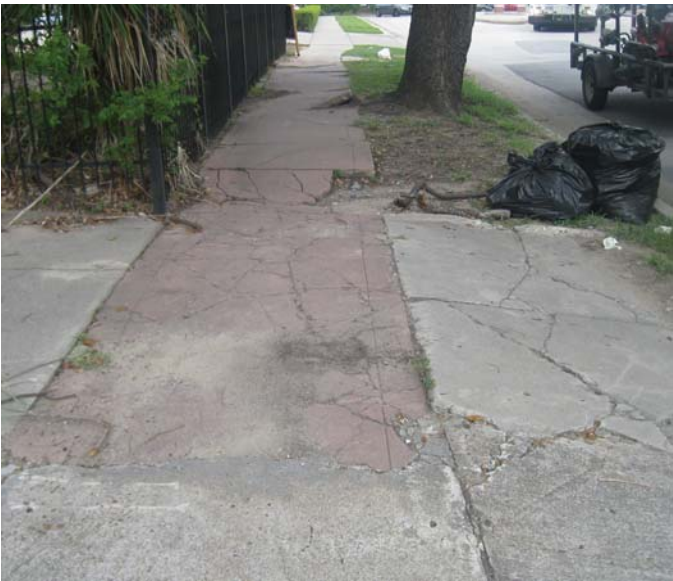
Photo 7-22, Segment 66A
Westheimer between Helena and Bagby
 Cracks and missing section of sidewalk, with upheaval between broken sections of the sidewalk.

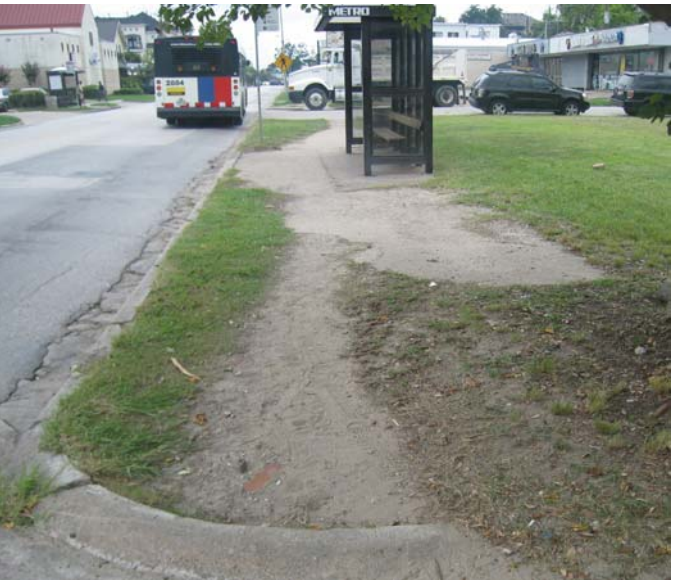
Photo 7-23, Segment 66A
Westheimer between Helena and Bagby
Missing section of sidewalk and ramp on the approach to bus shelter.

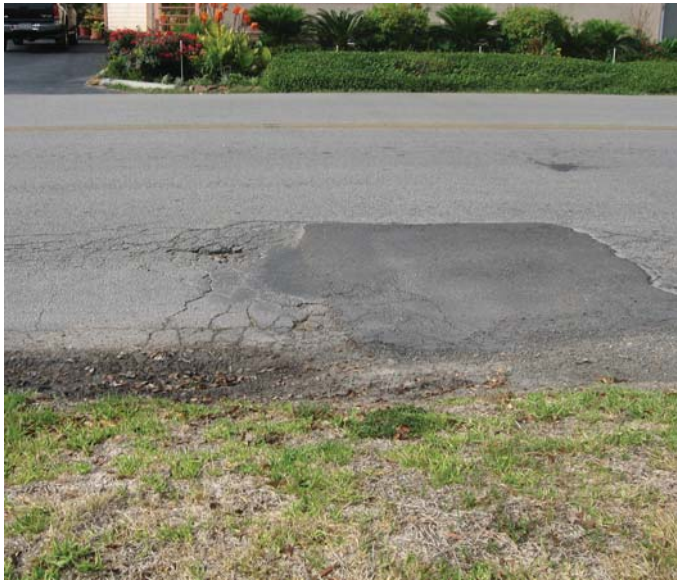
Photo 8-1, Segment 2A
Fairview between Shepherd and Huld
 Patched pavement with cracks and missing sections just before Shepherd.

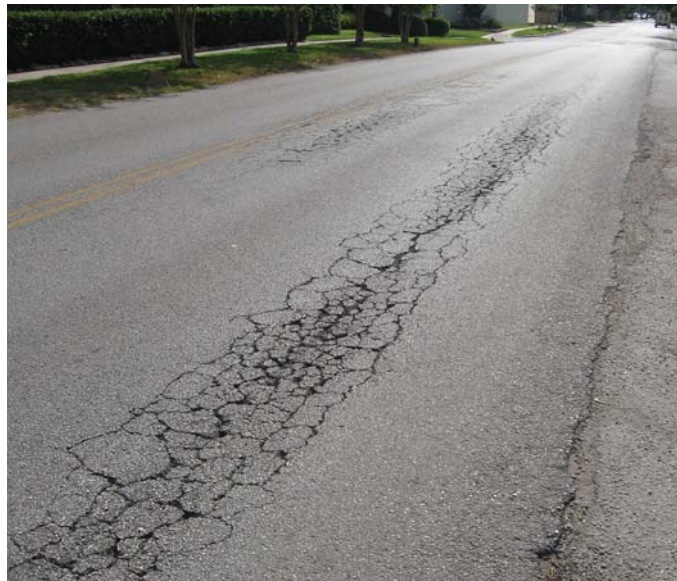
Photo 8-2, Segment 12B
Fairview between Driscoll and Morse
 Alligator cracks where tires traditionally travel.

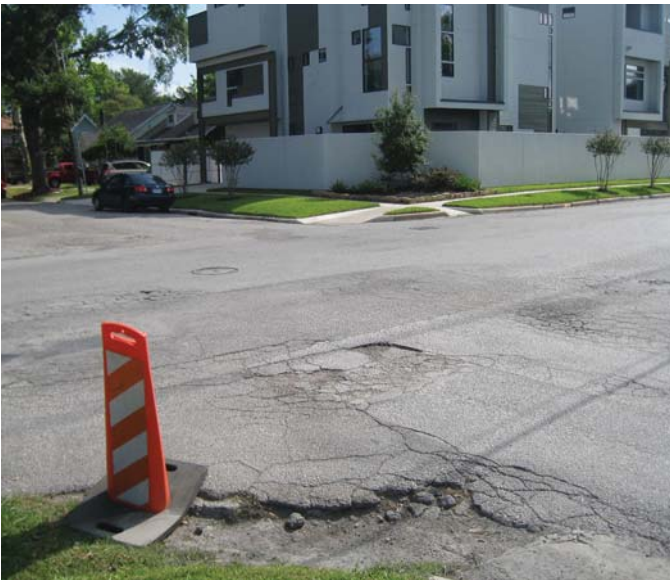
Photo 8-3, Segment 13
Fairview at Morse

There is no defined curb at corner and sections of asphalt have broken off.

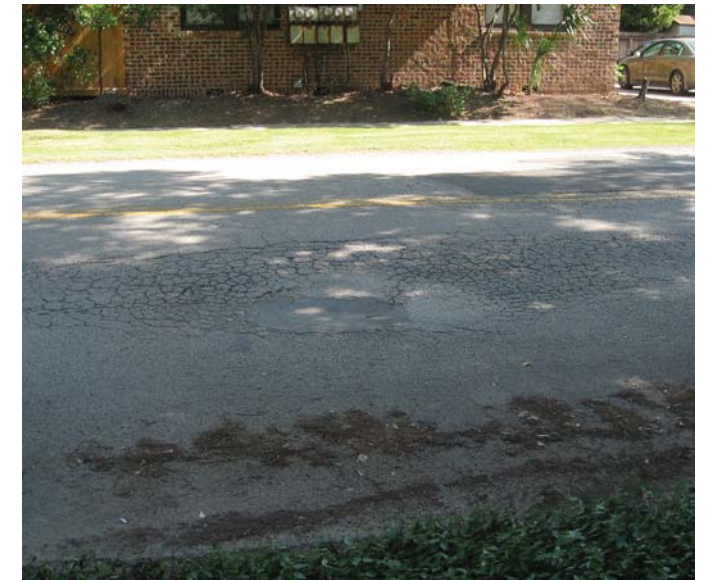
Photo 8-4, Segment 19
Fairview at Park

Alligator cracking and settling of the pavement, creating an uneven riding surface

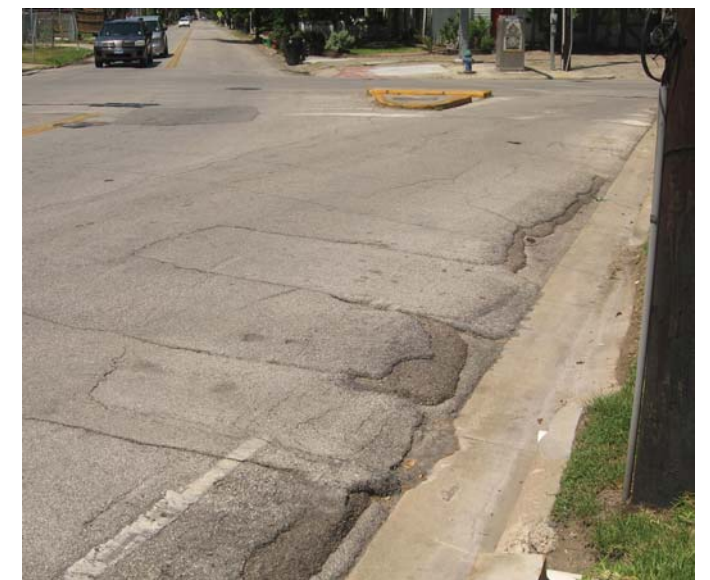
Photo 8-5, Segment 36A
Fairview between Vaughn and Upas

Visible settling of the pavement near the curb are worn, exposing previous asphalt overlays

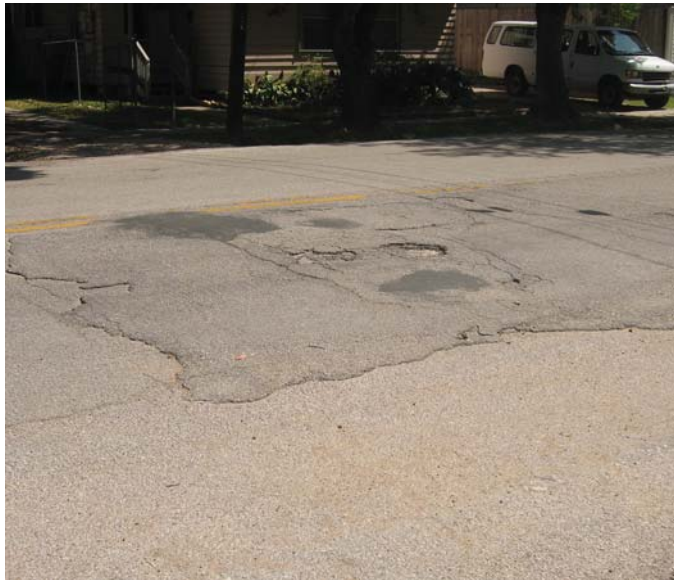
Photo 8-6, Segment 38B
Fairview between Upas and Van Buren
 Sections of a previous patch have begun to come up and create pot holes.

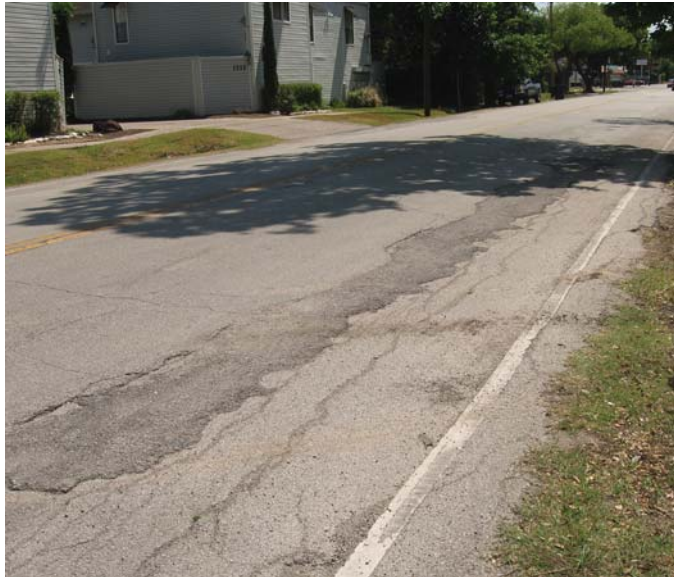
Photo 8-7, Segment 42B
Fairview between Yoakum and Montrose
 Roadway settling that has been previously patched is uneven with remaining roadway.

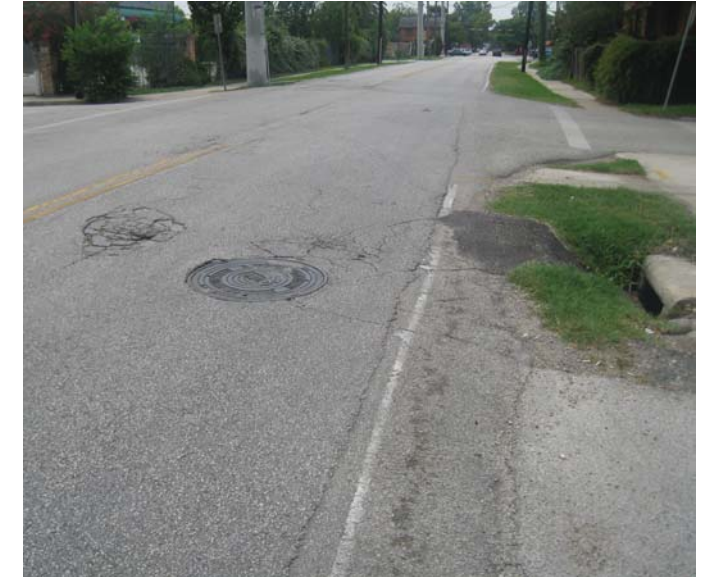
**Photo 8-8, Segment 48A
Fairview between Converse and Crocker**
Several cracks and a pothole have formed in this section of the pavement.

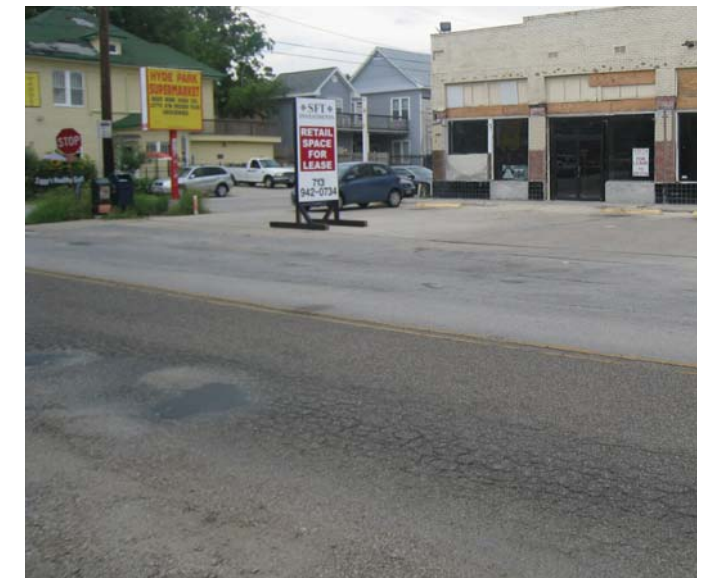
**Photo 8-9, Segments 60A & 60B
Fairview between Taft and Mason**
Eastbound lanes are weathered forming cracks.
Westbound section has multiple potholes.

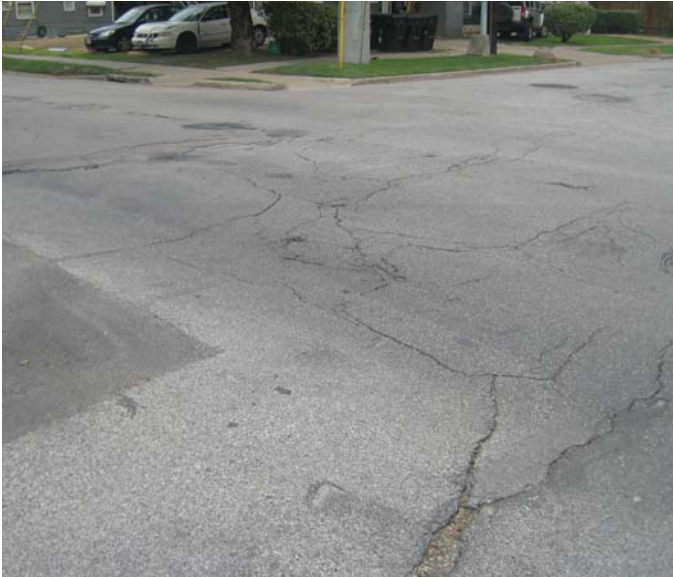
Photo 8-10, Segment 61
Fairview at Mason

Cracks and potholes can be seen in the middle of the intersection which create uneven riding surface.

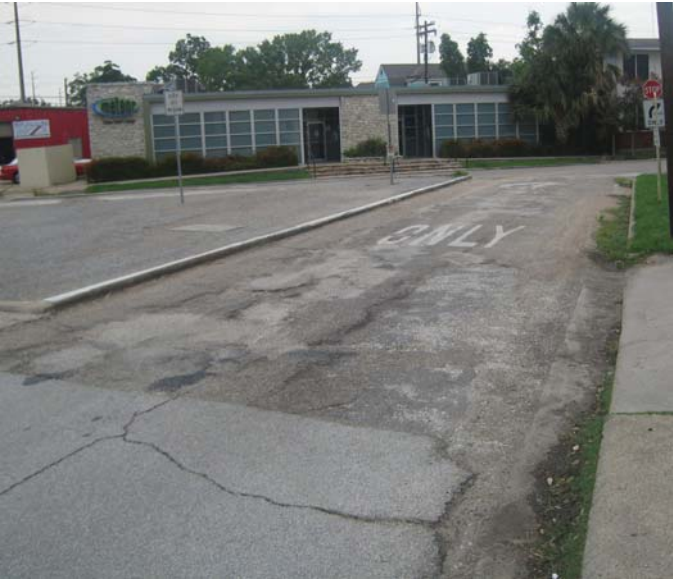
Photo 8-11, Segment 63
Fairview at Genesee

Several potholes exist on this section of the pavement creating uneven riding surface.

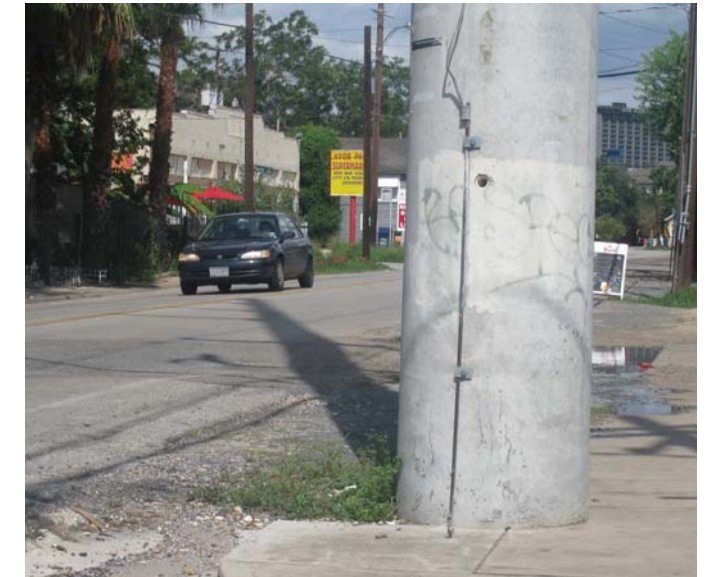
Photo 8-12, Segment 57
Fairview at Morgan
 Power pole obstructing view looking eastbound

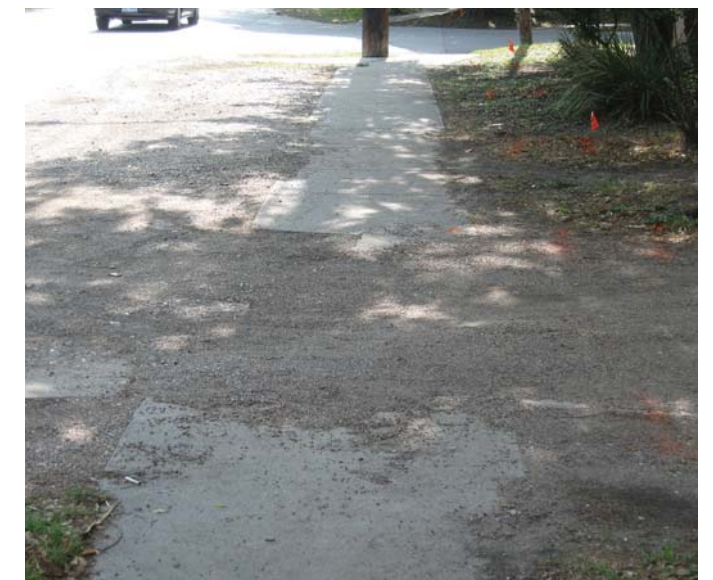
Photo 8-13, Segment 10B
Fairview between Hazard and Driscoll
 Missing section of sidewalk

Despite being a very popular pedestrian zone east of Montrose, particularly at night, sidewalk sections are missing or in poor condition for much of the length of the Fairview corridor, particularly near Montrose. It is recommended f that the roadway be reconstructed with curb and gutter and sidewalks for the full length of Fairview.

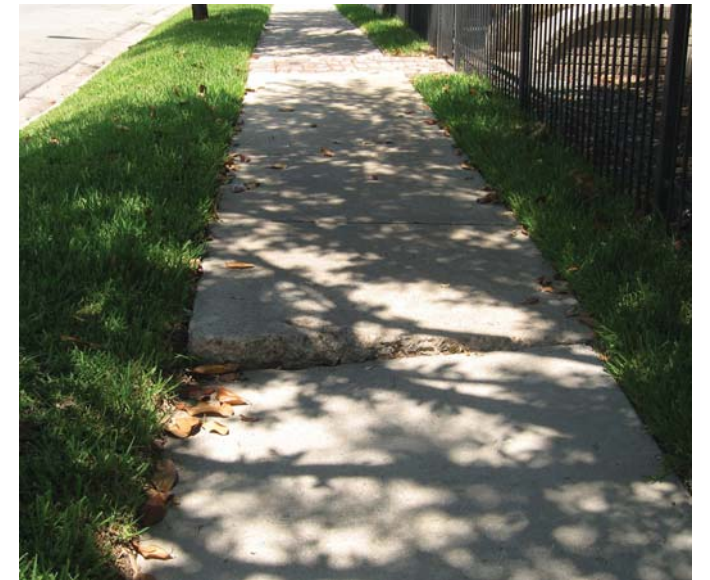
Photo 8-14, Segment 14A
Fairview between Morse and Woodhead
Sidewalk upheaval has created a tripping hazard.

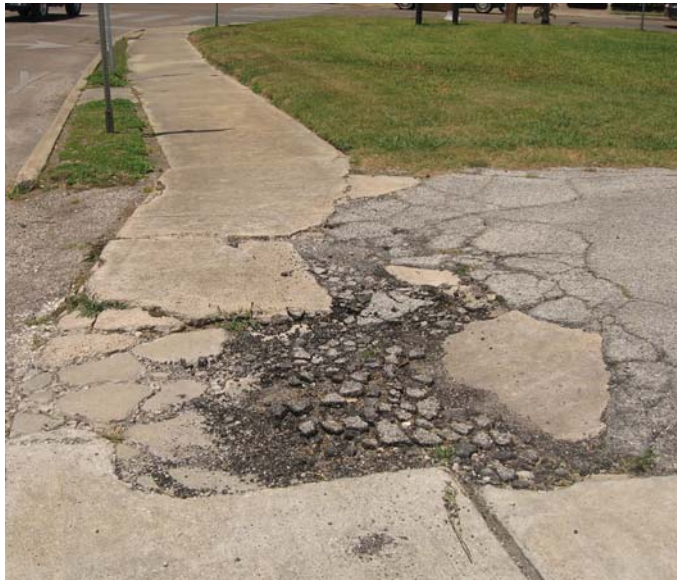
Photo 8-15, Segment 21
Fairview at Dunlavy
Settling of the sidewalk at the ramp and drain has created a tripping hazard.

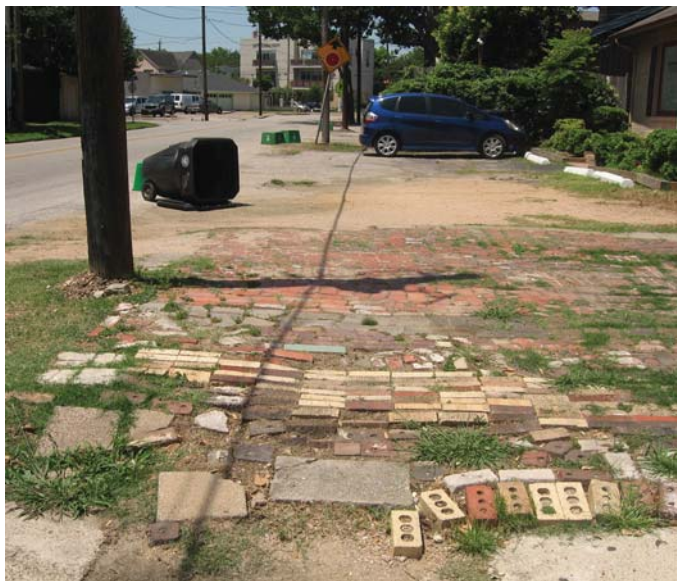
Photo 8-16, Segment 22A
Fairview between Dunlavy and Ralph
 Broken and missing section of sidewalk creates a section that is challenging to traverse.

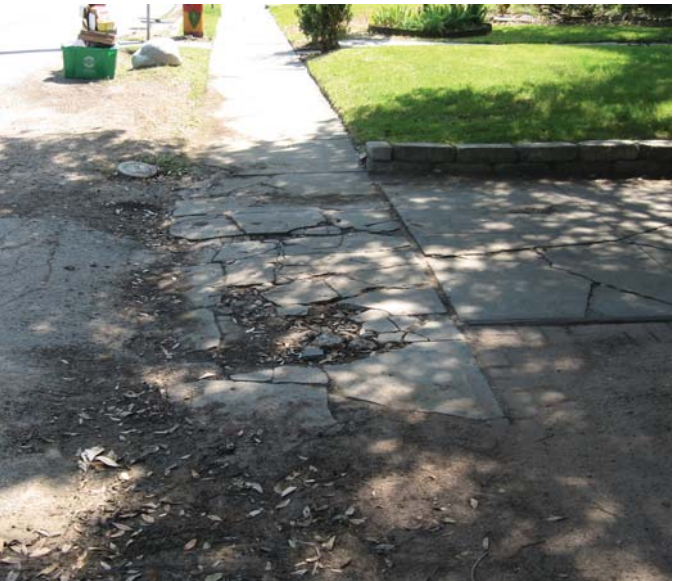
Photo 8-18, Segment 26B
Fairview between Mandell and Ridgewood
Sidewalk is cracked with sections missing and loose.

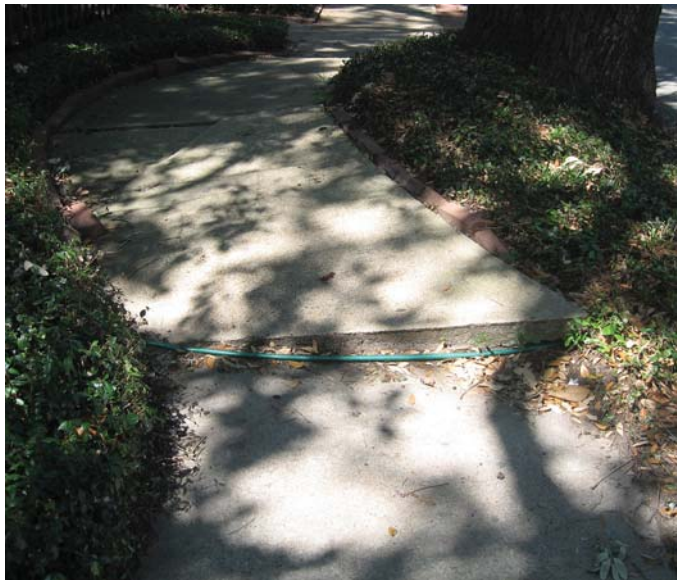
Photo 8-19, Segment 30B
Fairview between Windsor and Yupon
 Tree root growth has shifted whole section of the sidewalk, creating a tripping hazard.

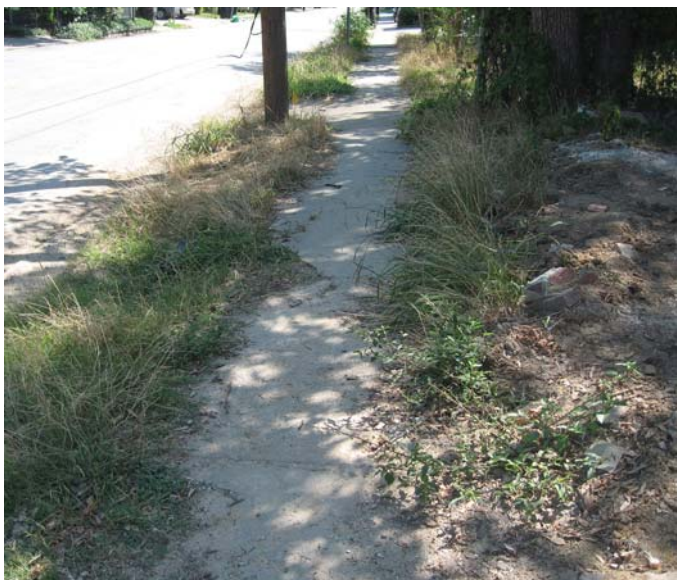
Photo 8-20, Segment 32B
Fairview between Yupon and Commonwealth
 Sidewalk is cracked, and adjacent landscaping has started to overtake the sidewalk, narrowing the passable area.

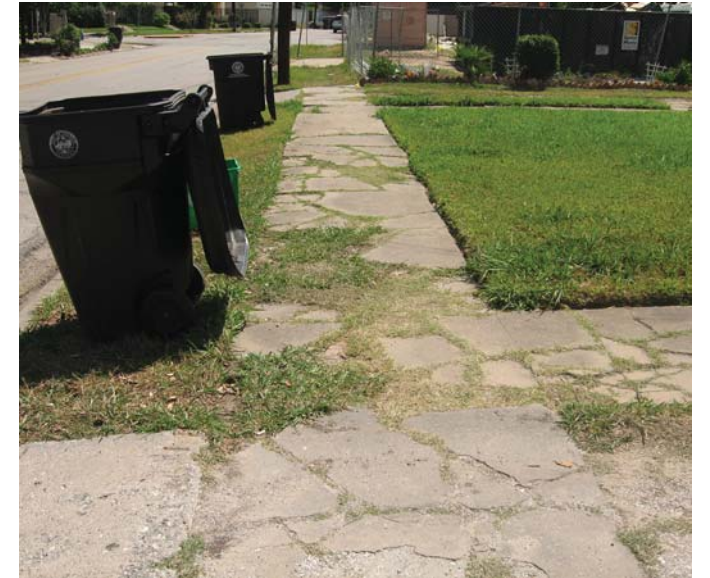
Photo 8-21, Segment 32B
Fairview between Yupon and Commonwealth
 Sidewalk is cracked and sections are missing.

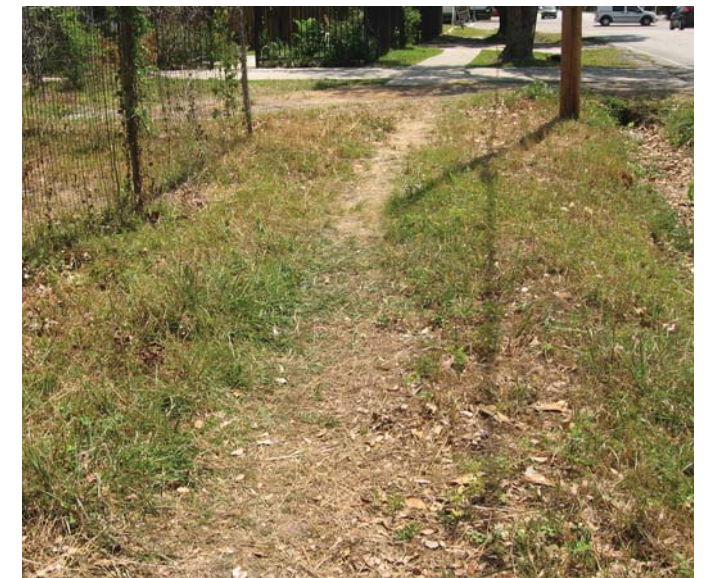
Photo 8-22, Segment 42A
Fairview between Yoakum and Montrose
 Missing sidewalk

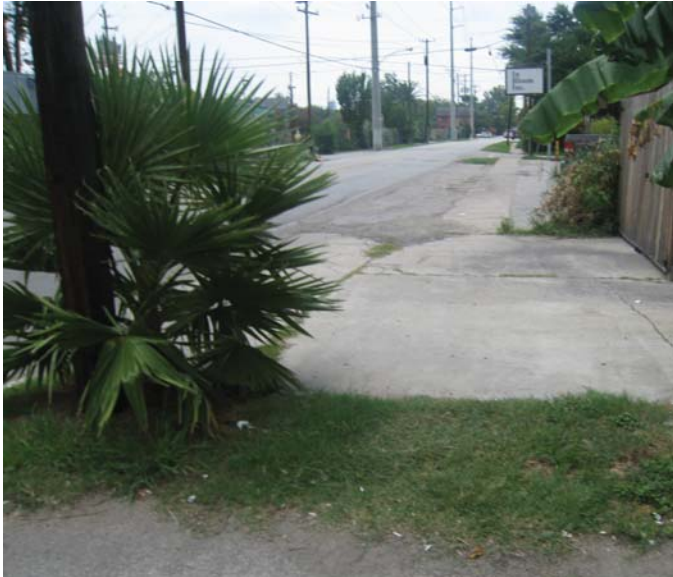
Photo 8-23, Segment 48A
Fairview between Converse and Crocker
 Sidewalk is missing. Vegetation growth in the sidewalk which makes it difficult for pedestrians to use the sidewalk.

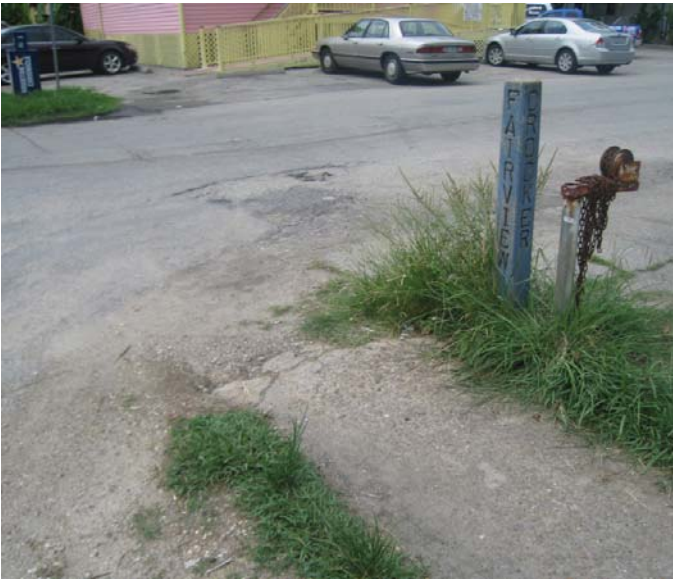
Photo 8-24, Segment 49
Fairview at Crocker
 Missing intersection ramps

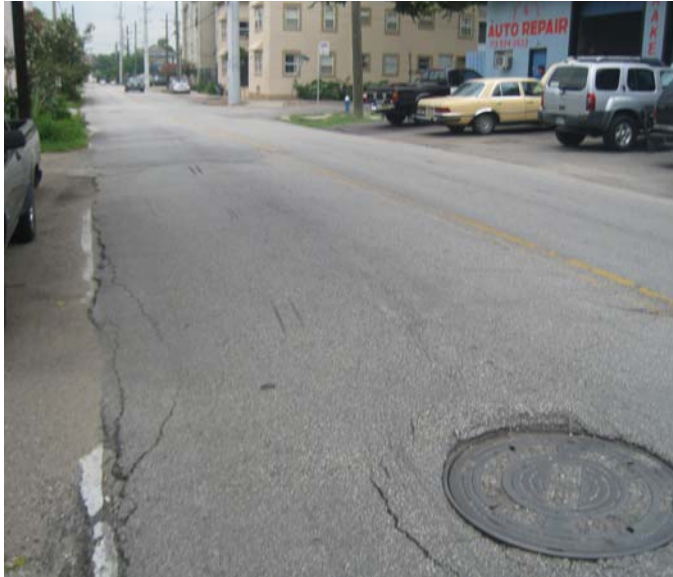
Photo 8-25, Segment 54B
Fairview between Hopkins and Whitney
 Parking in front of the auto shop extends through the sidewalk space, leaving pedestrians minimal space to walk on the south side of the street.

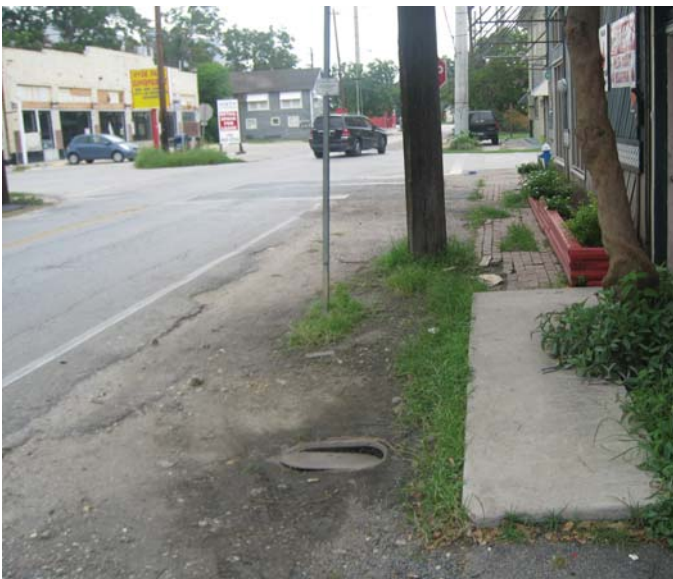
Photo 8-26, Segment 58B
Fairview between Morgan and Taft
 Narrow and uneven sidewalk with inconsistent use of materials

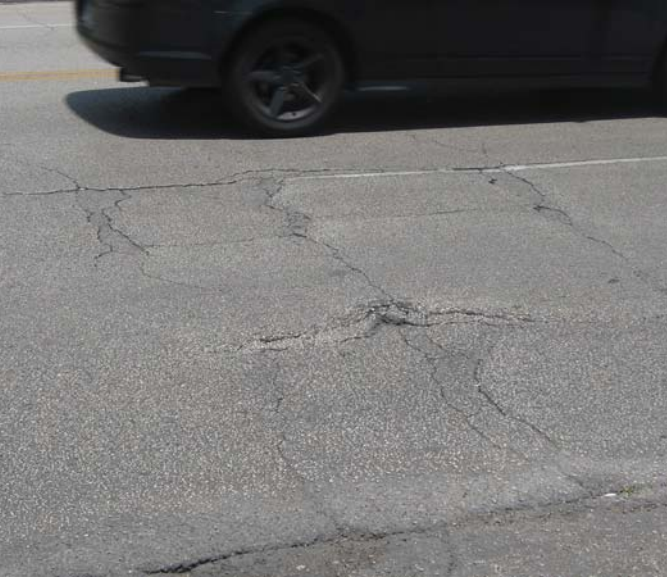
Photo 9-1, Segment 4B
W. Gray between Driveway and McDuffie
Pavement settling has created an uneven riding surface.

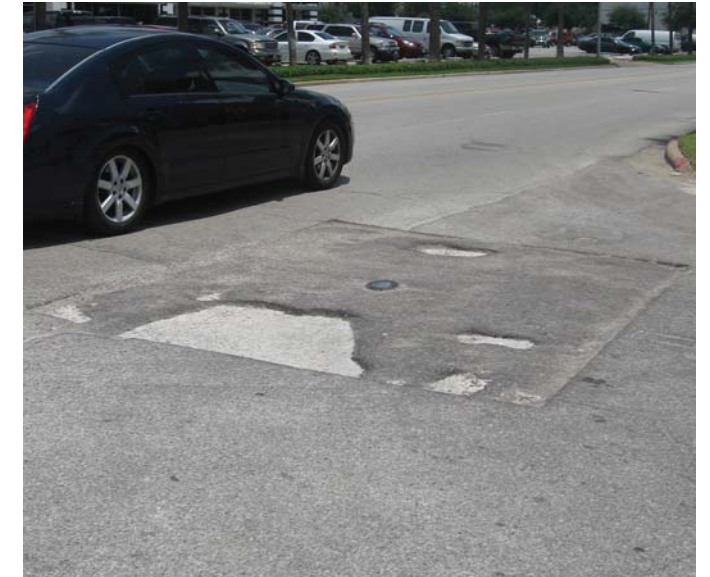
Photo 9-2, Segment 7
W. Gray at Driscoll
 Previous patch is coming up in sections, creating potholes and an uneven riding surface.

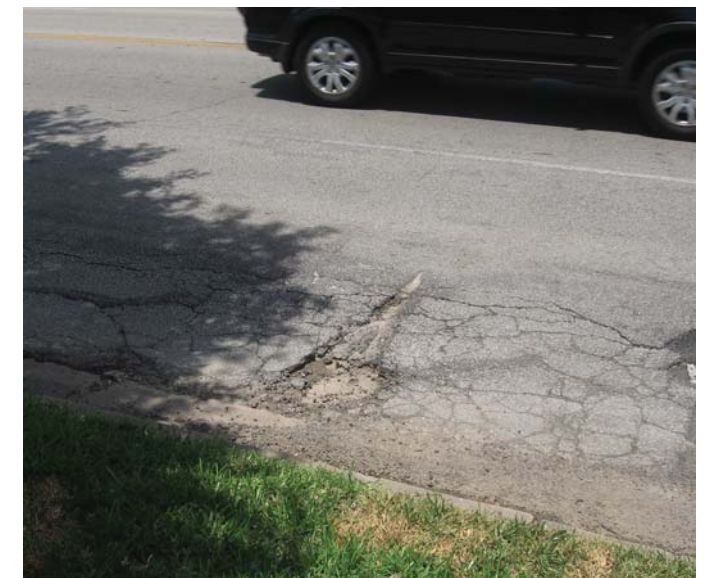
Photo 9-3, Segment 10B
W. Gray between Woodhead and Dunlavy
 Cracking near the curb has begun to create section that have been kicked up and create potholes.

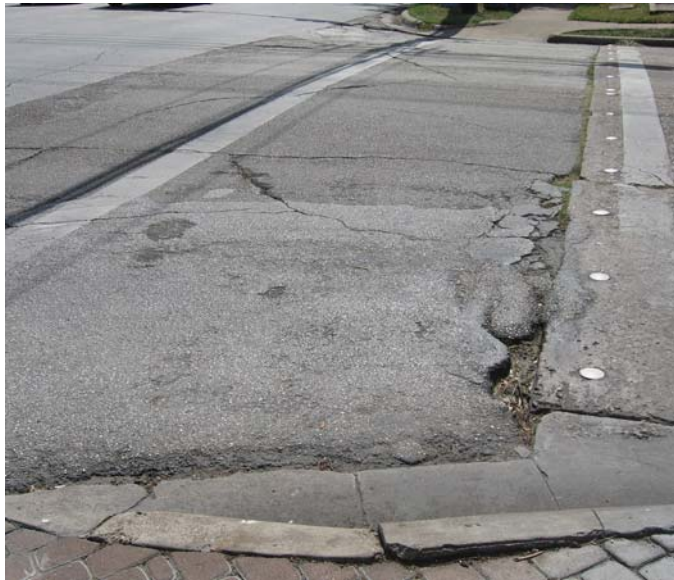
Photo 9-4, Segment 11
W. Gray at Dunlavy

There are cracks and sections missing near the pavement joints.

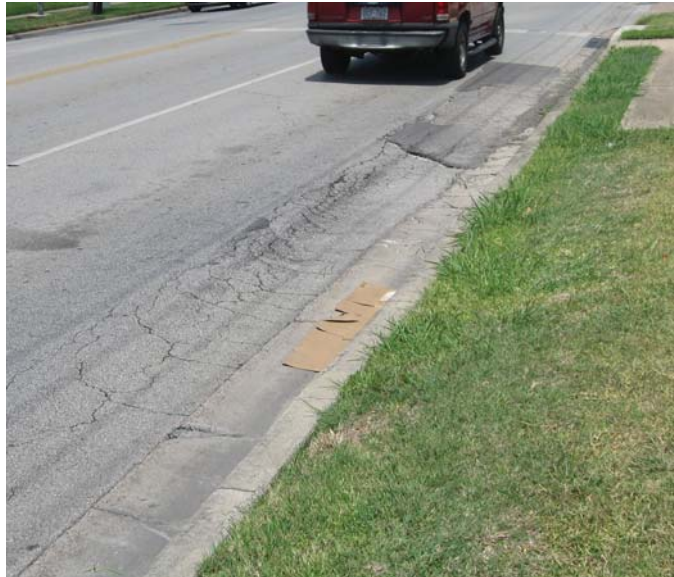
Photo 9-5, Segment 12B
W. Gray between Dunlavy and Metropolitan
Settlement has created alligator cracking.

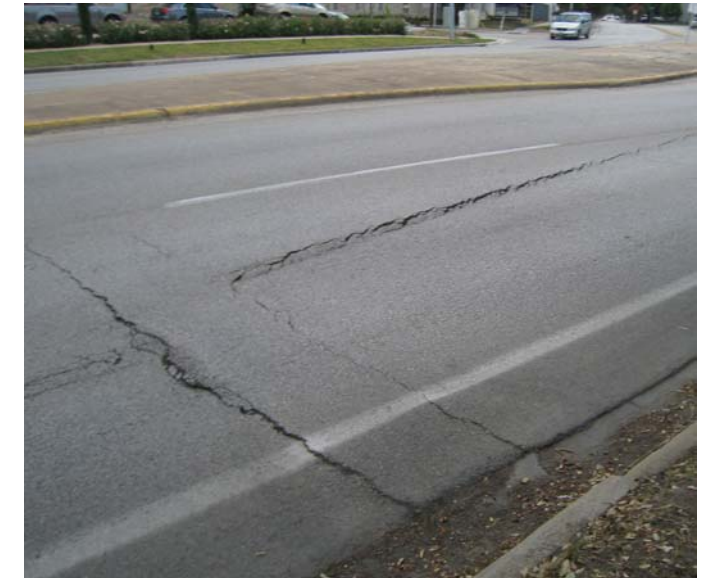
**Photo 9-6, Segment 15
W. Gray at Waugh**

Settling both parallel and perpendicular to the vehicular travel path

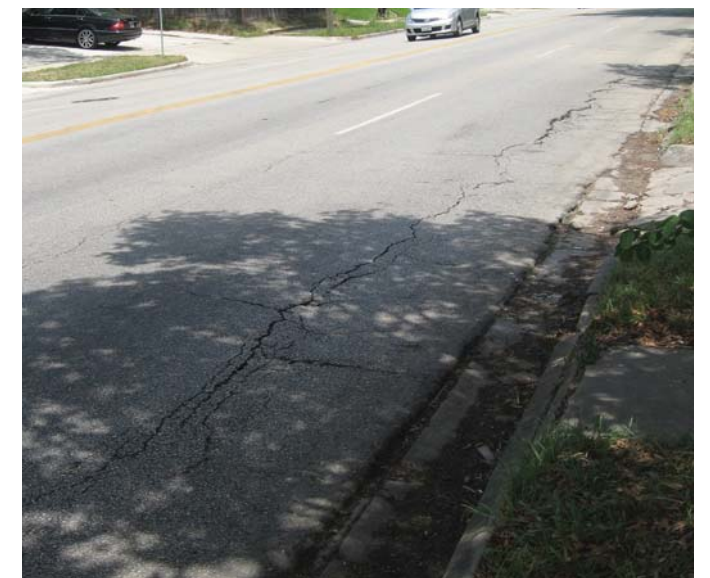
**Photo 9-7, Segment 16B
W. Gray between Waugh and Hazel**

Settling near the curb

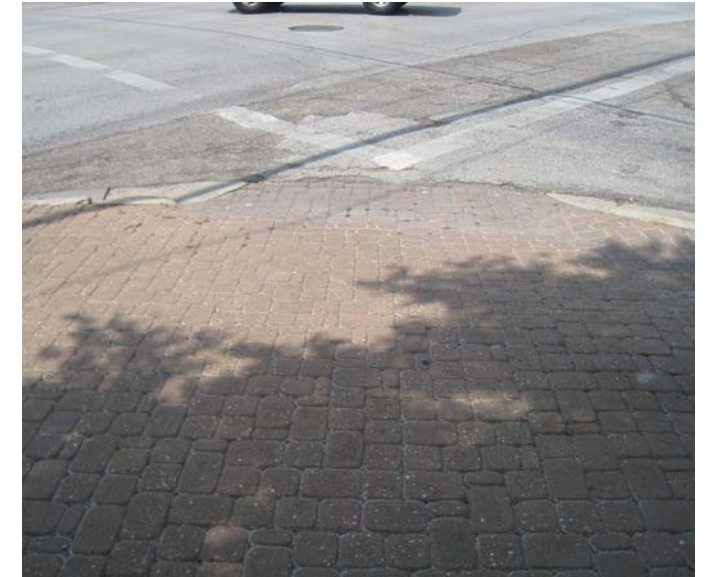
Photo 9-8, Segment 11
W. Gray at Dunlavy
Non-compliant ramp
