COMPREHENSIVE DISTRICT-WIDE MOBILITY STUDY

*An evaluation of pavement condition, pedestrian accessibility,
cut-through traffic, and markings within the Montrose District*

WALTER P MOORE

February 2012

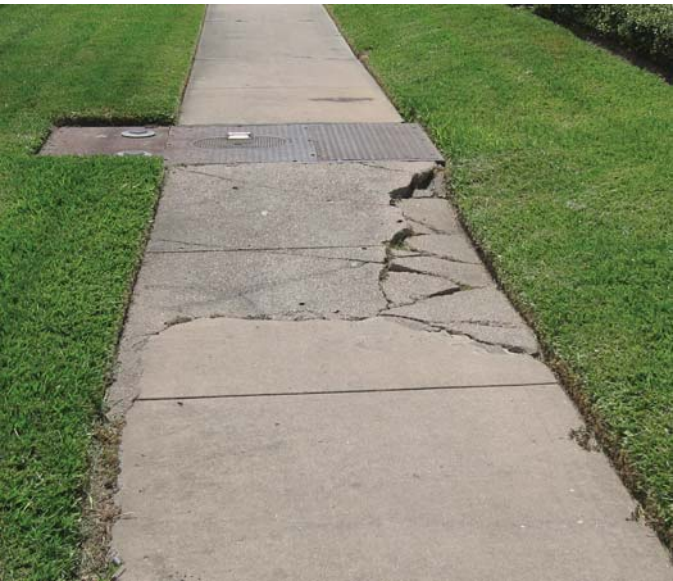
Photo 9-9, Segment 12A
W. Gray between Dunlavy and Metropolitan
Cracking of the sidewalk

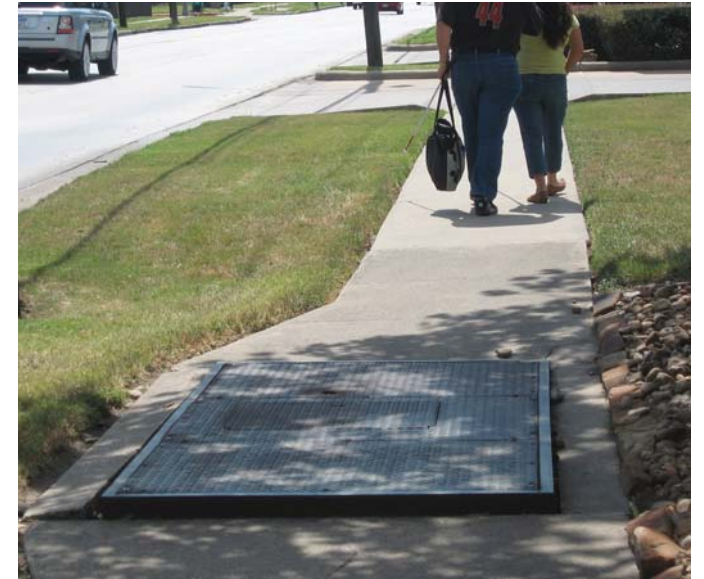
Photo 9-10, Segment 14A
W. Gray between Metropolitan and Waugh
Metal utility feature is not even with the sidewalk and creates a tripping hazard.

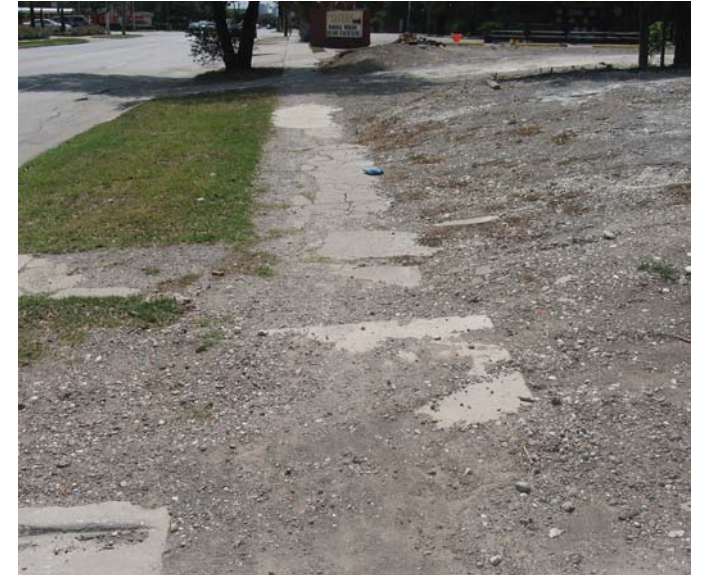
Photo 9-11, Segment 16A
W. Gray between Waugh and Hazel
Major portions of the sidewalk are either missing or covered by dirt and gravel.

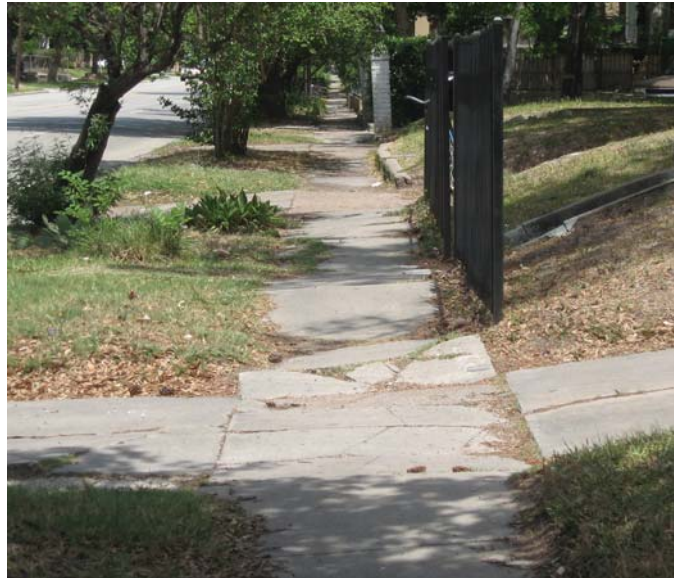
Photo 9-12, Segment 16B

Sections of the sidewalk are in various states of upheaval, making it hard to pass for pedestrians with disabilities.

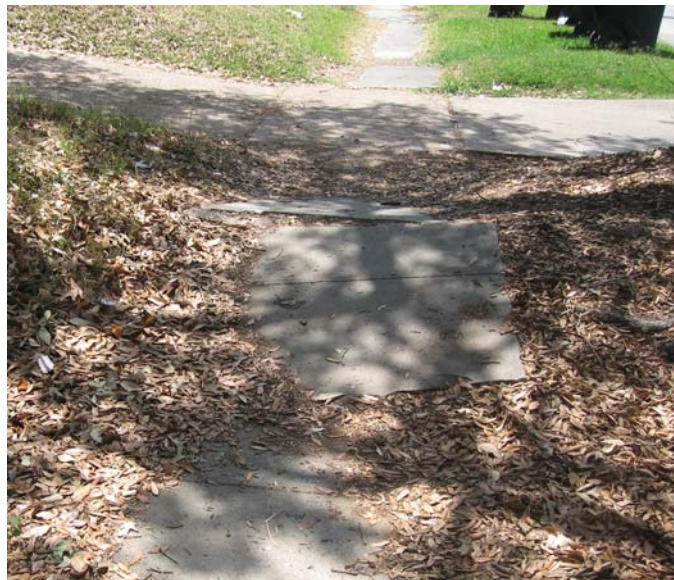
Photo 9-13, Segment 18B

Tree roots have caused a section of the sidewalk to become a tripping hazard.

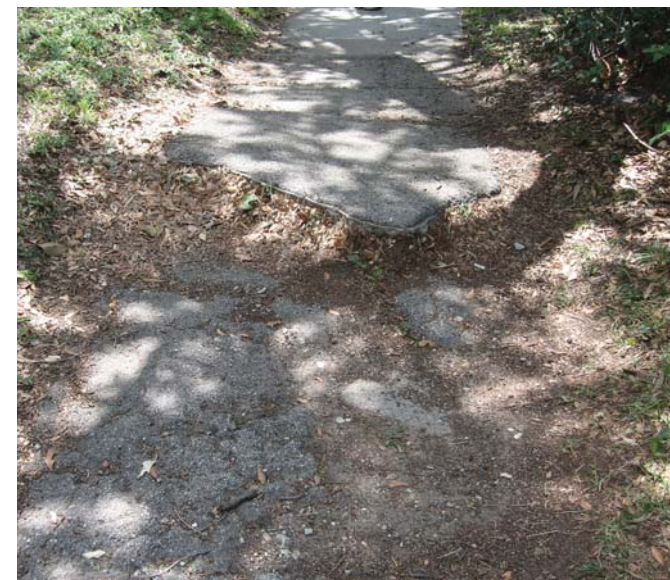
Photo 9-14, Segment 22B
W. Gray between Van Buren and Marconi
Uneven settling creates a tripping hazard

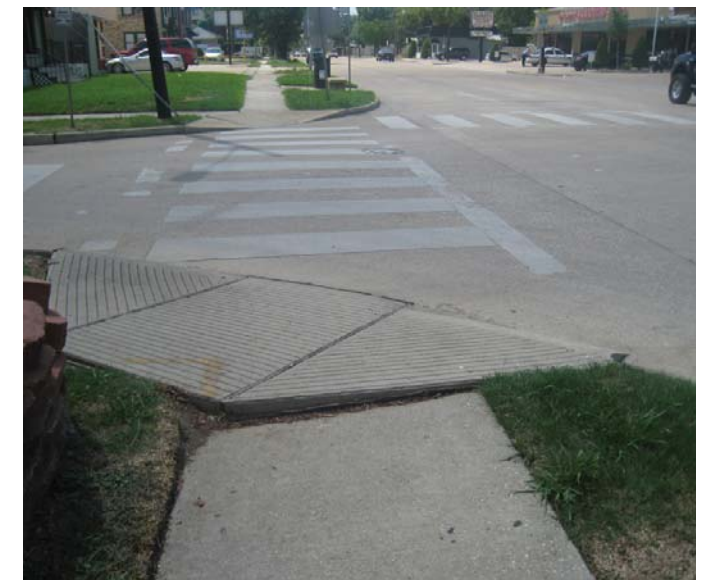
Photo 9-15, Segment 31
W. Gray at Stanford
Settling has separated the sidewalk from the ramp on the southeast corner.

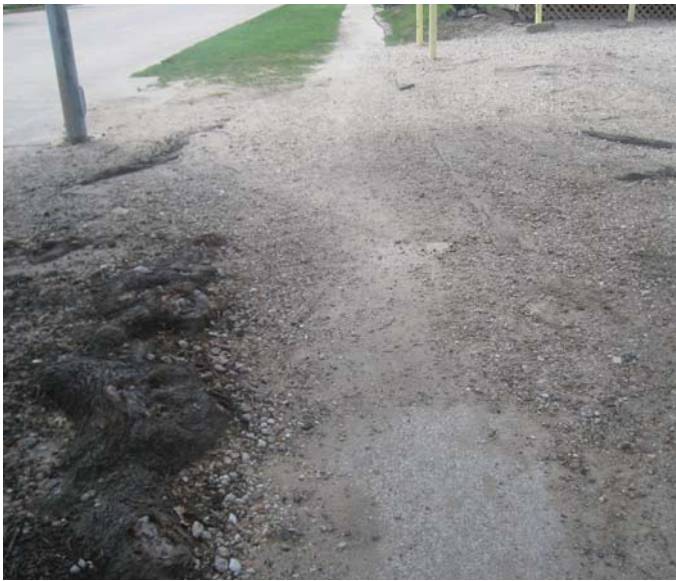
**Photo 9-16, Segment 32A
W. Gray between Stanford and Taft**
Tree roots are encroaching on the sidewalk. Dirt and pebbles accumulate on the sidewalk washed from the adjacent parking lot.

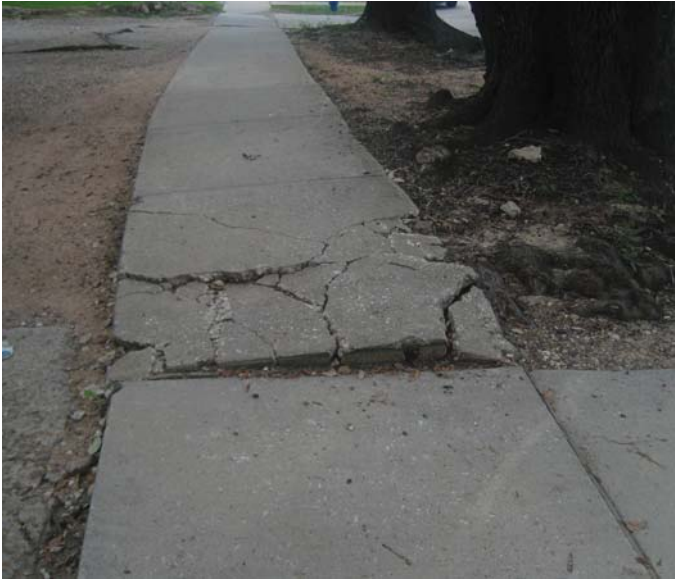
**Photo 9-17, Segment 32B
W. Gray between Stanford and Taft**
Sidewalk section is cracked by tree roots

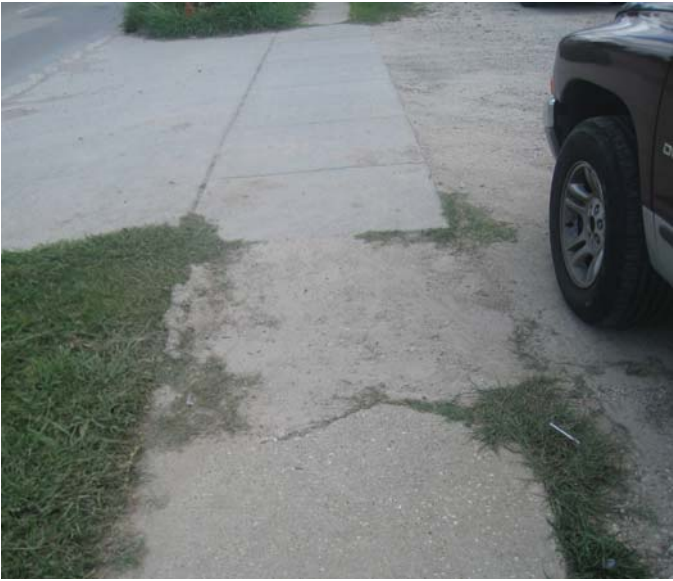
**Photo 9-18, Segment 32B
W. Gray between Stanford and Taft**
Missing section of sidewalk

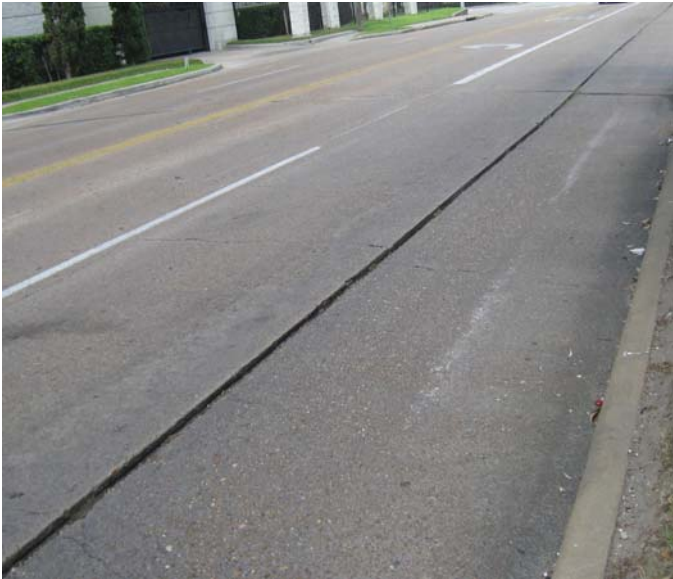
Photo 10-1, Segment 2A
W. Dallas between Shepherd and Gross
Pavement separation at joints

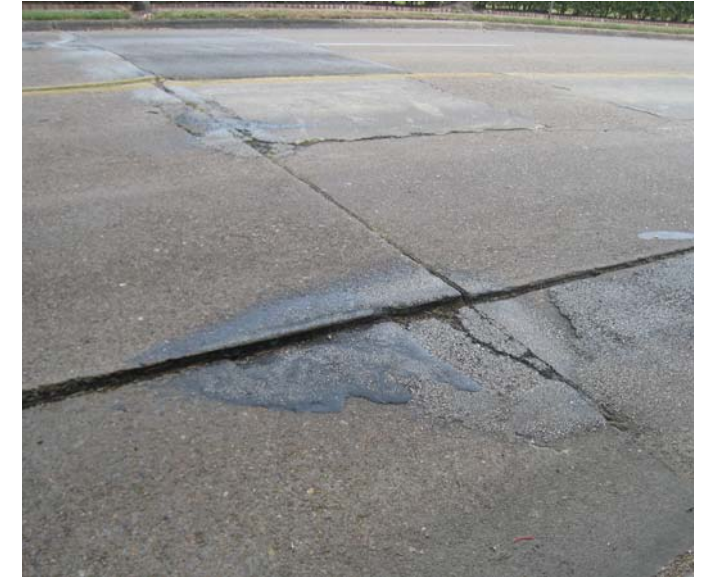
Photo 10-2, Segment 6B
W. Dallas between Tirell and Dunlavy
 Settling creating an uneven surface

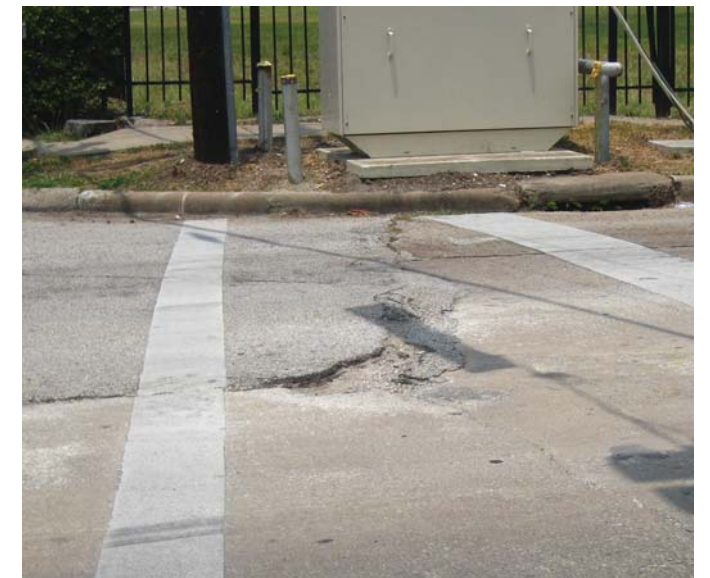
Photo 10-3, Segment 7
W. Dallas at Dunlavy
 Edges of a previous patch have begun to wear and have chipped away creating a noticeable bump.

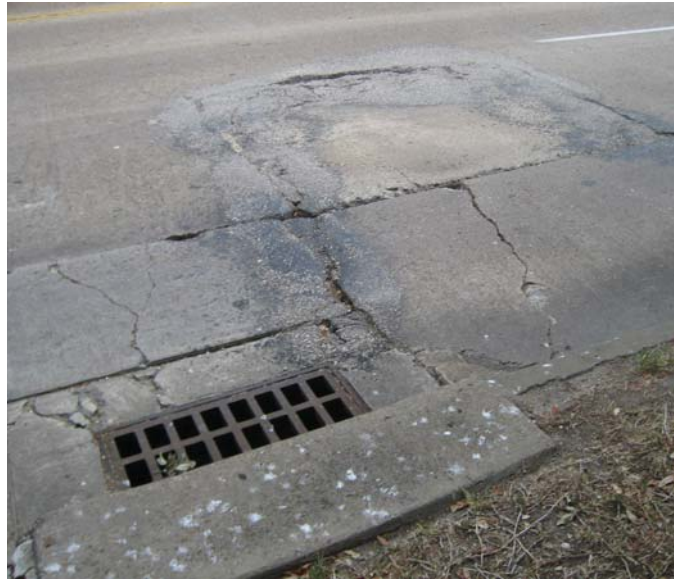
Photo 10-4, Segment 8B
W. Dallas between Dunlavy and Rowchow
 Pavement is cracked and uneven near storm drain.

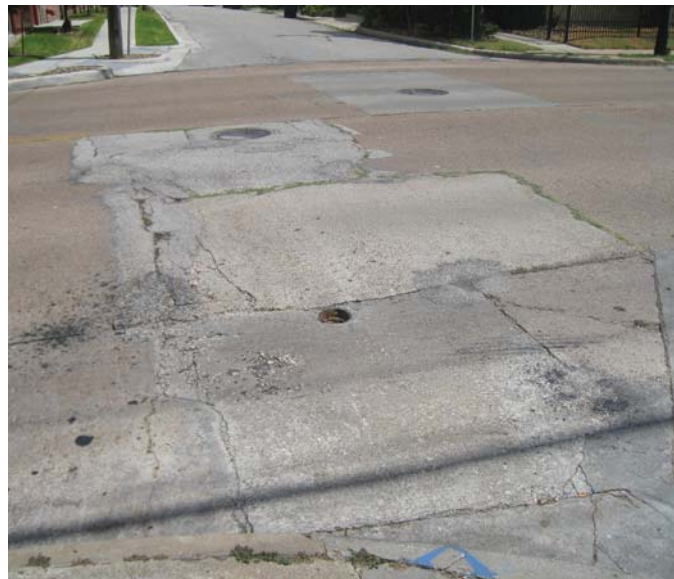
Photo 10-5, Segment 12B
W. Dallas between Rosine and Waugh
 Several previous patches have resulted in an uneven surface.

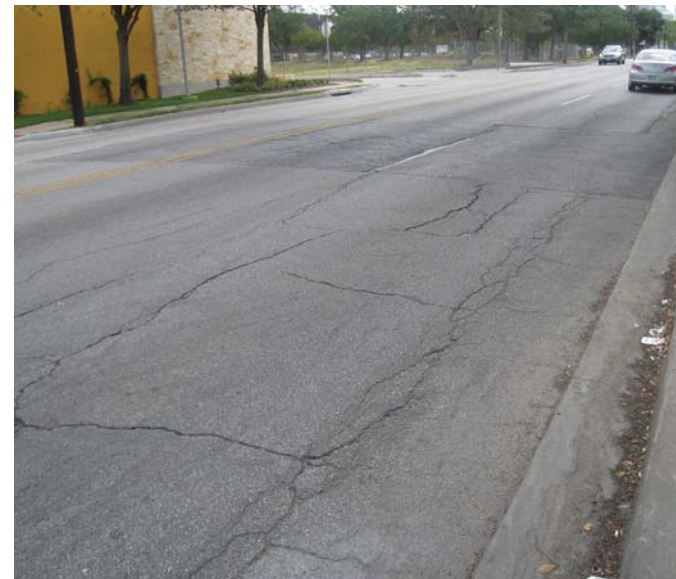
Photo 10-6, Segment 14B
W. Dallas between Waugh and Peveto
 Long cracks create a ladder shape throughout this section of W. Dallas.

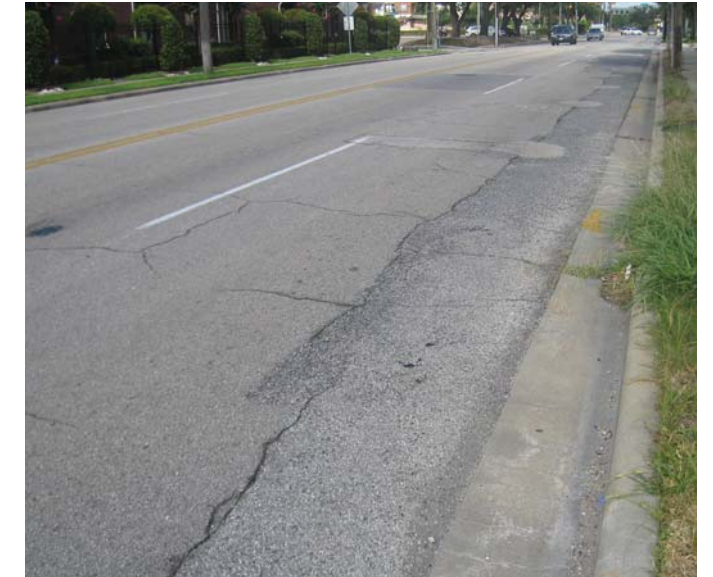
Photo 10-7, Segment 16B
W. Dallas between Peveto and Joe Annie
Road has settled near the curb.

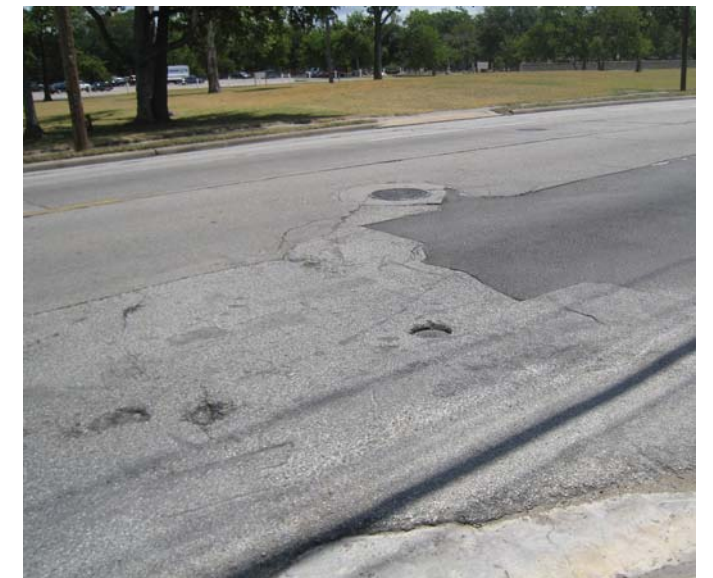
Photo 10-8, Segment 27
W. Dallas at Marconi
Potholes at locations where utility connections have not been adjusted after an overlay.

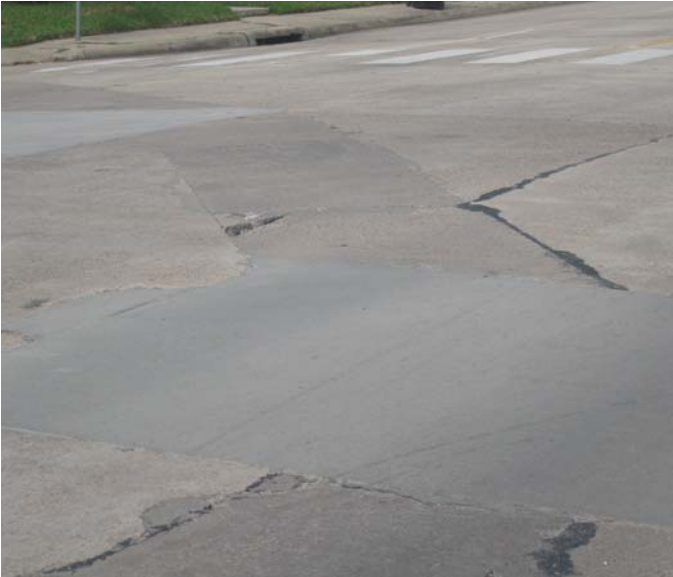
Photo 10-9, Segment 35
W. Dallas at Stanford

Several cracks and a pothole in the middle of the intersection, create uneven riding surface.

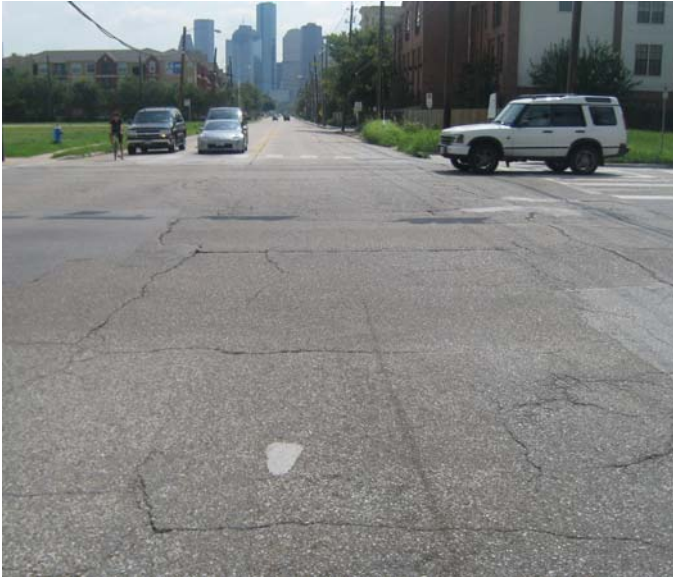
Photo 10-10, Segment 29
W. Dallas at Montrose

The intersection has severe cracking which creates uneven riding surface.

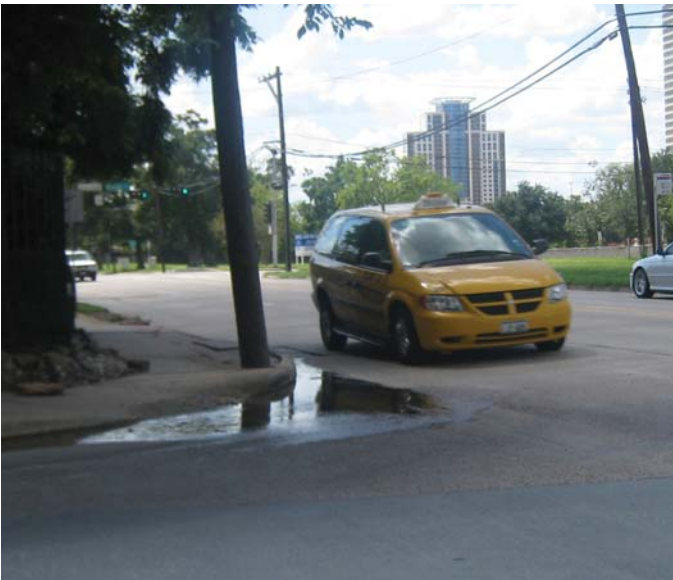
Photo 10-11, Segment 31
W. Dallas at Columbus

Telephone pole and fence obstruct view of oncoming traffic

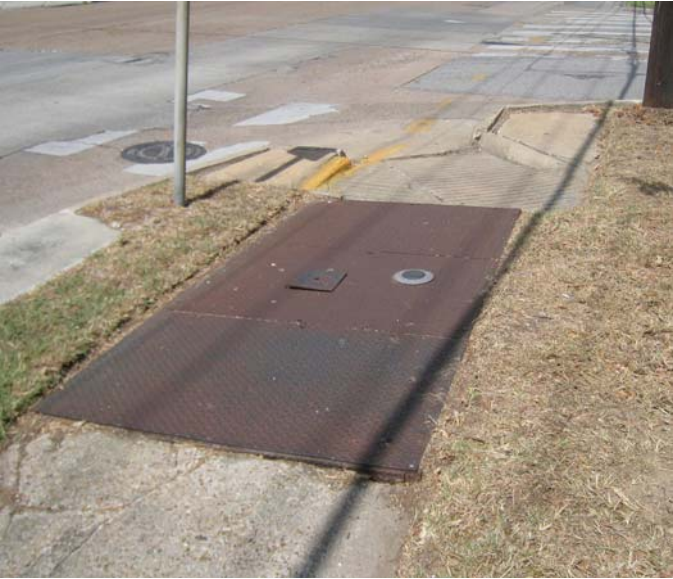
Photo 10-12, Segment 3
W. Dallas at Gross

Metal utility grate is not level with sidewalk, creating a tripping hazard. This is of particular concern because it is near a school for the blind.

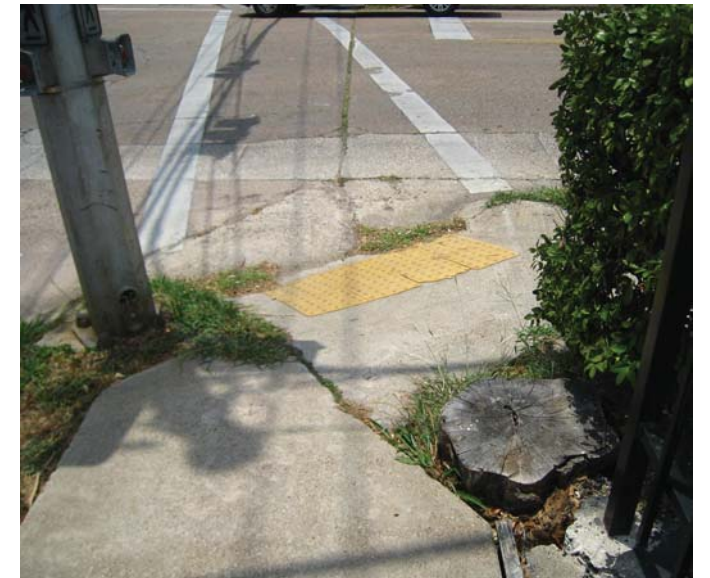
Photo 10-13, Segment 7
W. Dallas at Dunlavy
Narrow sidewalk and steep ramp

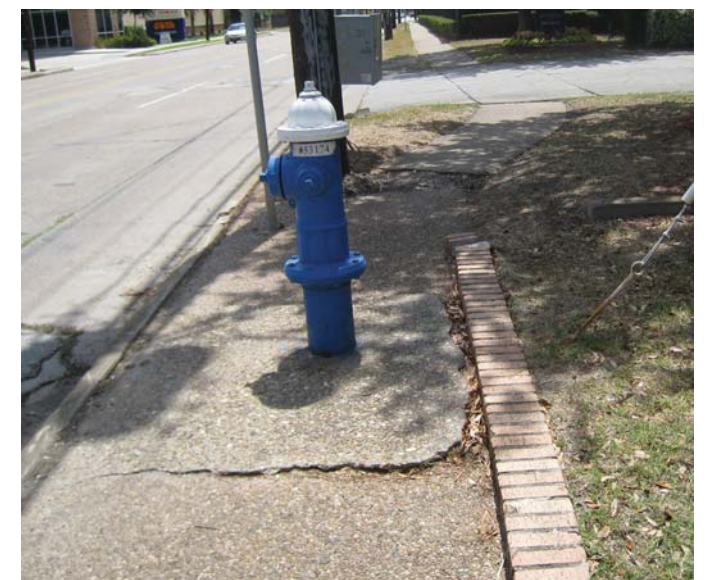
Photo 10-14, Segment 10B
W. Dallas between Rowchow and Rosine
Fire hydrant in the middle of the sidewalk makes access difficult.

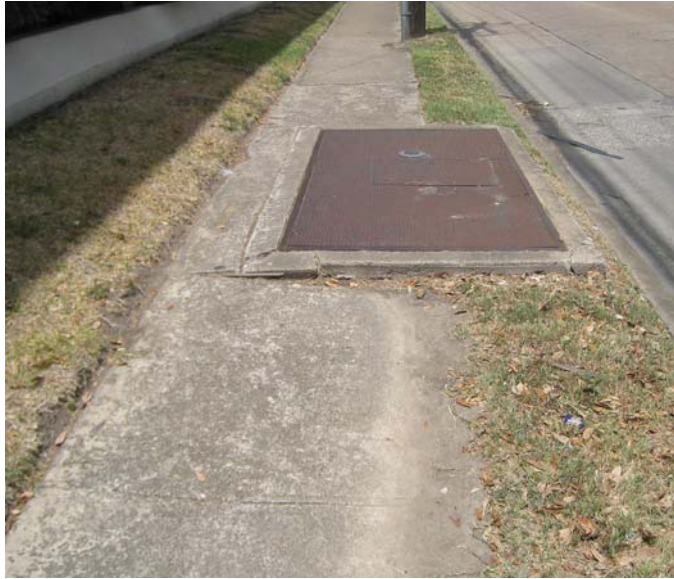
Photo 10-15, Segment 12A
W. Dallas between Rosine and Waugh
 Sidewalk has settled around the metal utility grate, creating a tripping hazard.

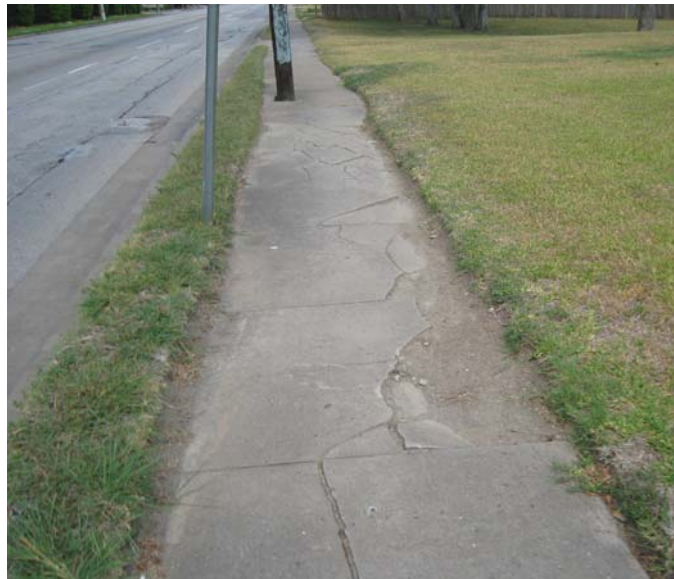
Photo 10-16, Segment 24A
W. Dallas between Van Buren and Wilkenson
 Sidewalk is cracked, and sections are missing near the edge.

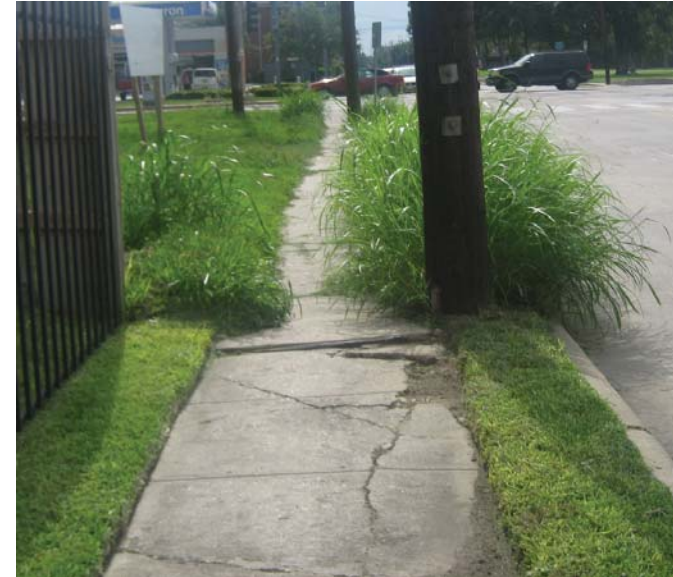
Photo 10-17, Segment 30B
W. Dallas between Montrose and Columbus
Cracking and overgrown vegetation

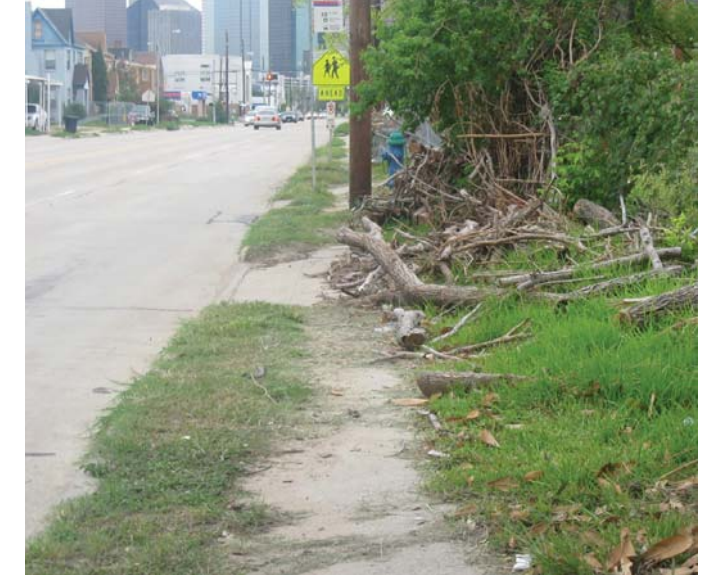
Photo 10-19, Segment 36B
W. Dallas between Stanford and Taft
Grass growth, debris and pole obstruction in the middle of the sidewalk

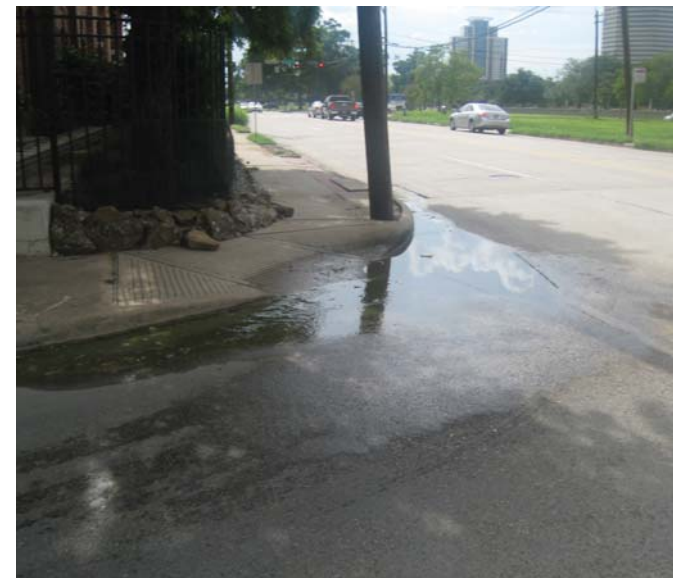
Photo 10-18 Segment 31
W. Dallas at Columbus
Water accumulates at the bottom of the ramp

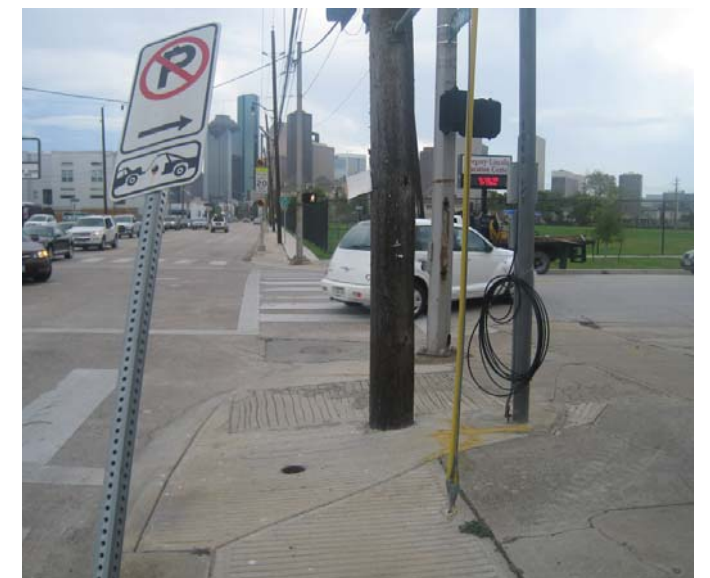
Photo 10-20, Segment 37
W. Dallas at Taft
Pole obstructions

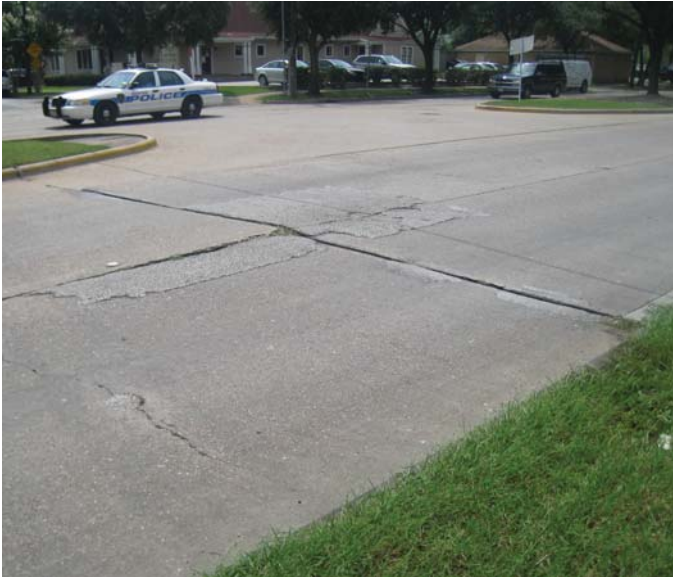
Photo 11-1, Segment 6A
Montrose between W. Gray and Peden
The concrete joint sealant has come out, there are cracks in the pavement, and patching is worn, creating an uneven riding surface.

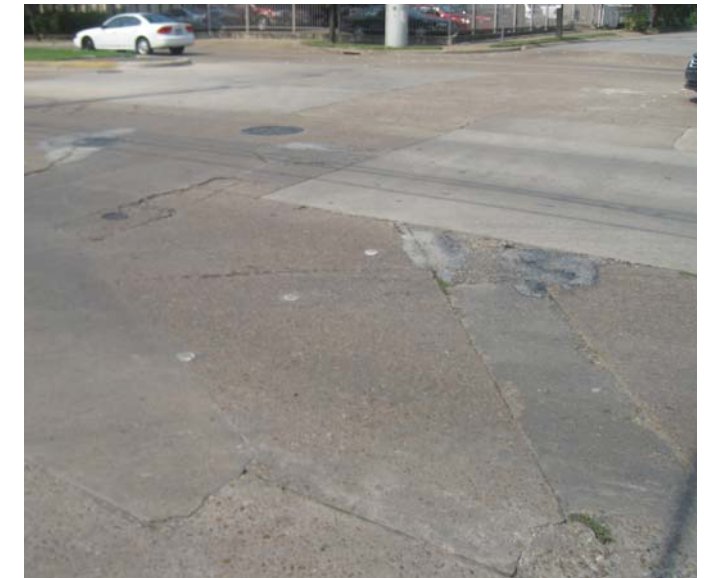
**Photo 11-2, Segment 13
Montrose at Welch**
Numerous cracks and patching at the intersection create an uneven riding surface.

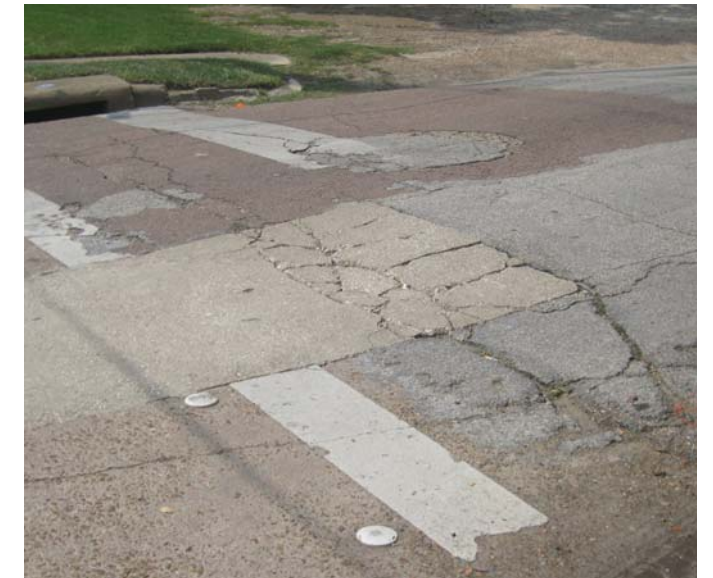
**Photo 11-3, Segment 15
Montrose at Drew**

Numerous cracks in the pavement and in the patches

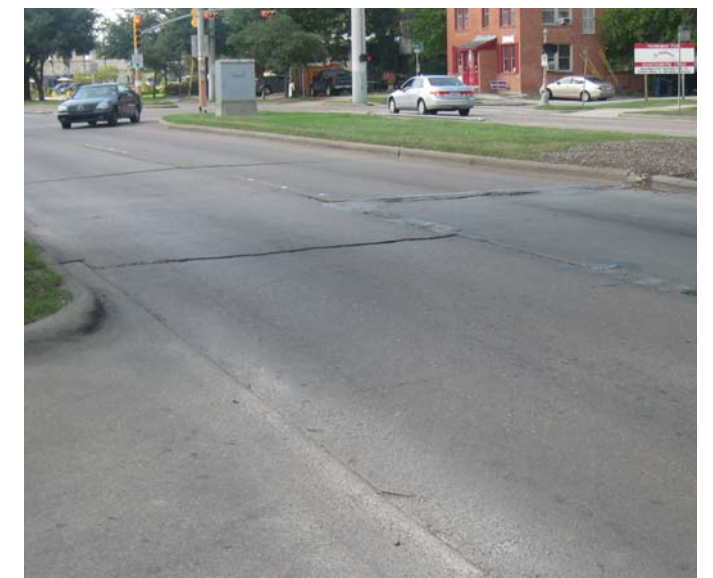
**Photo 11-4, Segment 18A
Montrose between Jackson and Fairview**

The sealant has come out of the pavement joints creating wide gaps and a poor riding experience.

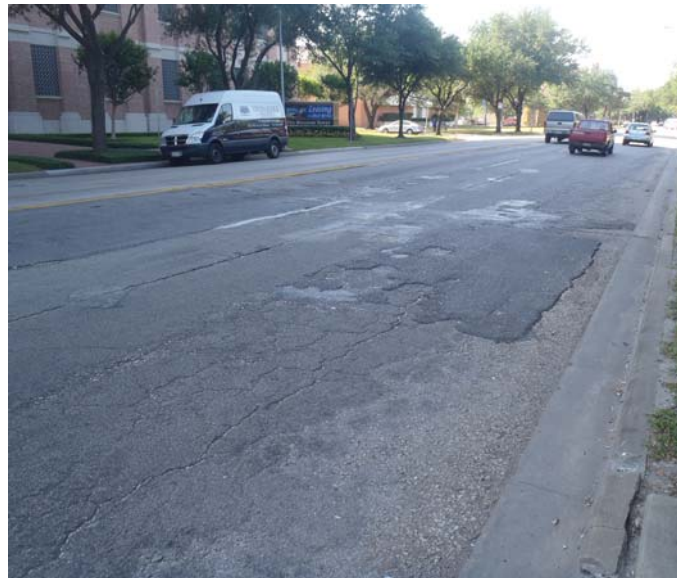
Photo 11-5, Segment 30A
Montrose at between Banks and Milford
 There are multiple layers of asphalt in varying levels of disrepair that create an uneven riding surface.

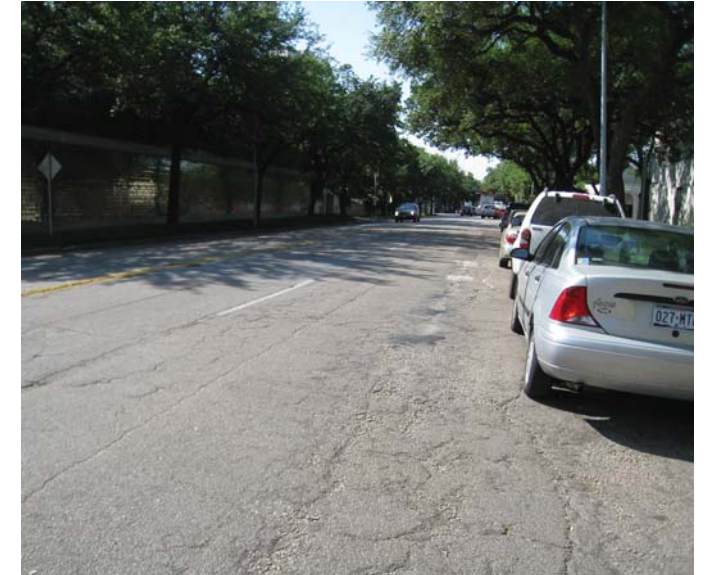
Photo 11-6, Segment 65
Montrose at Bartlett

Cracking and deteriorating pavement, particularly in the lane where parking is allowed

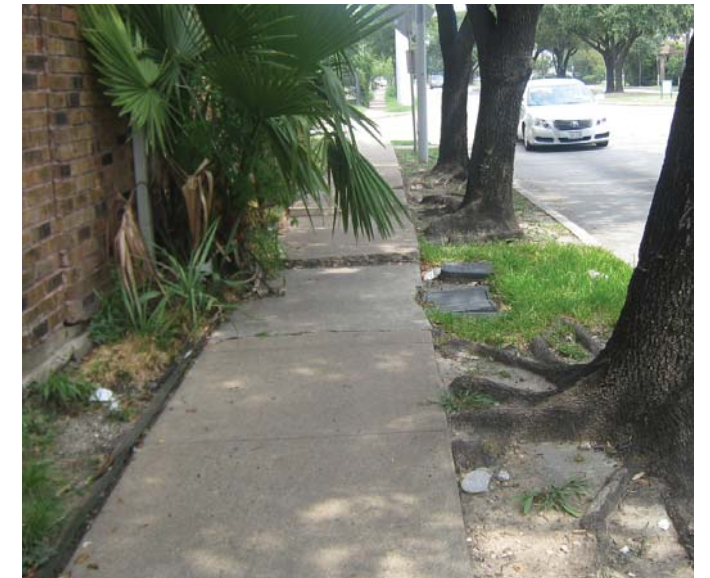
Photo 11-7, Segment 18A
Montrose between Jackson and Fairview
Upheaval between two sections of sidewalk and the adjacent vegetation growth obstruct pedestrian path.

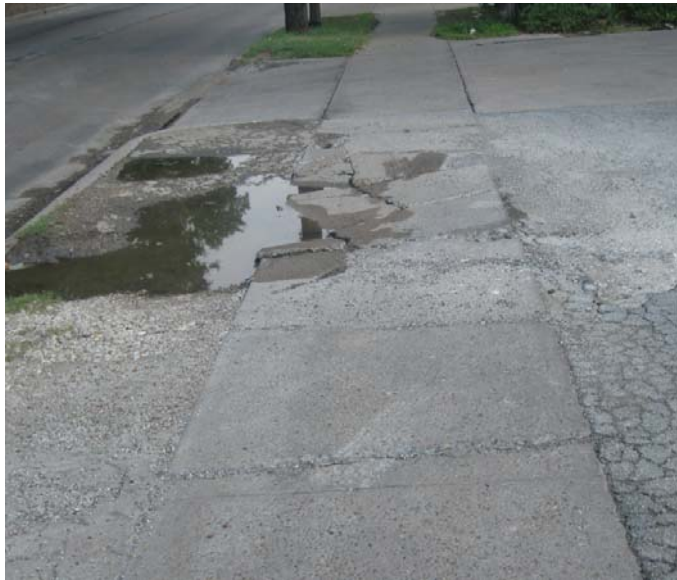
Photo 11-8, Segment 18B

Montrose between Jackson and Fairview

A section of sidewalk is broken creating a pothole which accumulates water and creates a tripping hazard.

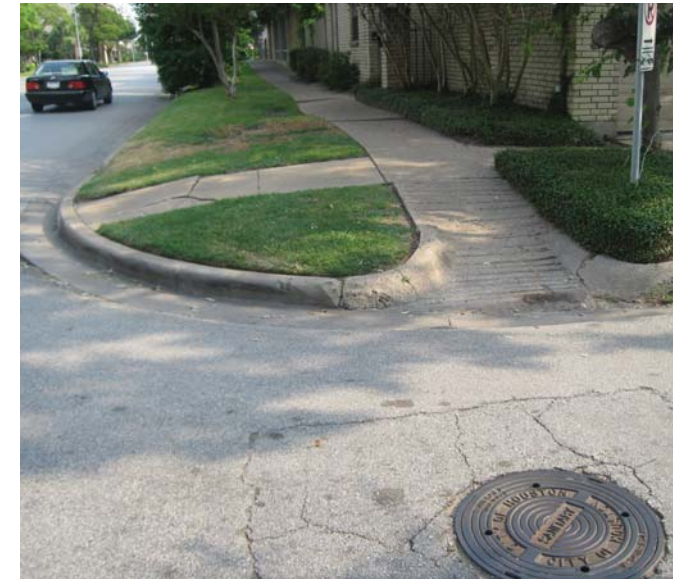
Photo 11-9, Segment 35
Montrose at Kipling

The southbound ramp is narrow and steep making it difficult for use by pedestrians. There is no westbound ramp.

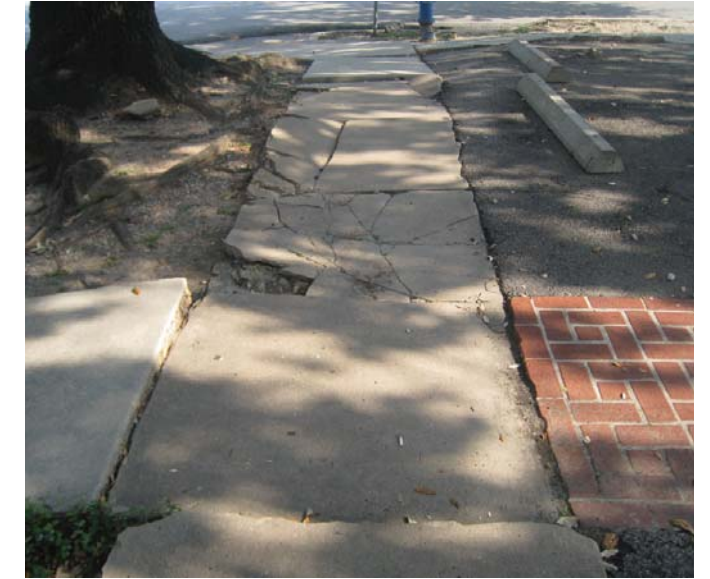
Photo 11-10, Segment 36B
Montrose between Kipling and Marshall
 Sidewalk has severe cracking and upheaval, creating a tripping hazard.

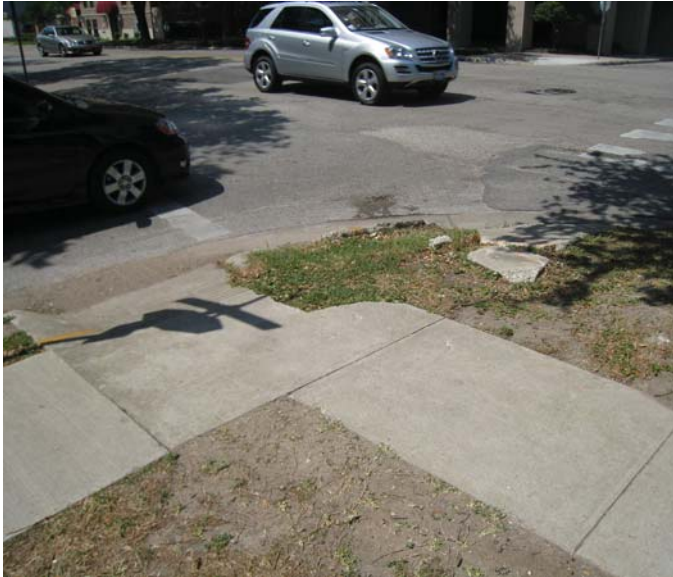
Photo 11-11, Segment 63
Montrose at Barkdull

Ramp only provides access to one of two crosswalks and has possible slope issues making it hard to navigate.

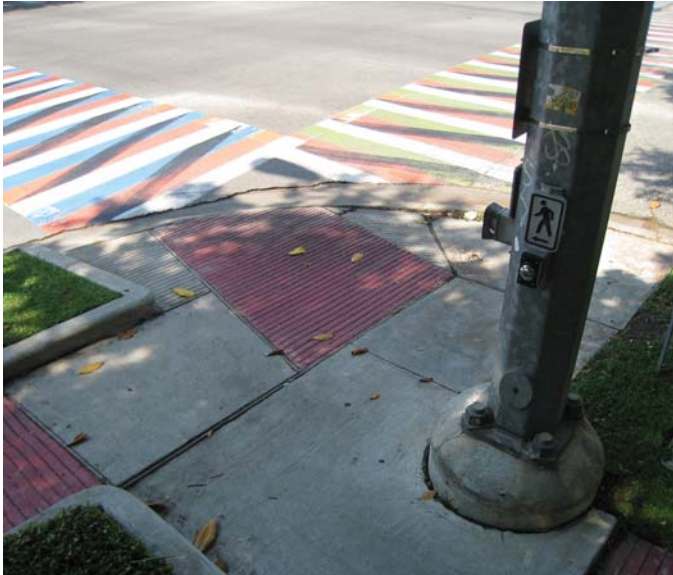
Photo 11-12, Segment 69
Montrose at Bissonnet

Settling and obstructions within ramp area

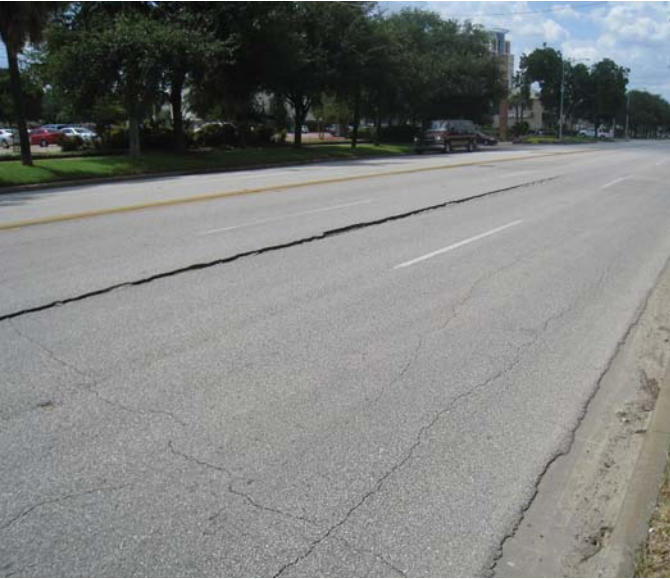
Photo 12-2, Segment 6B
Waugh between Bell and Pierce
Fault crack parallel to vehicular path.

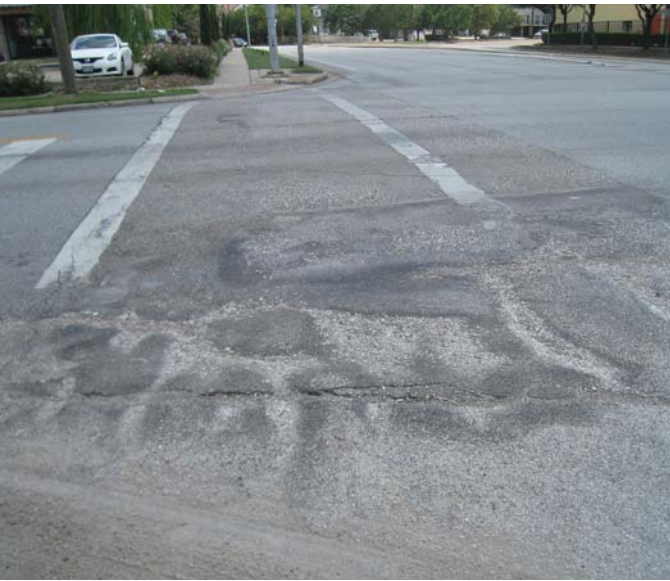
Photo 12-3, Segment 9
Waugh at W. Gray
Wear pattern and settling has created an uneven surface.

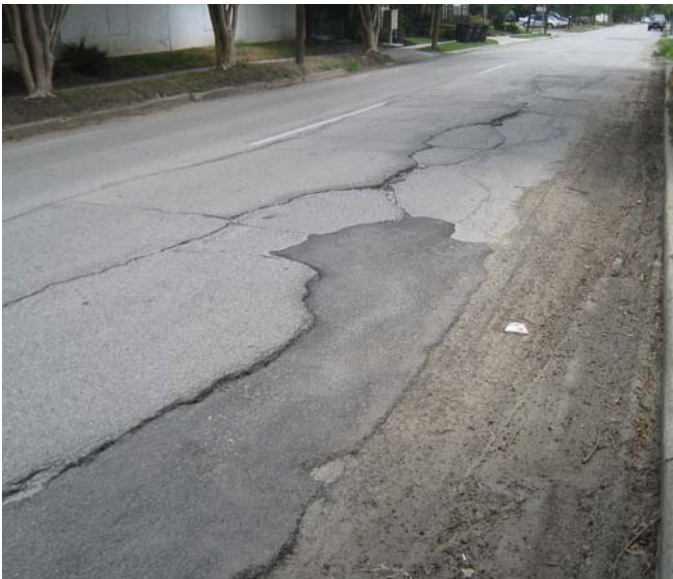
Photo 12-4, Segment 16A
Waugh between Vermont and Welch
Prior patching and further settlement have created an uneven surface.

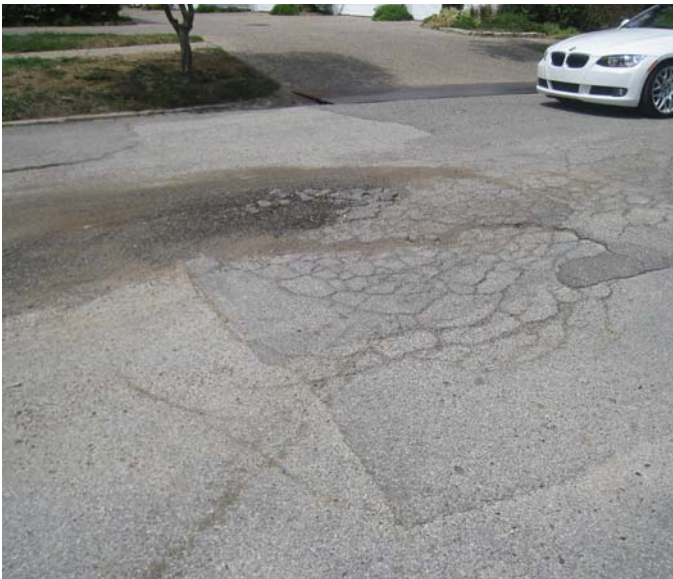
Photo 12-5, Segment 25
Waugh at Jackson

Alligator cracking in the intersection has sunken down creating a place for ponding.

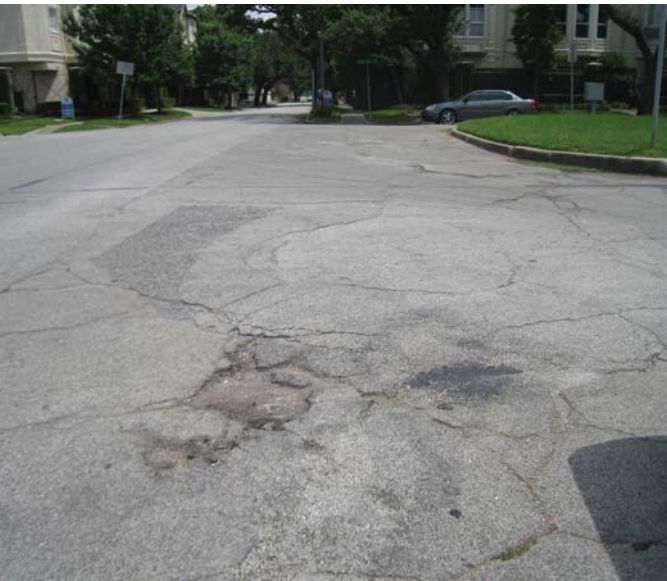
Photo 12-6, Segment 31
Waugh at Hyde Park
Cracking in the intersection, with sections that are missing

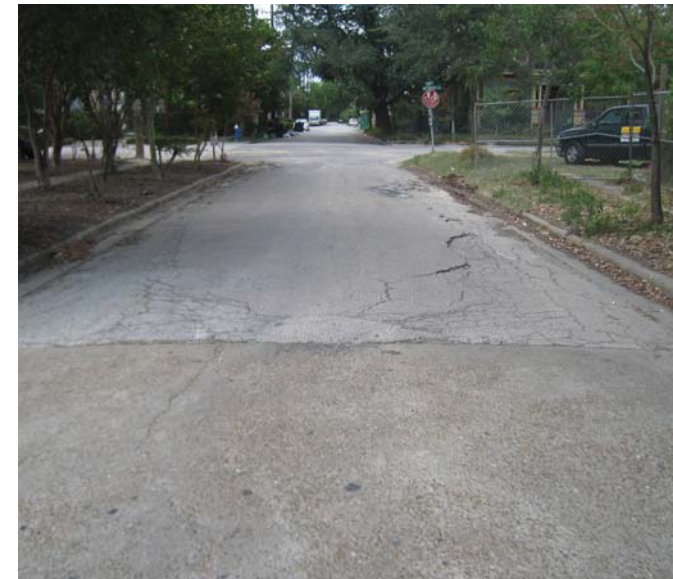
Photo 12-7, Segment 39
Waugh at Yoakum
Roadway is settling unevenly near the curb.

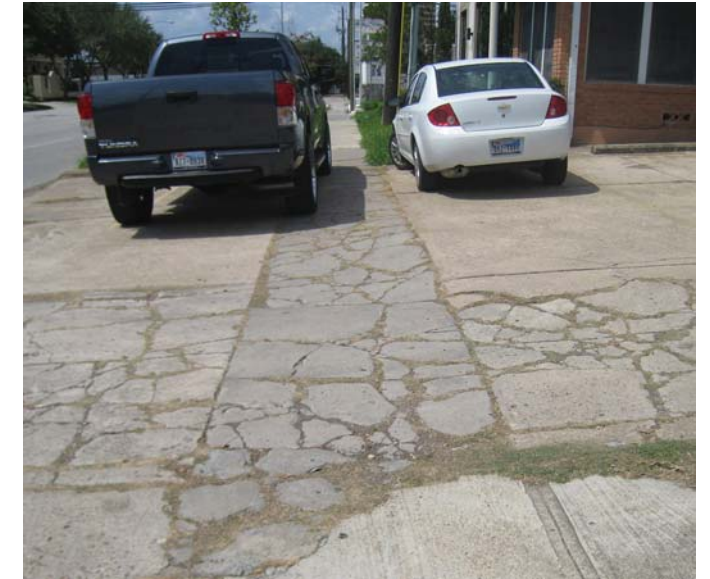
Photo 12-9, Segment 4B
Waugh between W. Clay and Bell
Sidewalk is severely cracked and used for the parking, making it hard to access as a pedestrian.

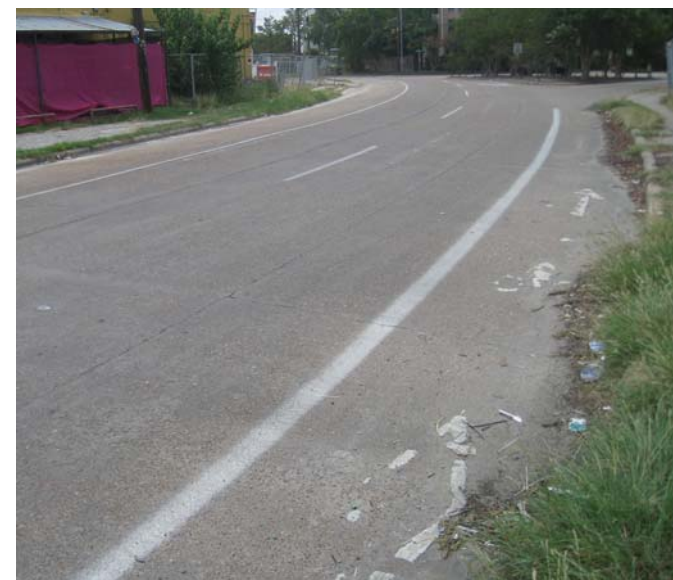
Photo 12-8, Segment 40B
Waugh between Yoakum and Westheimer
Roadside landscaping is encroaching on the bike lane.

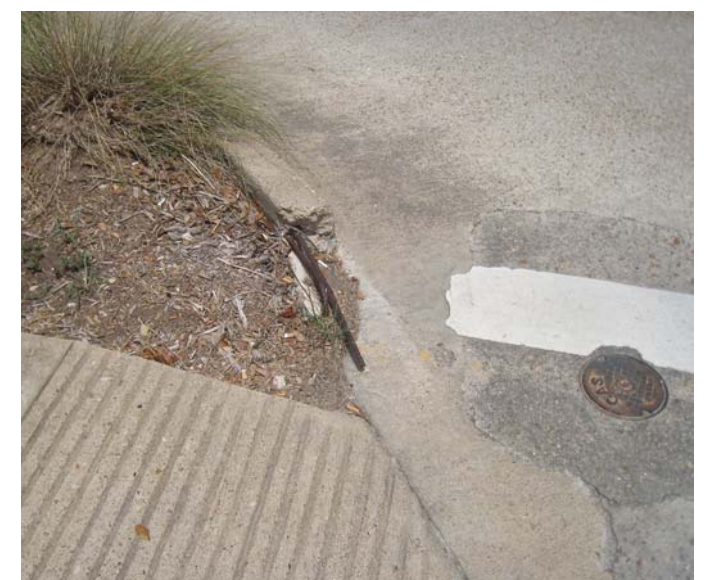
Photo 12-10, Segment 7
Waugh at Pierce
Curb is broken at the ramp, exposing rebar.

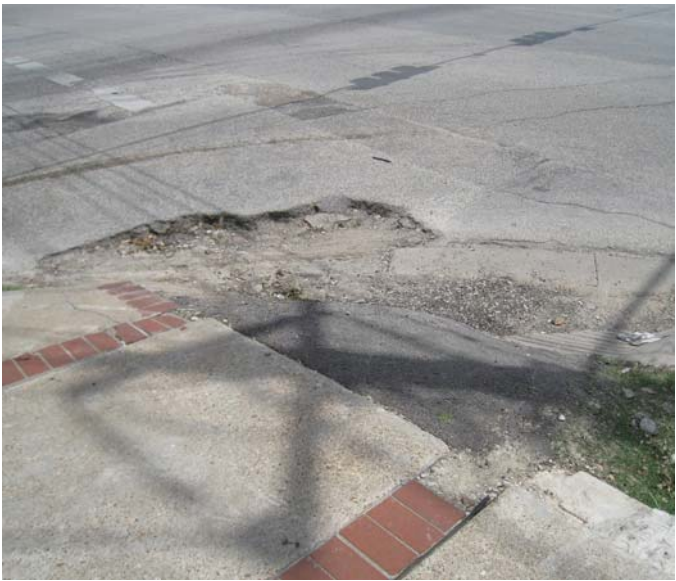
Photo 12-11, Segment 9
Waugh at W. Gray
 Broken ramp was patched with a steep grade. A section of pavement is missing

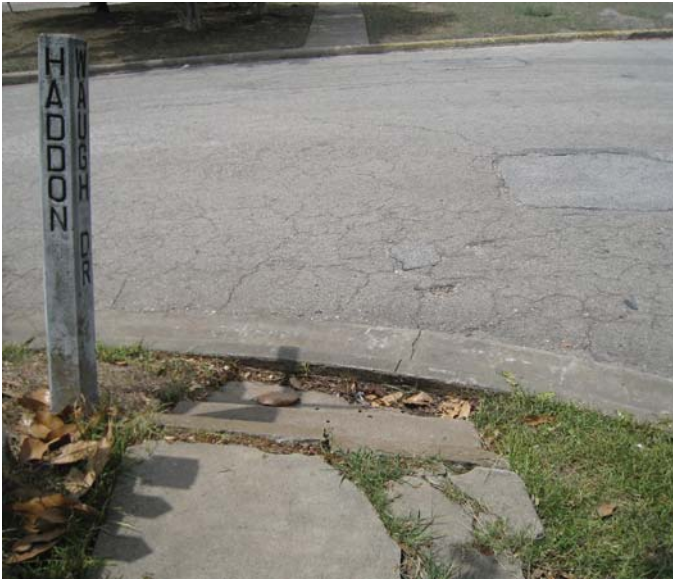
Photo 12-12, Segment 11
Waugh at Haddon/Peden
Ramp missing

- Construct missing ramps and reconstruct existing ramps
 - Waugh at all intersection
 - Reconstruct sidewalk
 - West side of Waugh south of W. Dallas
 - East side of Waugh from north of W. Clay to W. Gray
