COMPREHENSIVE DISTRICT-WIDE MOBILITY STUDY

*An evaluation of pavement condition, pedestrian accessibility,
cut-through traffic, and markings within the Montrose District*

WALTER P MOORE

February 2012

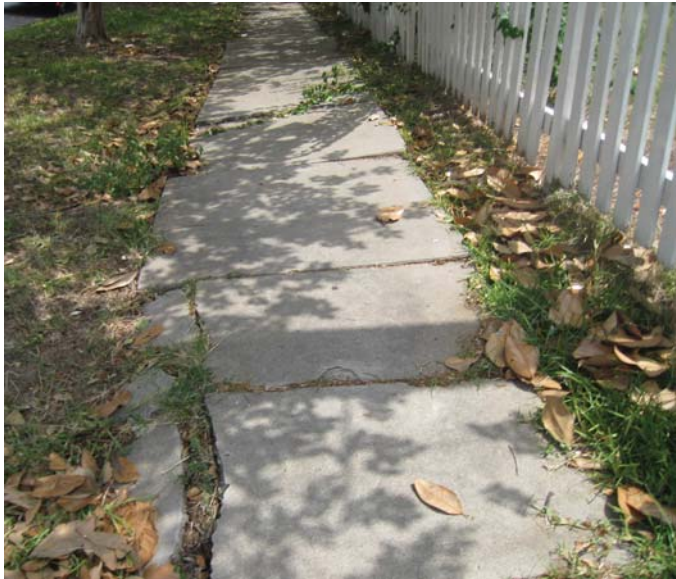
Photo 12-13, Segment 12A
Waugh between Haddon/Peden and Nevada
Sidewalk cracking and settling

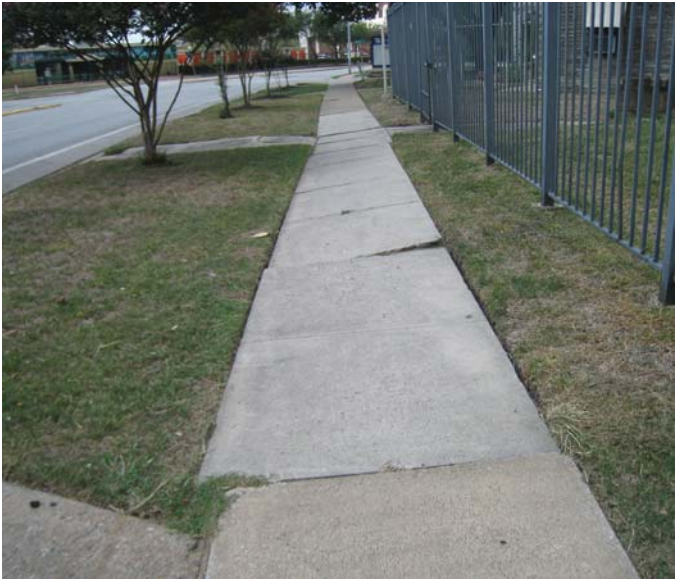
Photo 12-14, Segment 14B
Waugh between Nevada and Vermont
Whole sidewalk is on an angle

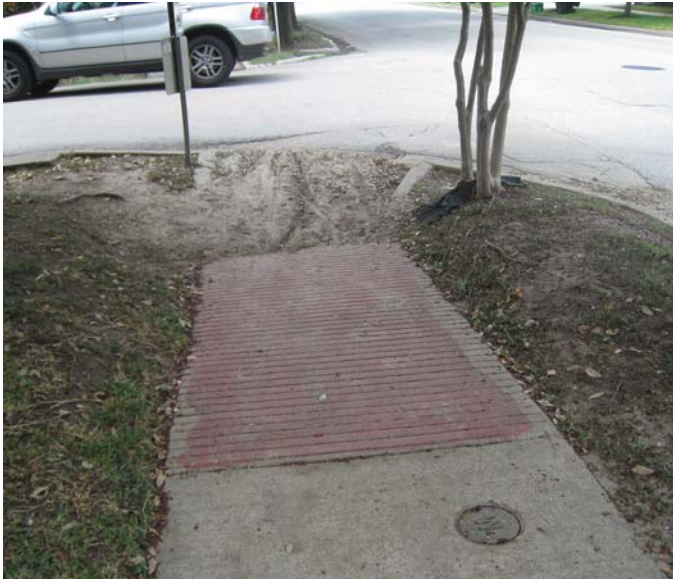
Photo 12-15, Segment 15
Waugh at Vermont
End of ramp missing or covered in dirt

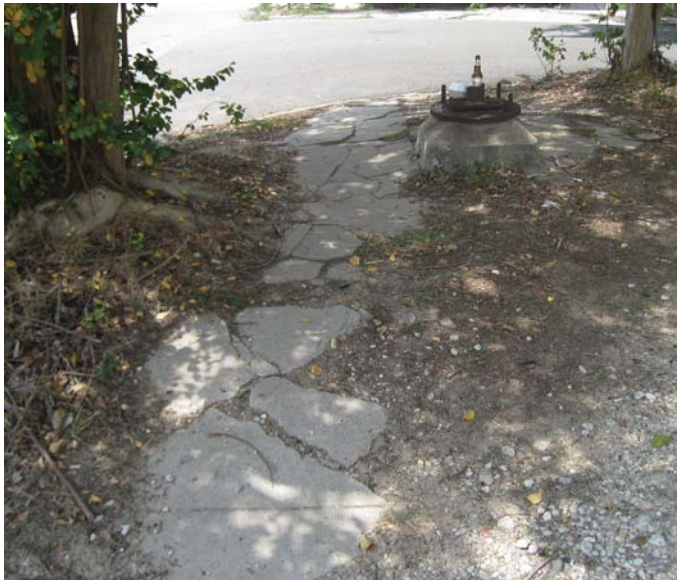
Photo 12-16, Segment 21
Waugh at W. Drew
Broken sidewalk with numerous tripping hazards and no ramp

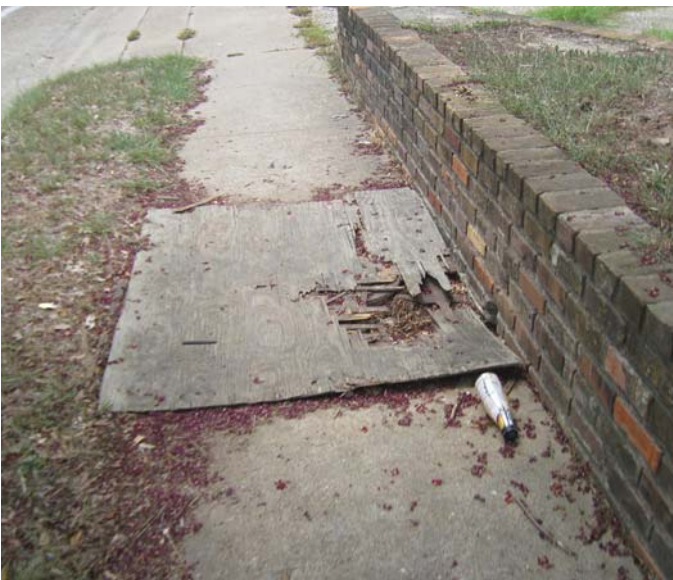
Photo 12-18, Segment 36B
Waugh between Waughcrest and California
Thin piece of plywood covers a hole in sidewalk.

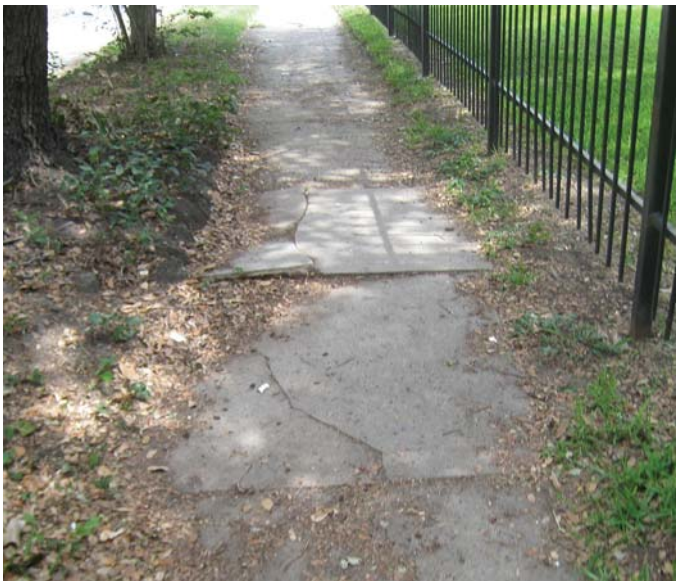
Photo 12-17, Segment 32A
Waugh between Hyde Park and Missouri
Roots have caused sidewalk movement and tripping hazards.

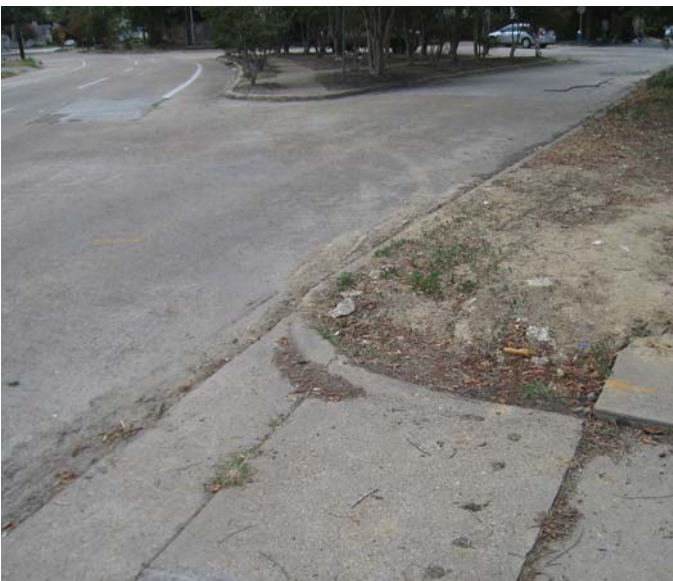
Photo 12-19, Segment 39
Waugh at Yoakum
Missing ramps

- Construct missing ramps and reconstruct existing ramps
 - Waugh at all intersection
 - Reconstruct sidewalk
 - West side of Waugh south of W. Dallas
 - East side of Waugh from north of W. Clay to W. Gray

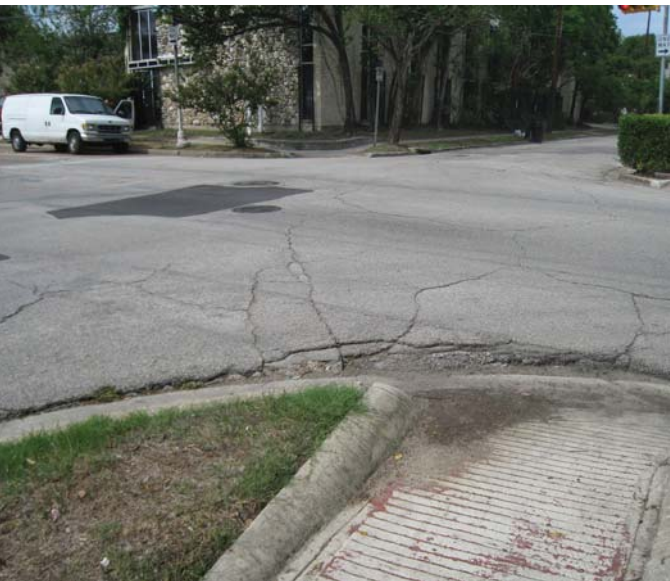
Photo 13-1, Segment 7
Commonwealth at Welch

Pavement cracks near the edges and previous patch is no longer level with surrounding pavement.

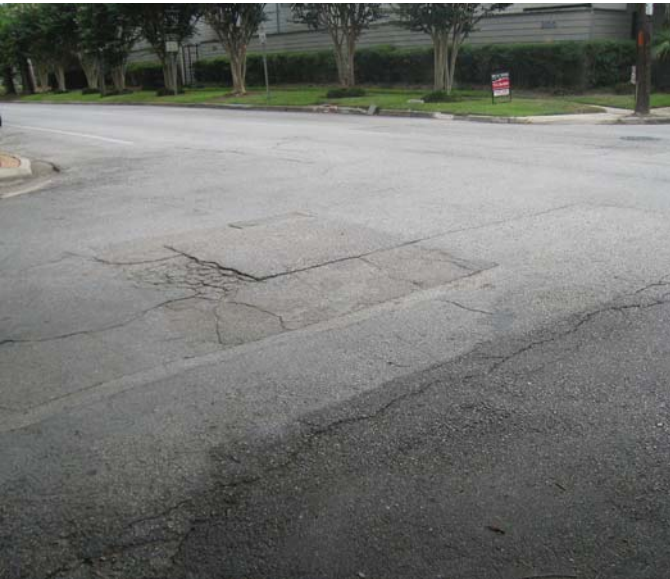
**Photo 13-2, Segment 9
Commonwealth at Indiana**
Uneven roadway surface with small cracks.

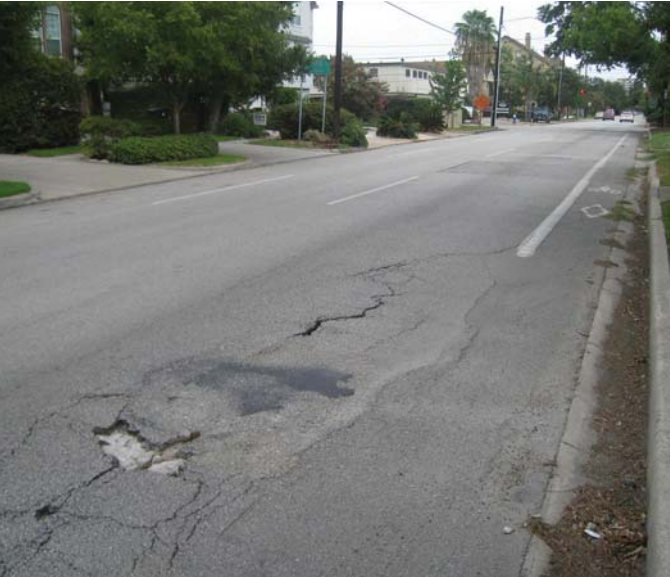
**Photo 13-3, Segment 12A
Commonwealth between Michigan and Maryland**
Cracking with small sections of pavement missing that create pot holes.

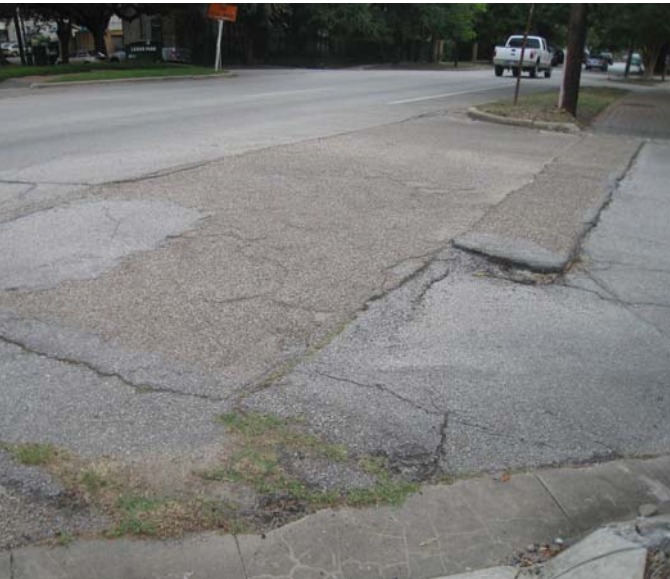
**Photo 13-4, Segment 17
Commonwealth at Hyde Park**
One section of the pavement is raised above the rest, creating an abrupt speed bump.

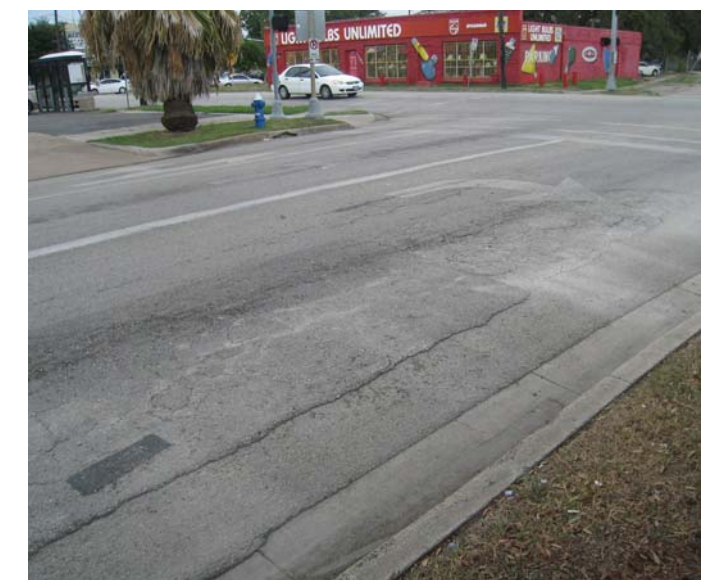
Photo 13-5, Segment 22A
Commonwealth between California and Westheimer
Alligator cracking near intersection

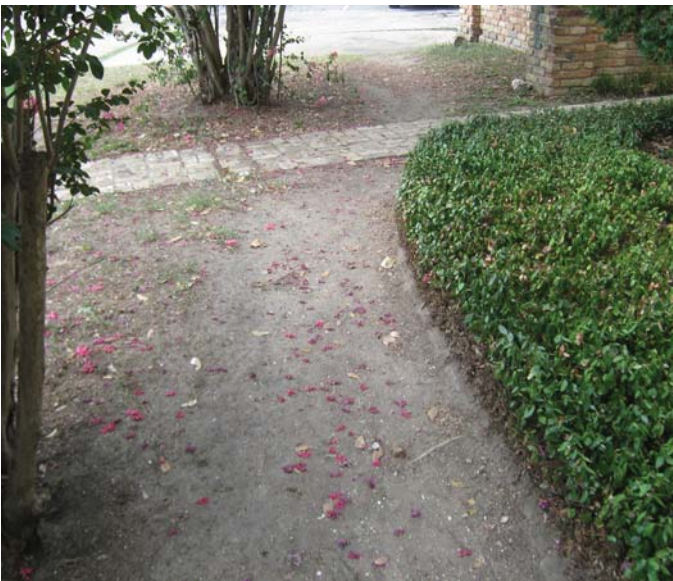
Photo 13-6, Segment 2B
Commonwealth between Haddon and Nevada
Missing sidewalk.

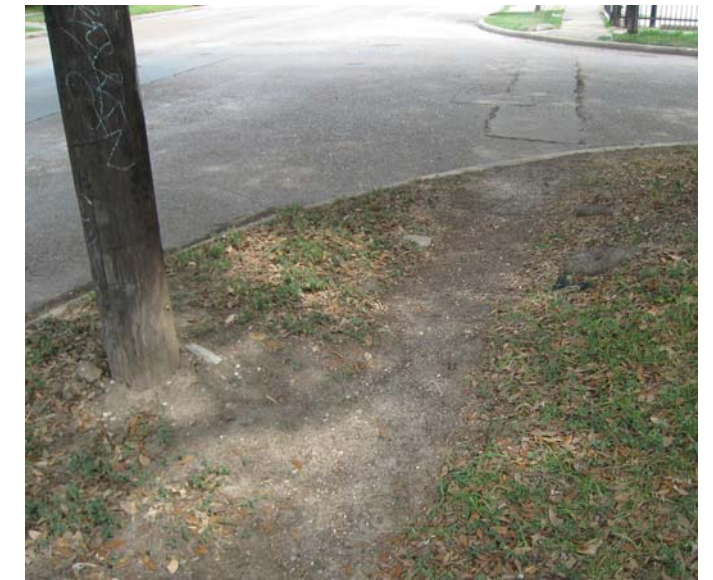
Photo 13-7, Segment 3
Commonwealth at Nevada
Missing sidewalk and ramp

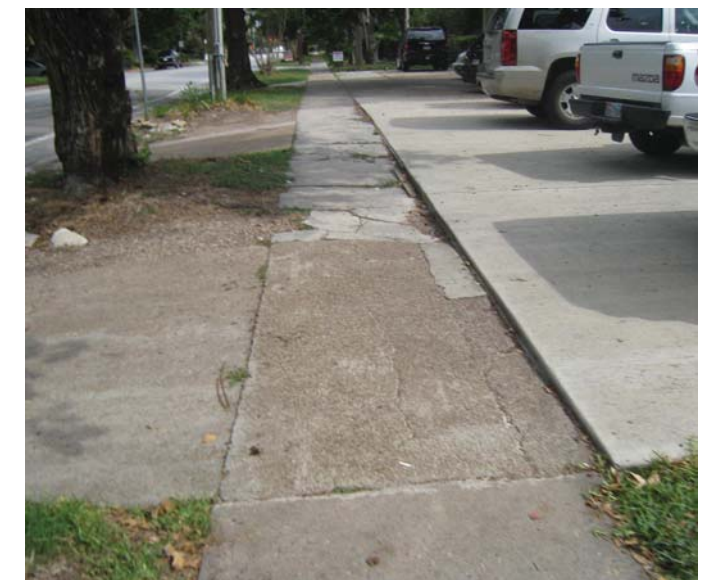
Photo 13-8, Segment 8A
Commonwealth between Welch and Indiana
Sidewalk has settled and is no longer flush with the adjacent pavement, creating a tripping hazard.

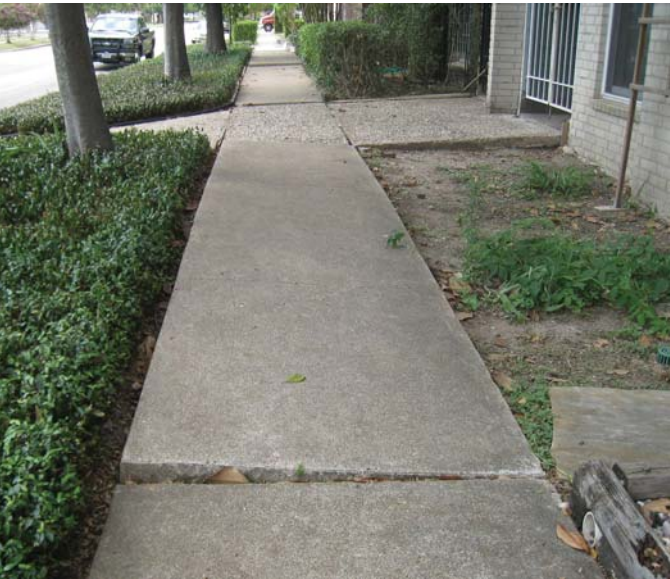
Photo 13-9, Segment 8B
Commonwealth between Welch and Indiana
Sidewalk section has shifted, creating both a slant and a tripping hazard.

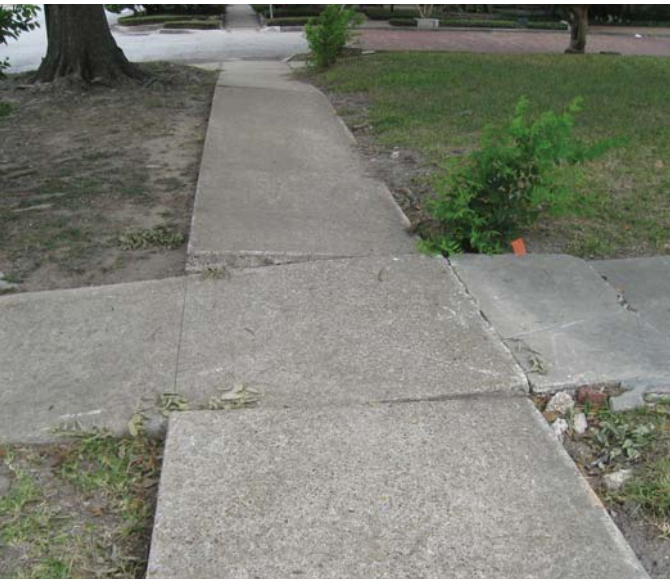
Photo 13-10, Segment 12A
Commonwealth between Michigan and Maryland
 Path to a house has settled in comparison to the adjacent sidewalk, creating of tripping hazards.

- **Ramps and Sidewalks:** Improving the ramps and crosswalks will increase pedestrian activity in the corridor, as it will improve their mobility.
 - Construct missing ramps and reconstruct existing ramps
 - Commonwealth at all intersections
 - Construct missing sidewalk and Reconstruct existing sidewalk
 - Commonwealth from W. Gray to Nevada
 - Commonwealth north of Vermont
 - Commonwealth from north of Welch to Indiana
 - West side of Commonwealth from Indiana to south of Hyde Park
 - East side of Commonwealth north of Michigan
 - East side of Commonwealth between Maryland and Fairview
 - East side of Commonwealth south of Hyde Park
 - West side of Commonwealth south of Missouri
 - East side of Commonwealth north of Westheimer
 - Reconstruct sidewalk at buckled locations
 - East side of Commonwealth between Michigan and Maryland

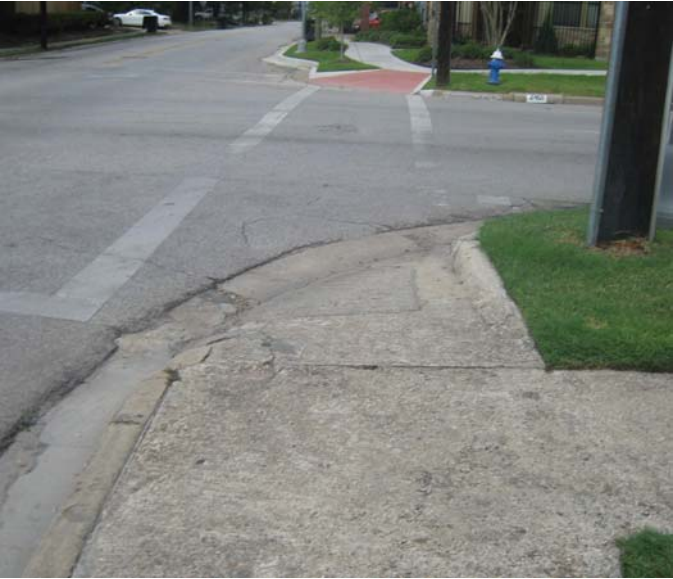
Photo 13-11, Segment 15
Commonwealth at Fairview
Appears to be a non-compliant ramp (too steep and too short)

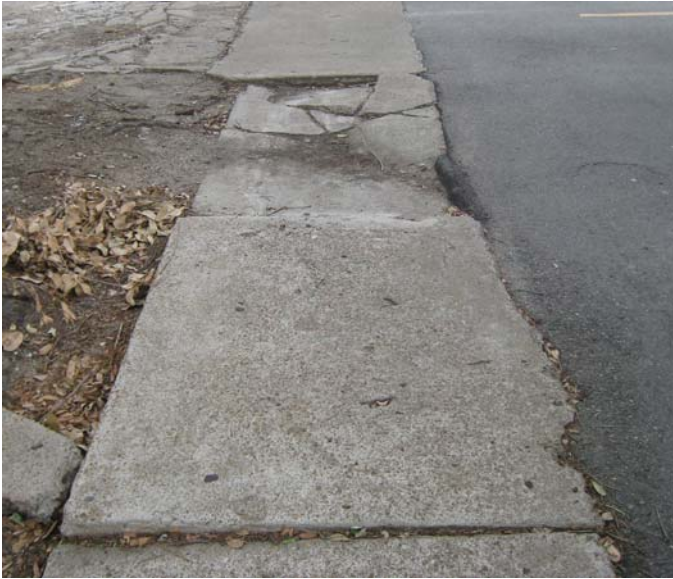
Photo 13-12, Segment 18A
Commonwealth between Hyde Park and Missouri
Sidewalk settling and cracking

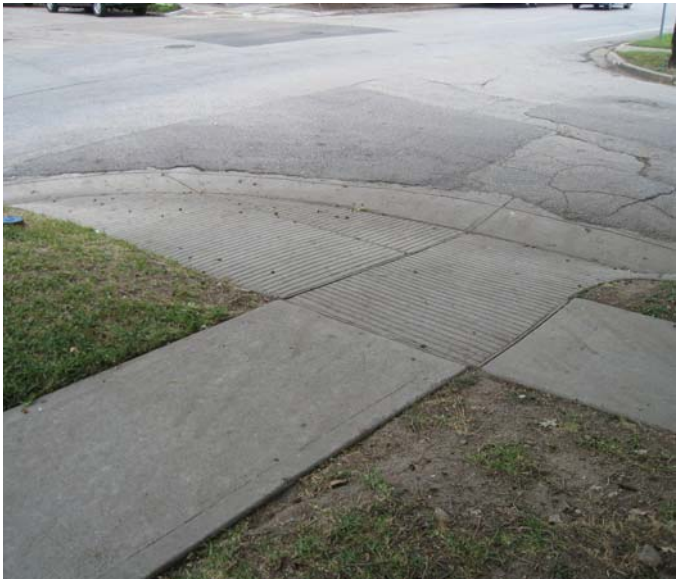
Photo 13-13, Segment 21
Commonwealth at California
Ramp appears to be non-compliant to ADA standards

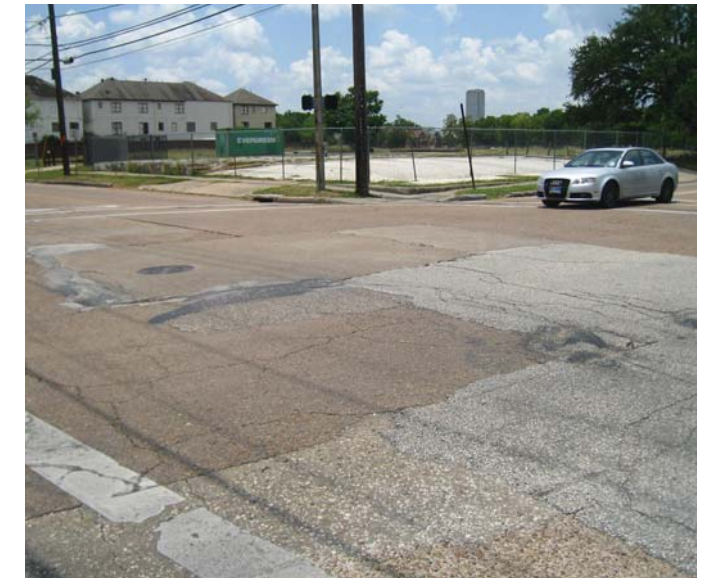
Photo 14-1, Segment 1
Dunlavy at W. Dallas
Patching creates an uneven riding surface

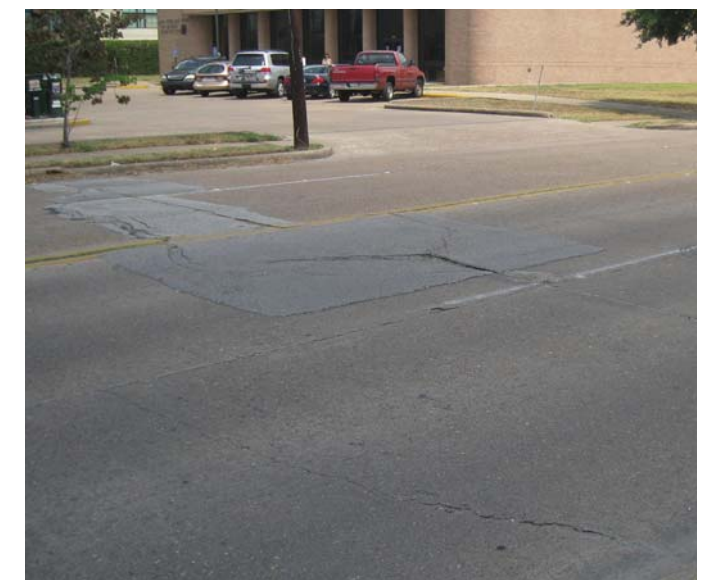
Photo 14-2, Segment 6A and 6B
Dunlavy between W. Bell and W. Gray
Patch is lower than the surrounding pavement, creating a depressed section.

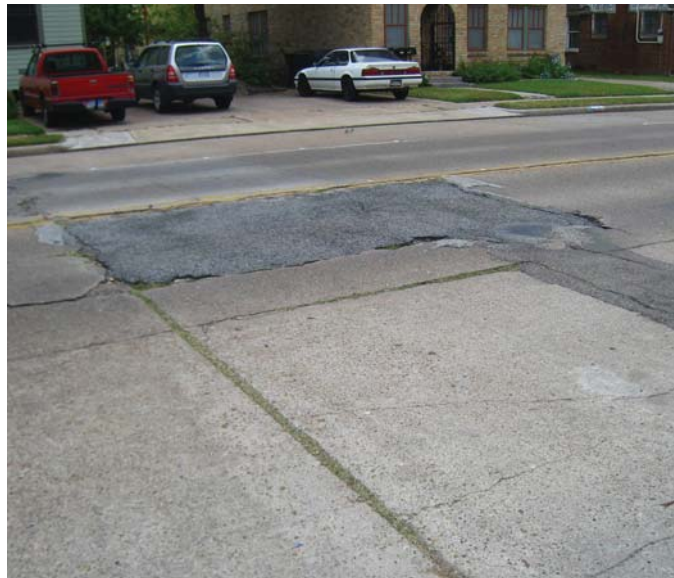
Photo 14-3, Segment 12B
Dunlavy between Haddon and Vermont
 Previous patch shows extreme wear and is uneven.

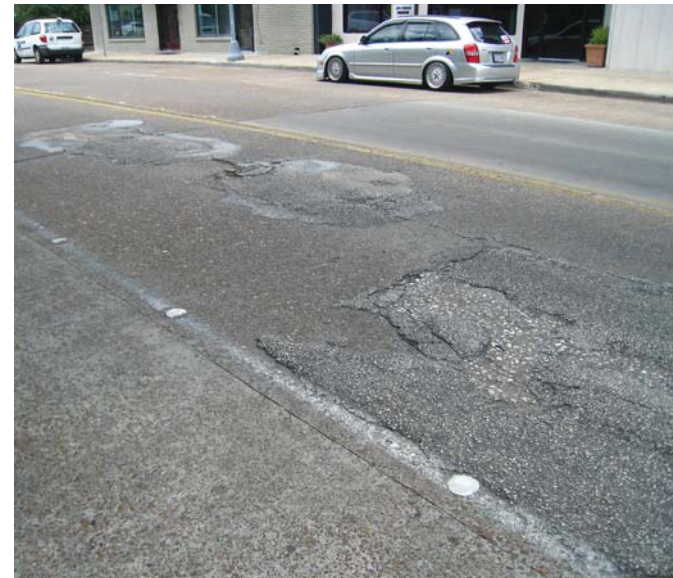
Photo 14-5, Segment 22A
Dunlavy between Maryland and Fairview
 Uneven pavement and pot holes, with evidence of possible patching.

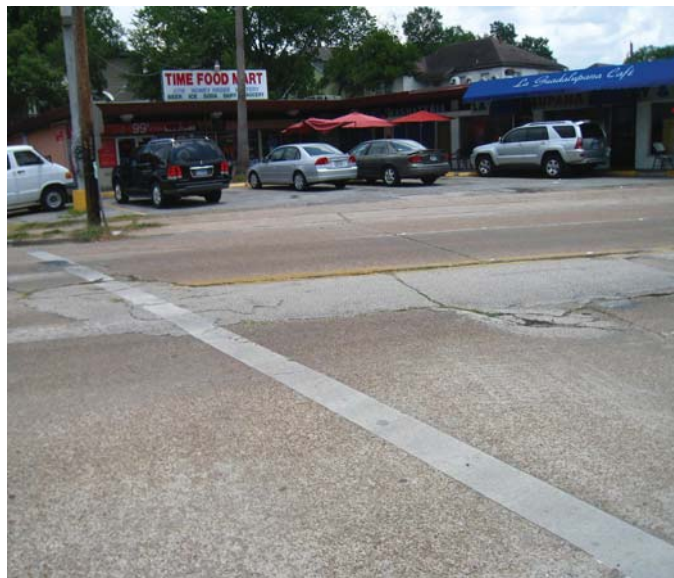
Photo 14-4, Segment 17
Dunlavy at Indiana
 Previous patch is cracking at the edges

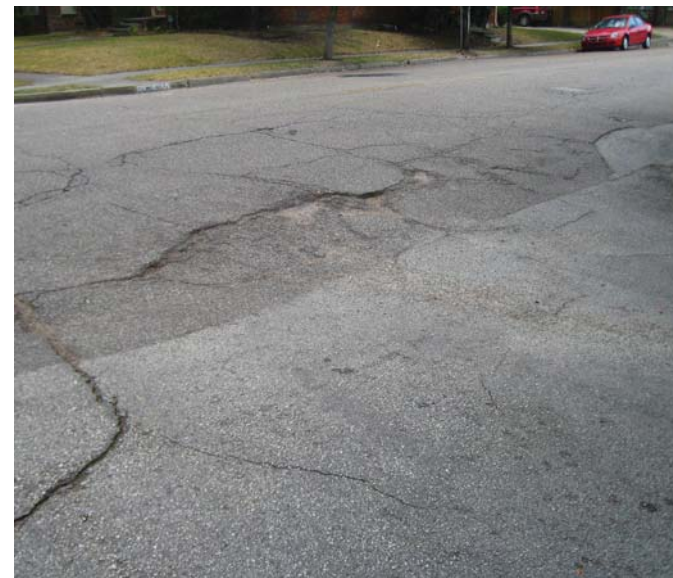
Photo 14-6, Segment 31
Dunlavy at Harold
 Ground settling creates uneven riding surface

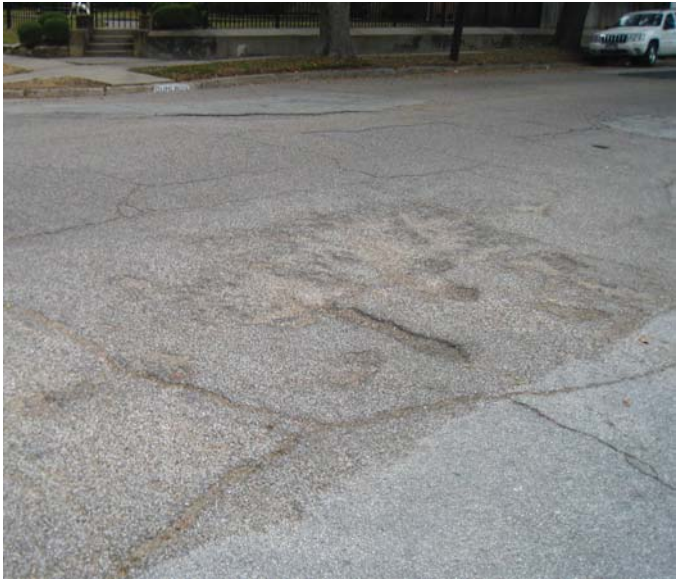
**Photo 14-7, Segment 33
Dunlavy at Kipling**

Wear of pavement at intersection has created a bumpy
divot.

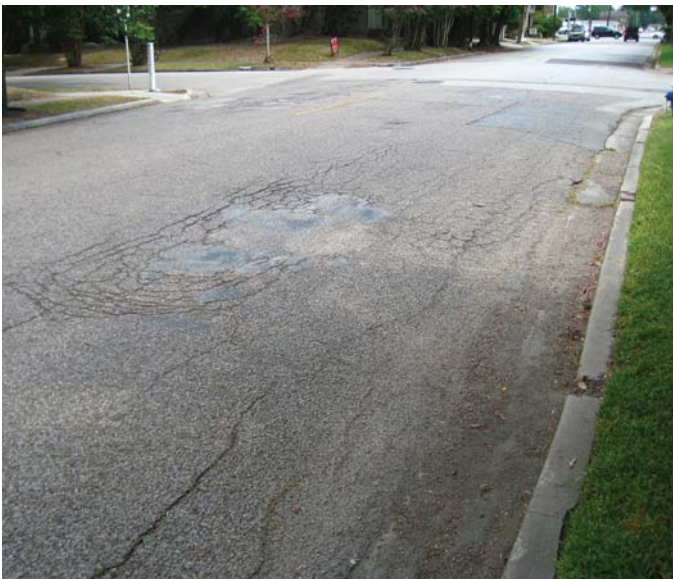
**Photo 14-8, Segment 34A
Dunlavy between Kipling and Marshall**

Alligator cracking with evidence of previous patching

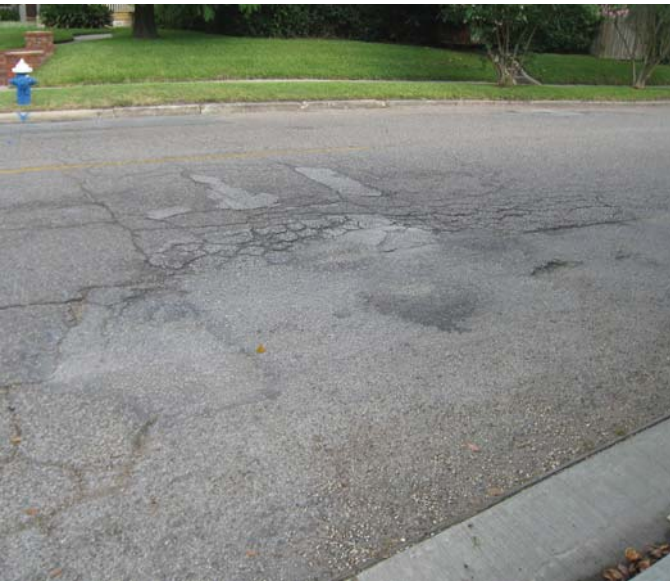
Photo 14-9, Segment 34B
Dunlavy between Kipling and Marshall
Alligator cracking and uneven settling, with evidence of previous patches

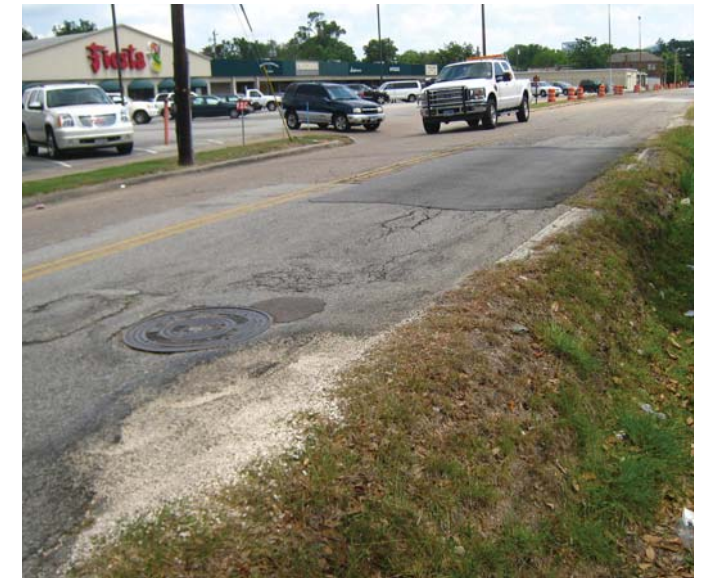
Photo 14-10, Segment 38A
Dunlavy between W. Alabama and W. Main
 During early observations, this section of Dunlavy was uneven with some pavement missing. [This section has been rebuilt since the photo as part of a developer project.]

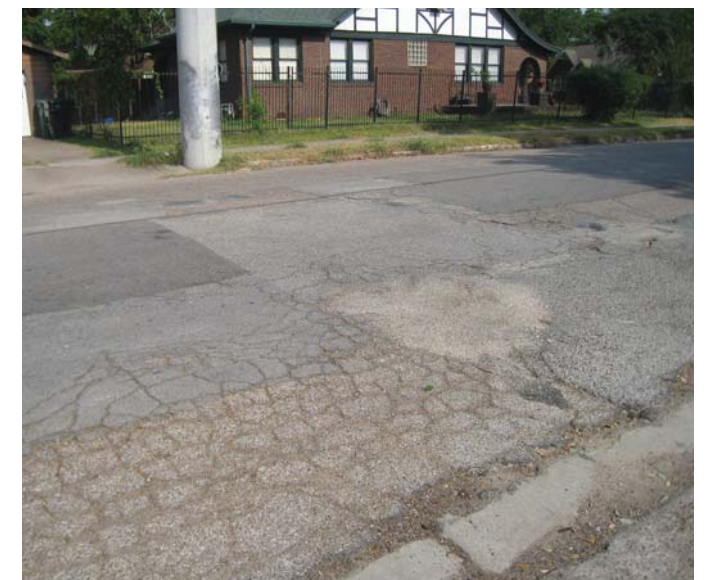
Photo 14-11, Segment 40A and 40B
Dunlavy between W. Main and Colquitt
 Alligator cracking in travel lanes

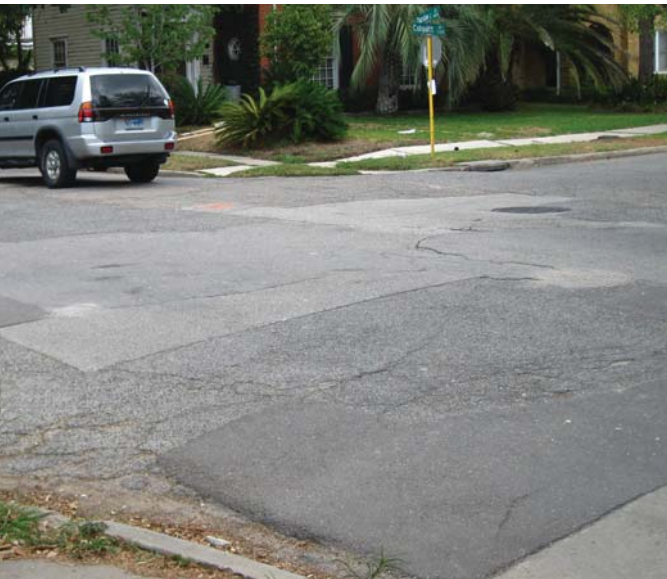
Photo 14-12, Segment 41
Dunlavy at Colquitt
Cracking in the intersection and numerous previous patches

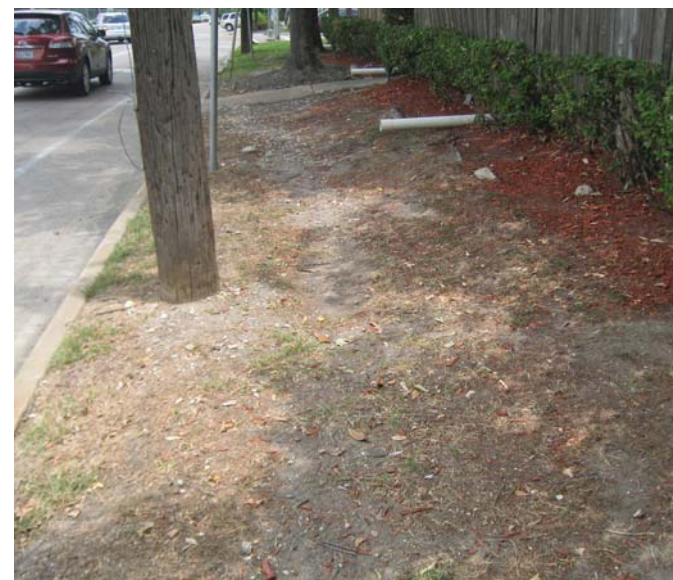
Photo 14-13, Segment 2A
Dunlavy between W. Dallas and W. Clay
Sidewalk missing

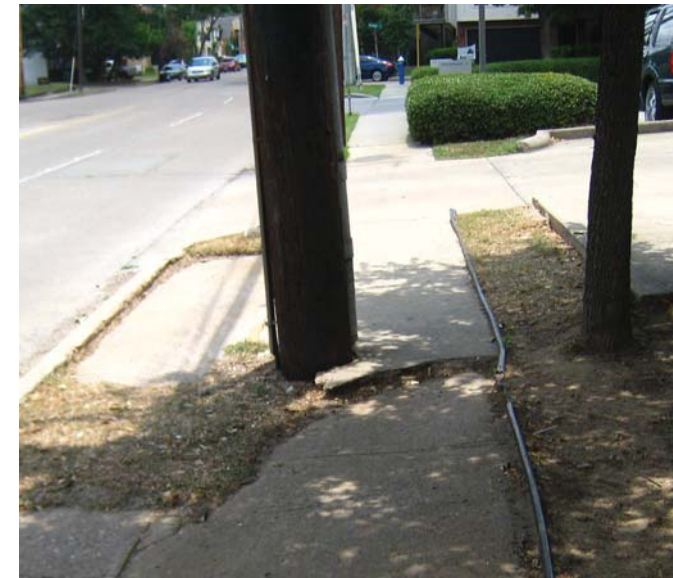
Photo 14-14, Segment 8B
Dunlavy between W. Gray and Peden
 Settling and obstructions

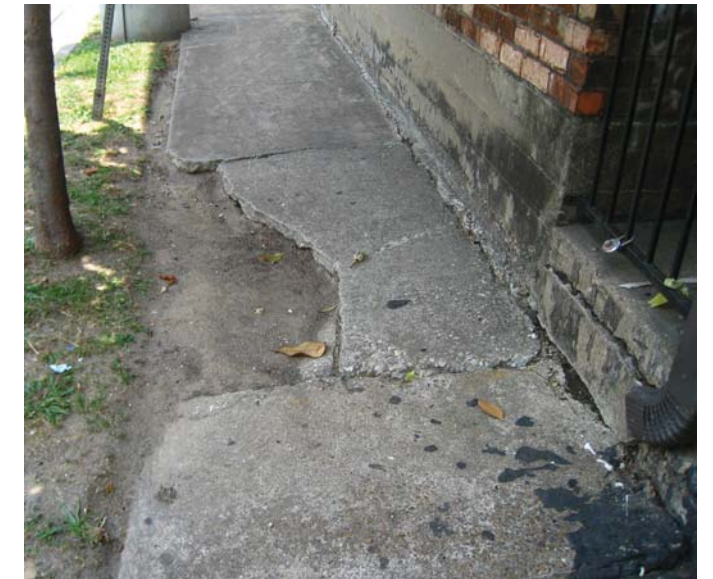
Photo 14-16, Segment 14A
Dunlavy between Vermont and Welch
 Settling and cracking

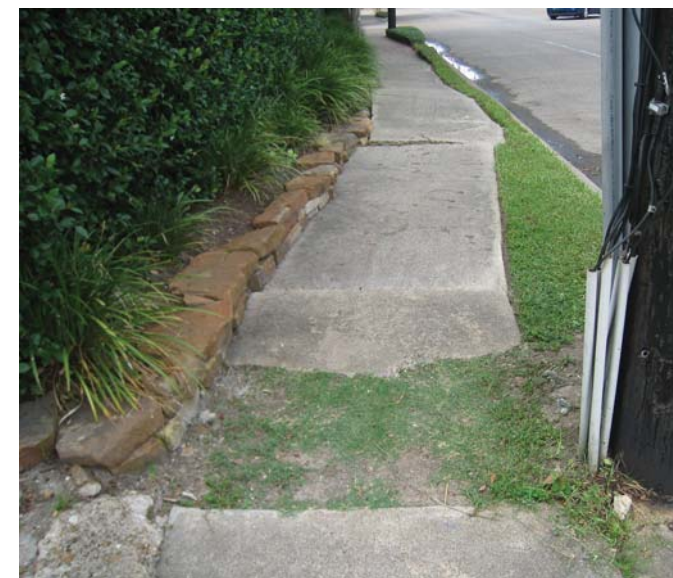
Photo 14-15, Segment 12B
Dunlavy between Haddon and Vermont
 Missing section of sidewalk

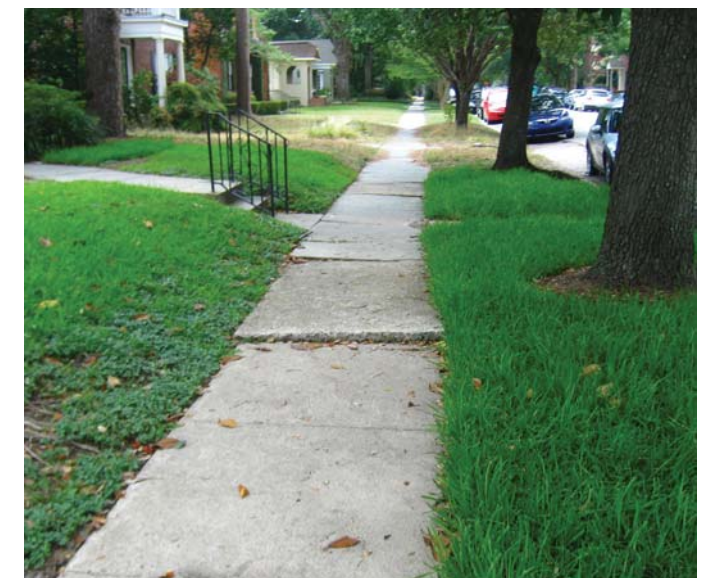
Photo 14-17, Segment 30A
Dunlavy between Hawthorne and Harold
 Sidewalk sections have shifted, creating tripping hazards at joints.

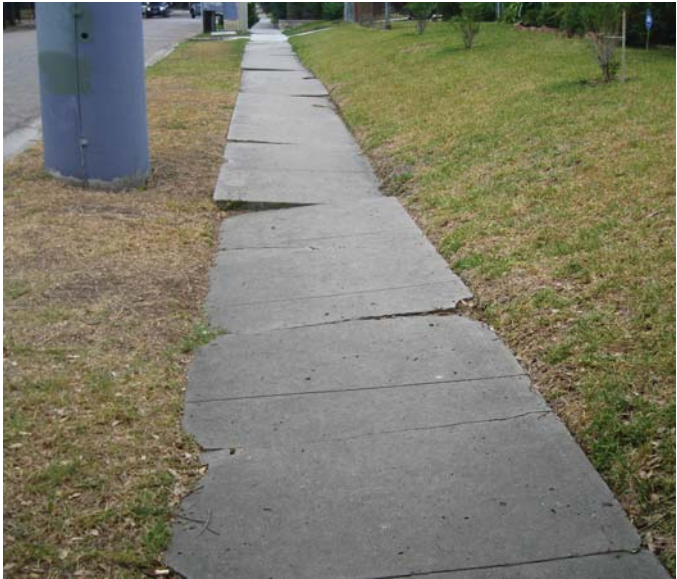
Photo 14-18, Segment 32A
Dunlavy between Harold and Kipling
Sidewalk sections have cracked and shifted, creating tripping hazards at the joint and cracks.

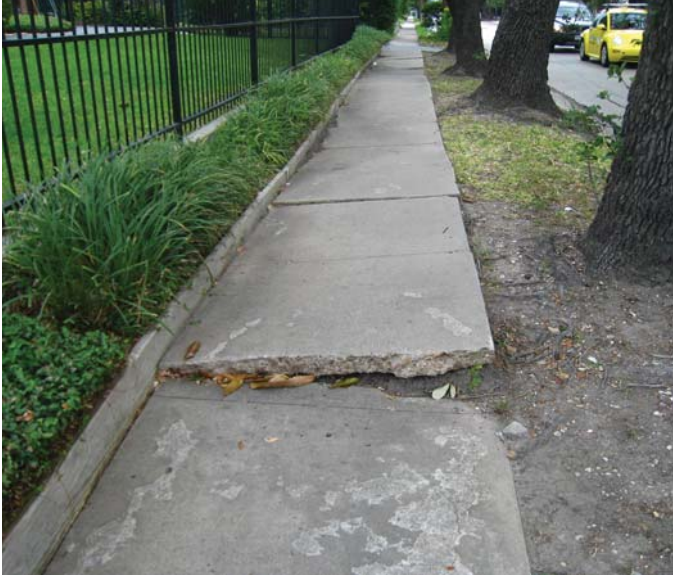
Photo 14-20, Segment 36A
Dunlavy between W. Main and Colquitt
Tree root has caused sidewalk to break and lift

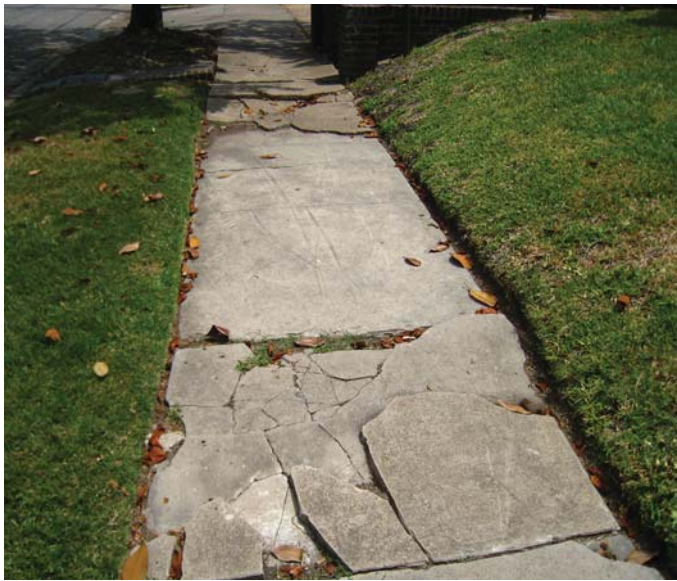
Photo 14-19, Segment 34A
Dunlavy between Kipling and Marshall
Cracking and settling

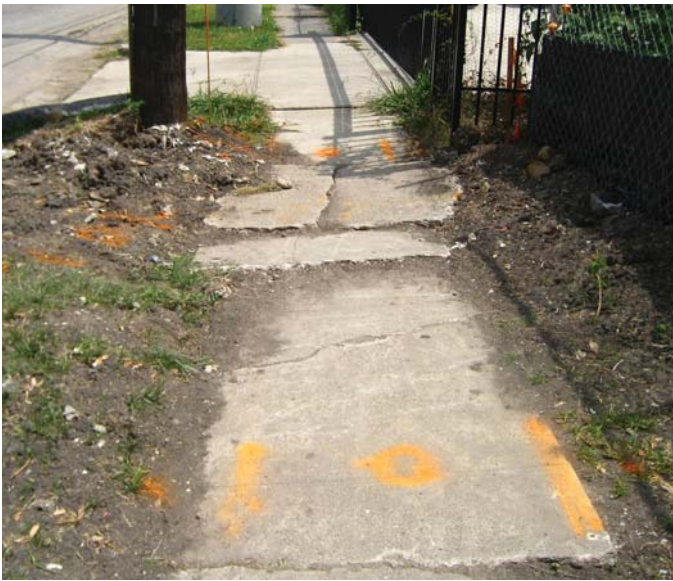
Photo 14-21, Segment 38A
Dunlavy between W. Alabama and W. Main
Cracking and settling

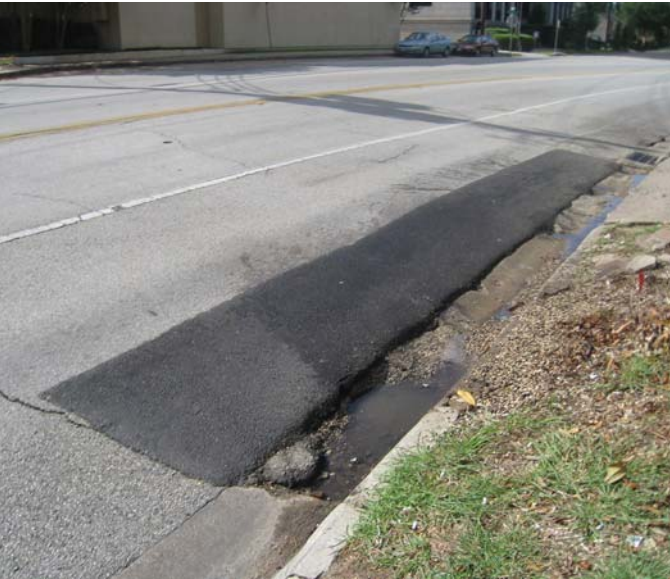
Photo 15-1, Segment 2A
Shepherd between W. Dallas and McDuffie
 Pavement slopes off steeply near curb.
