COMPREHENSIVE DISTRICT-WIDE MOBILITY STUDY

*An evaluation of pavement condition, pedestrian accessibility,
cut-through traffic, and markings within the Montrose District*

WALTER P MOORE

February 2012

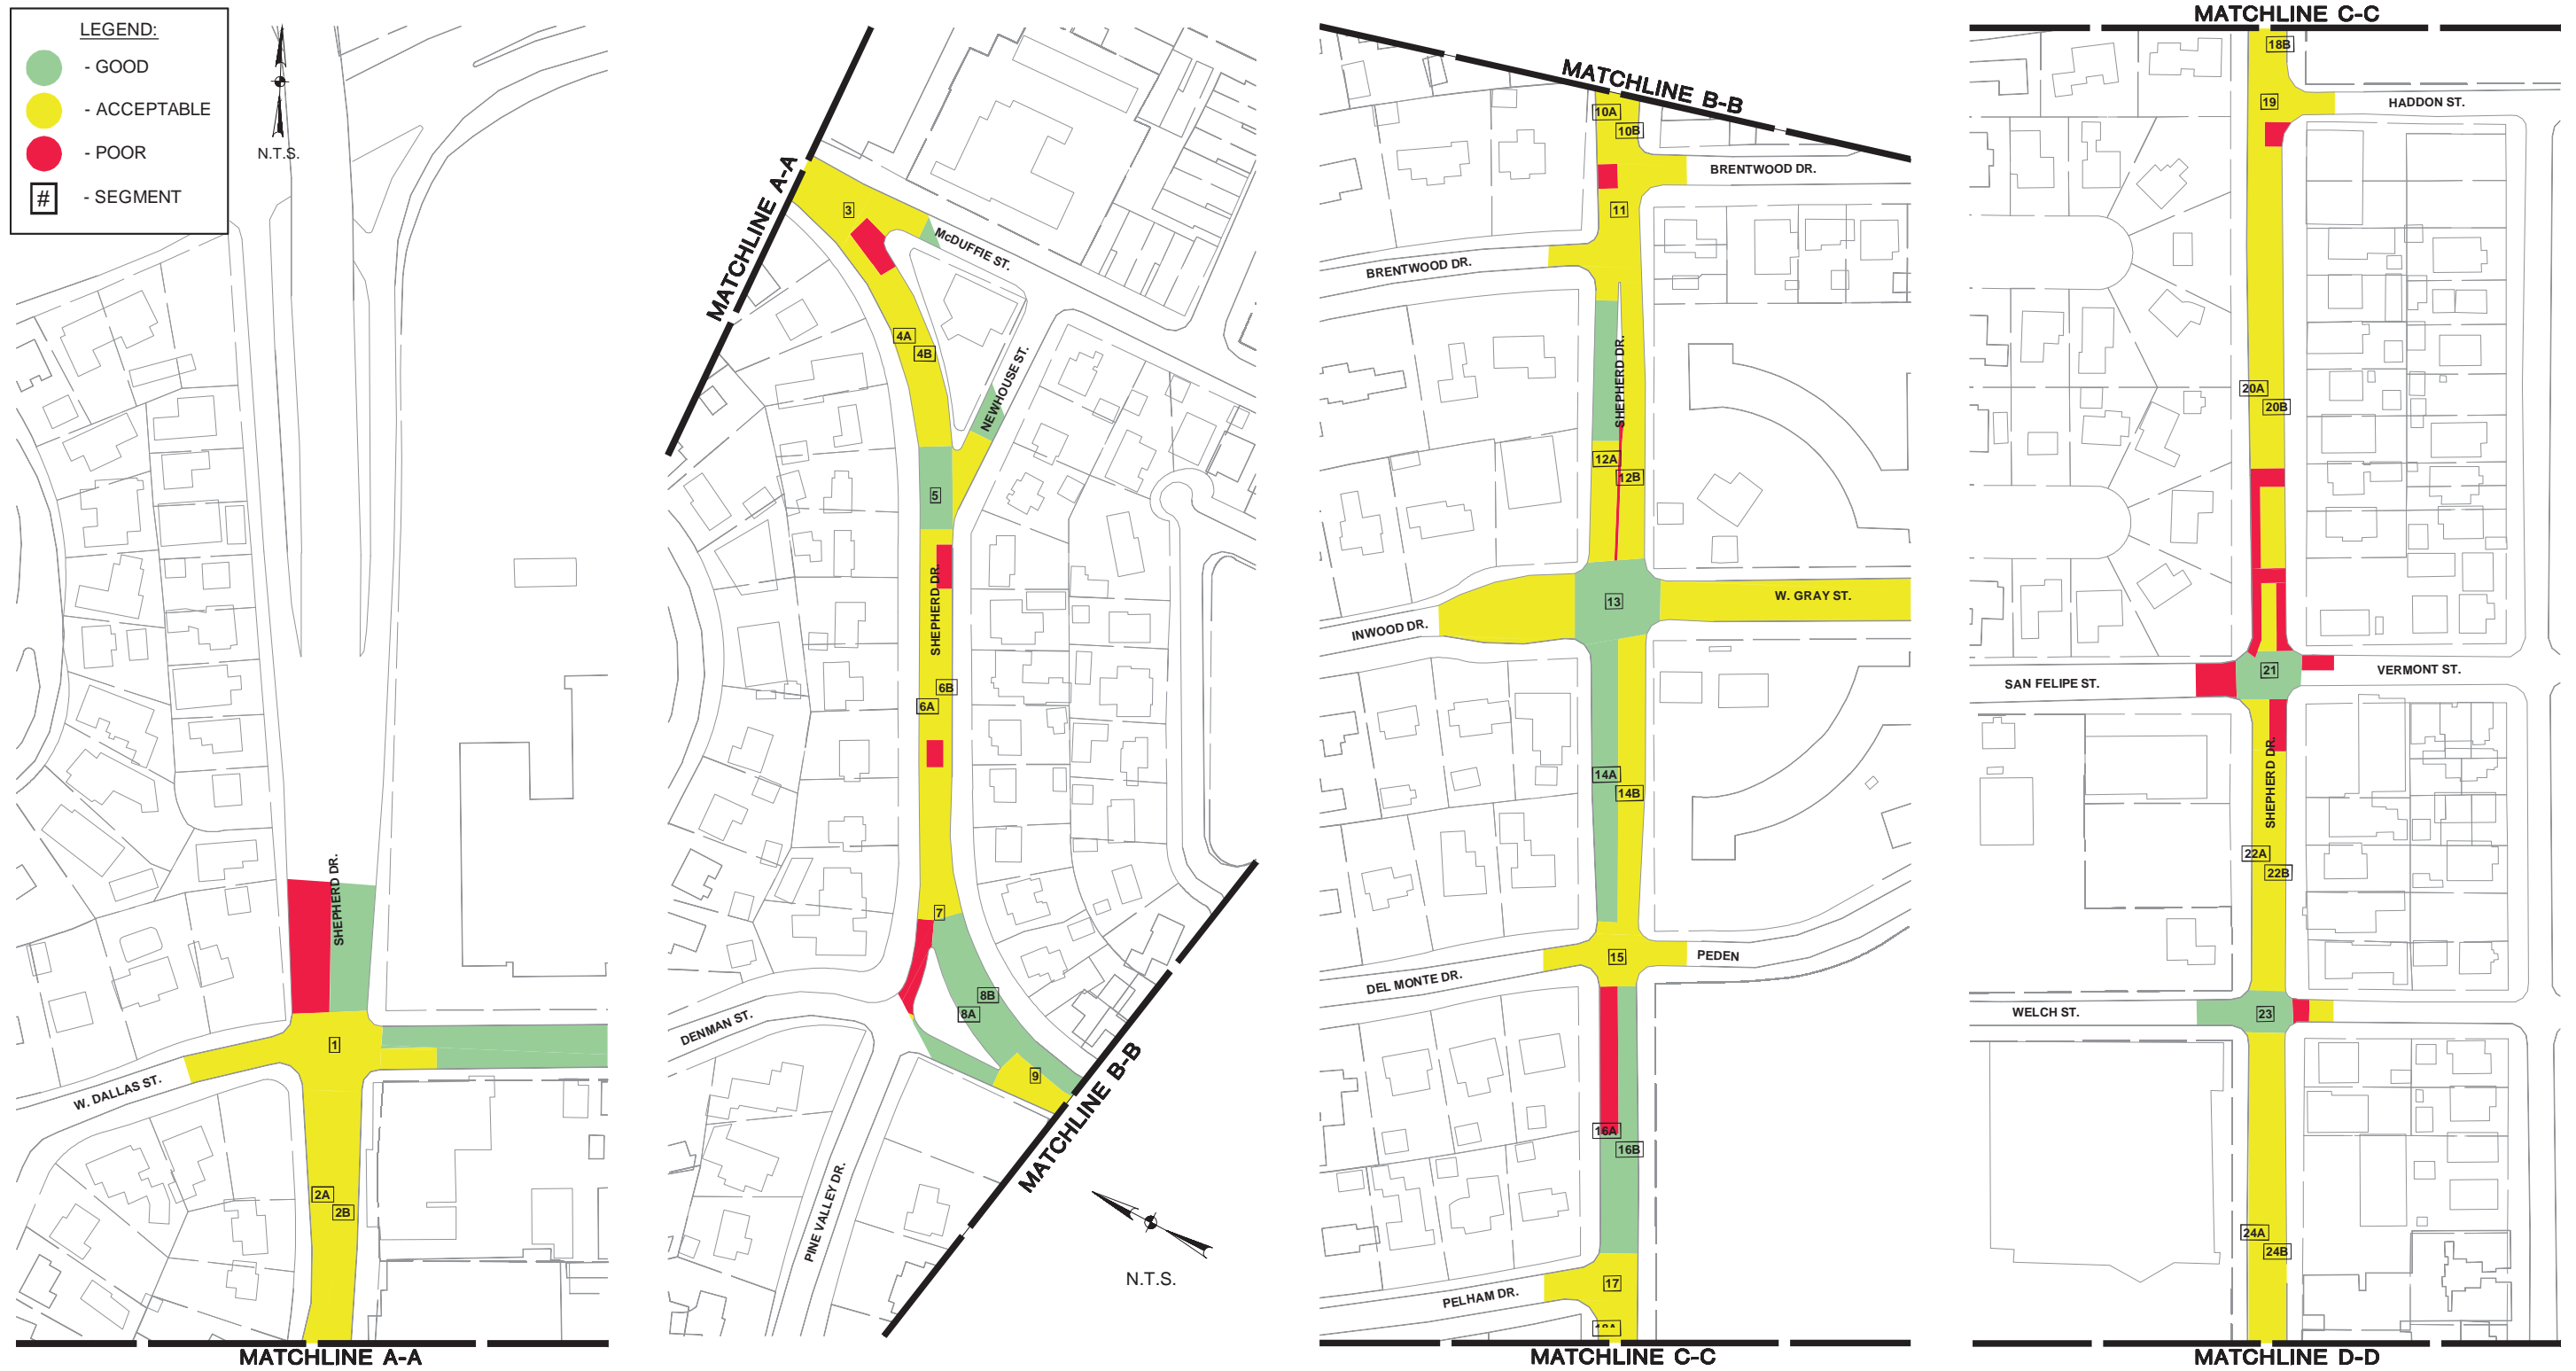
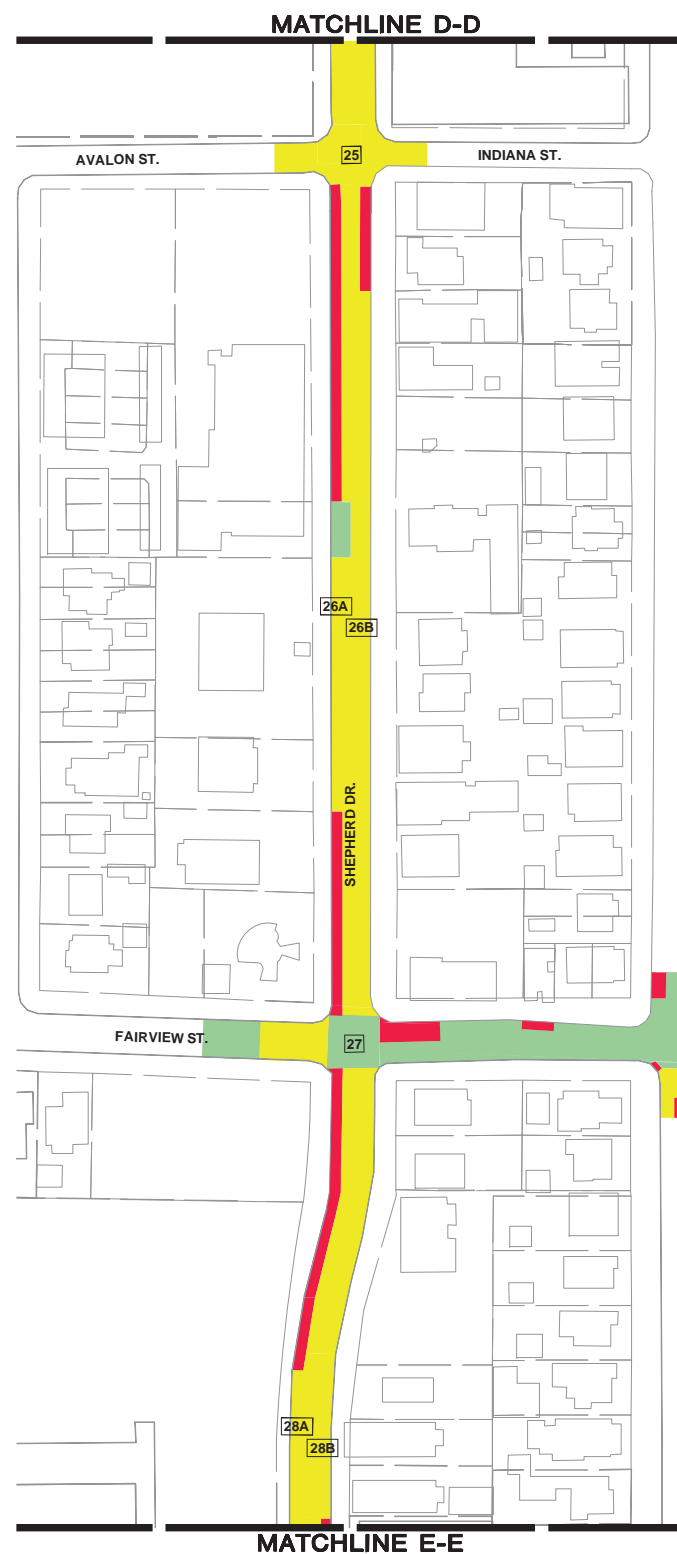
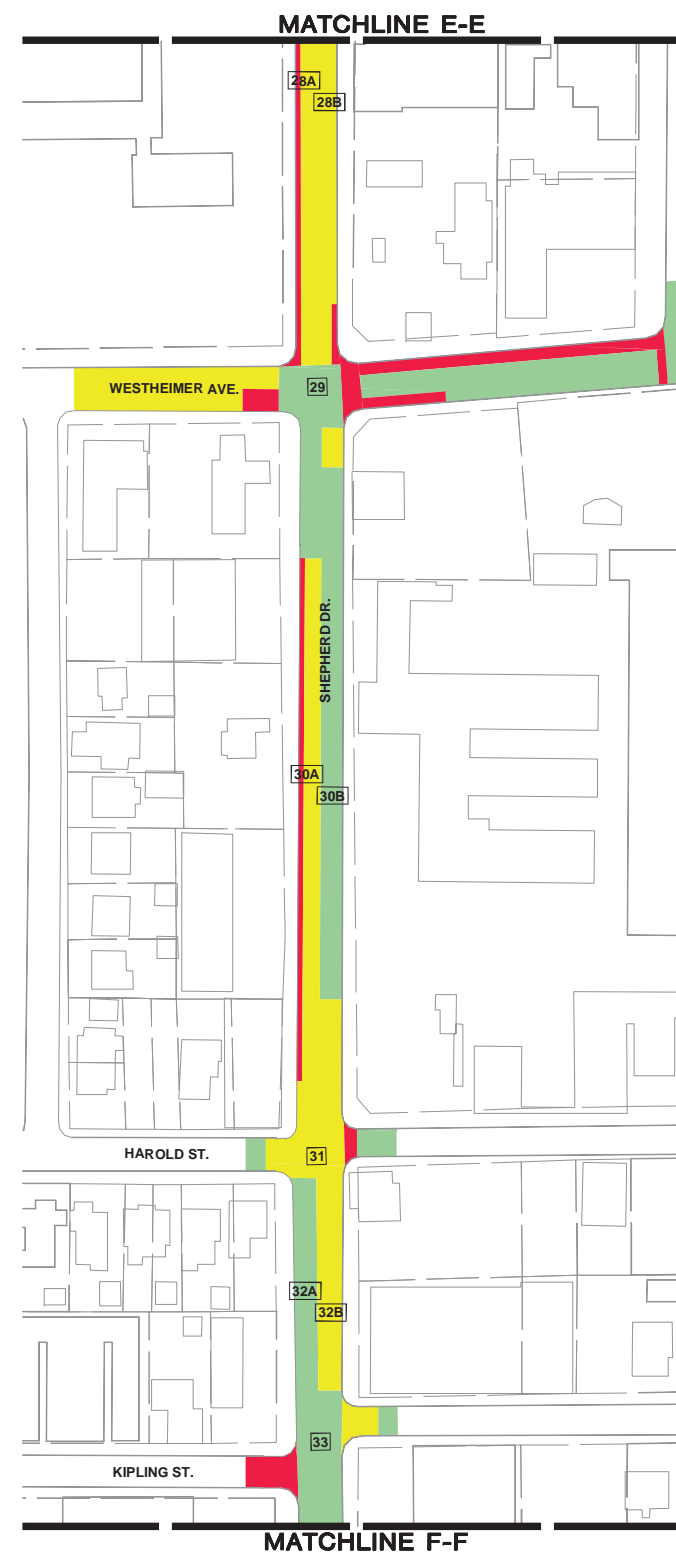
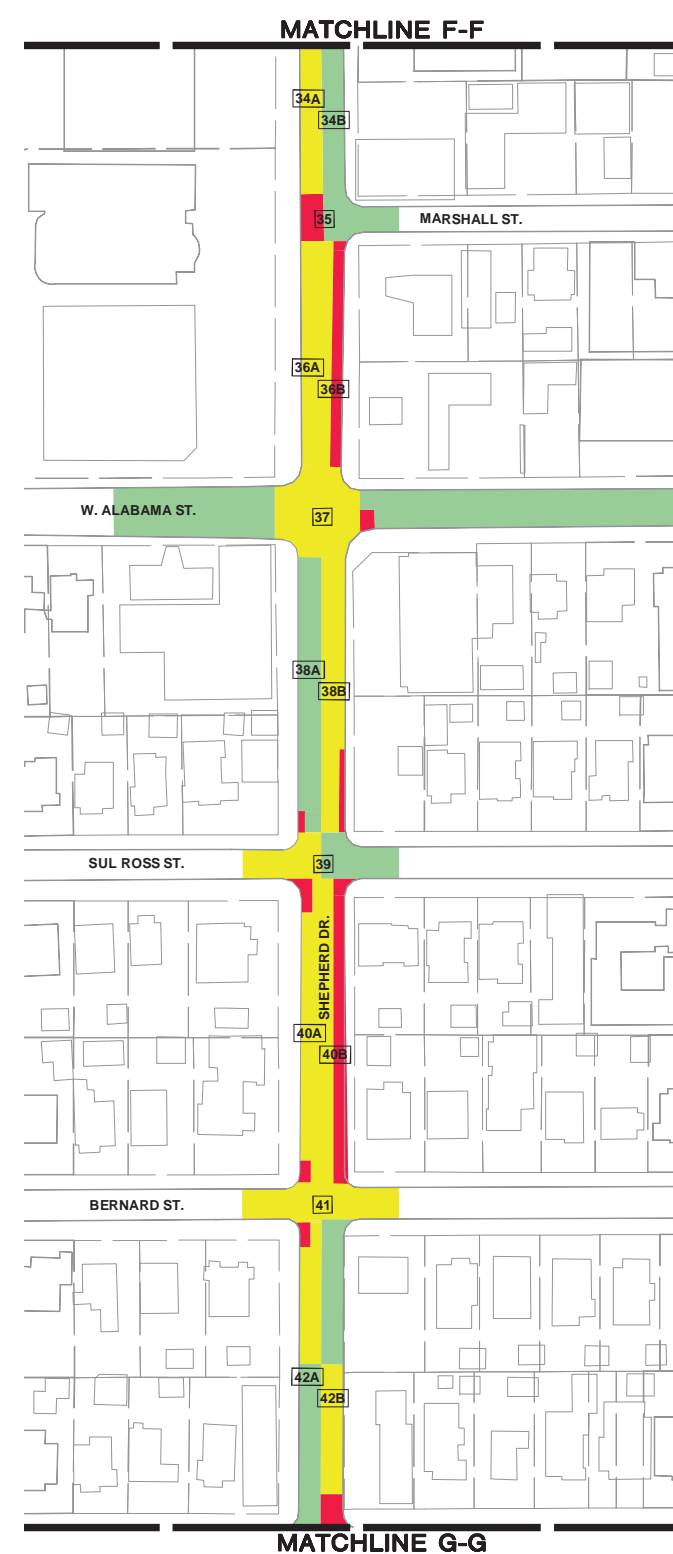
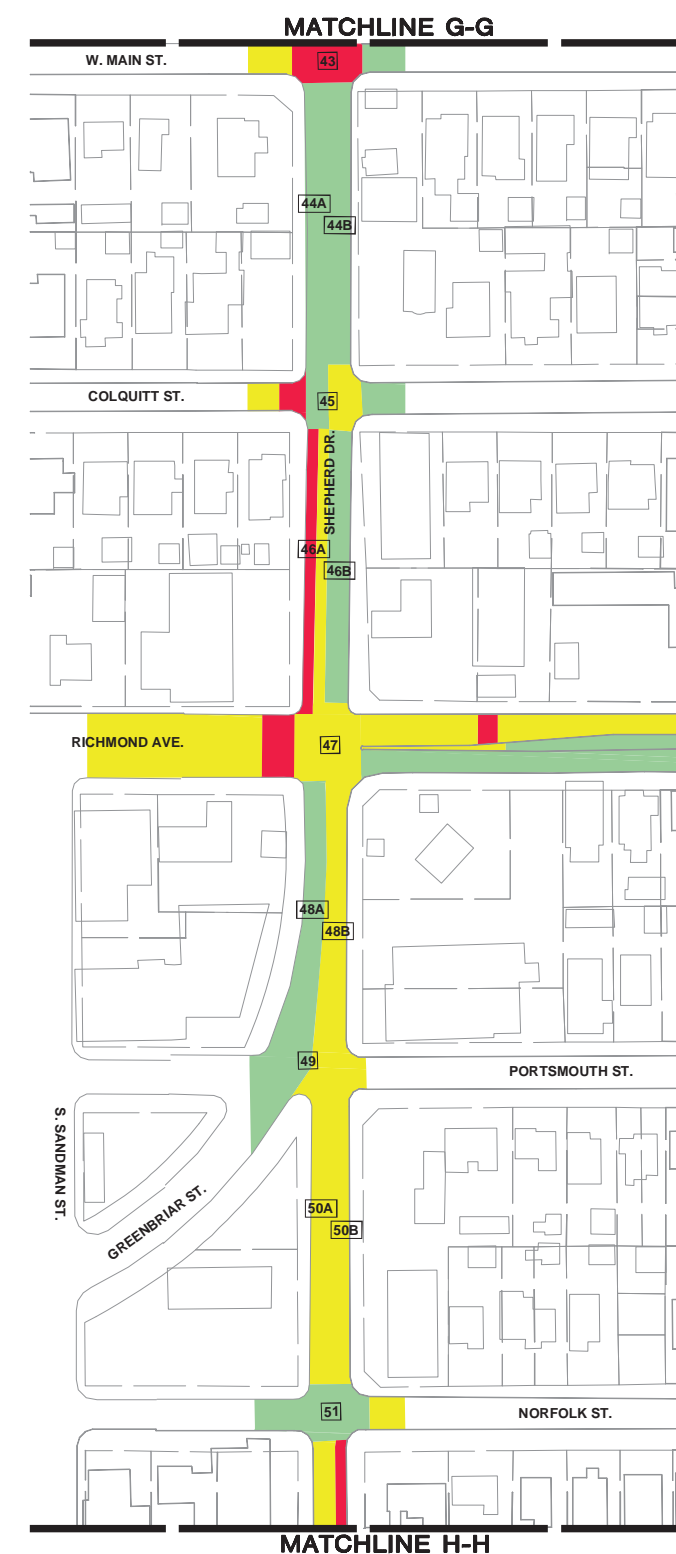
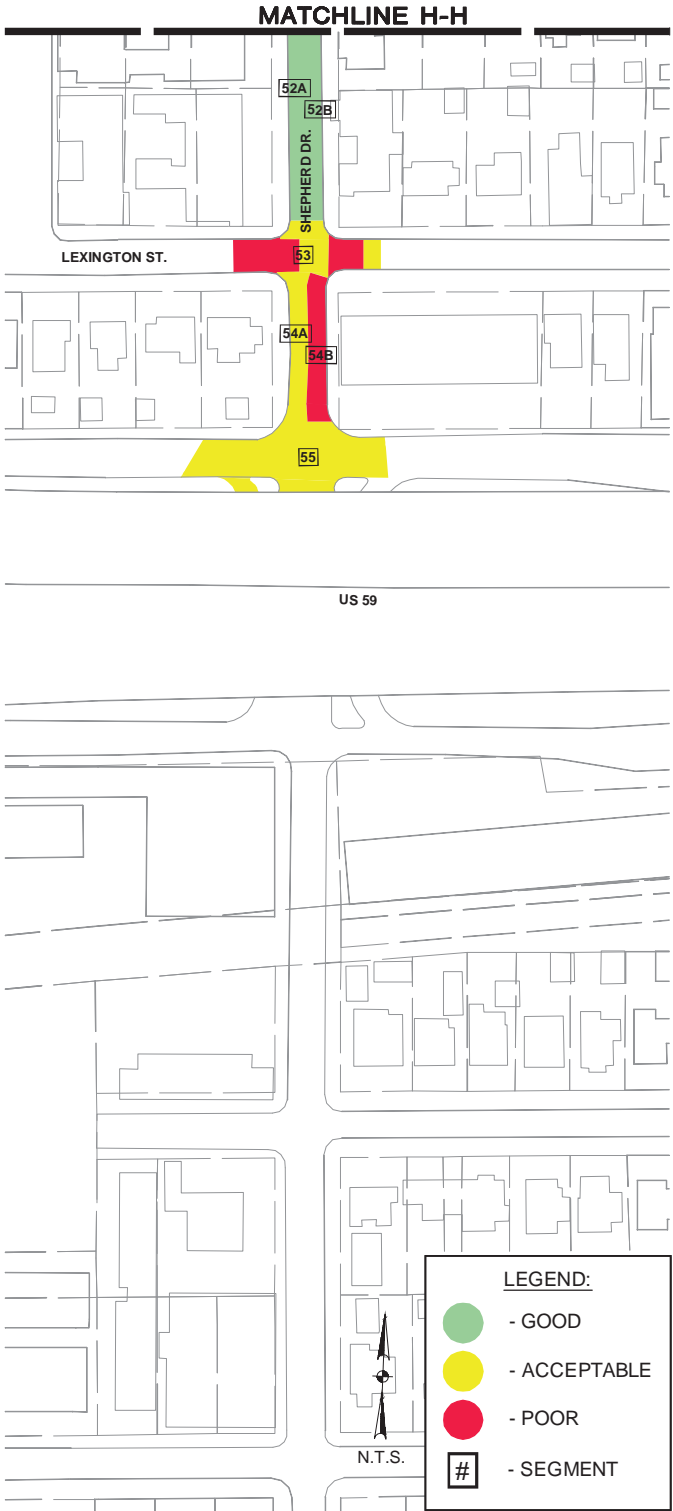
Figure 15-3
Shepherd Drive Pavement Conditions

15.2 PAVEMENT AND MEDIAN EVALUATION
 Shepherd is a four lane undivided street in the Montrose District. The pavement is concrete with curb and gutter. Shepherd pavement conditions were studied by means of visual observations and photos. Pavement conditions along Shepherd were generally acceptable, with sections of poor and good pavement. **Table 15-2** summarizes the results of the pavement and median review. **Figure 15-3** graphically depicts the pavement conditions observed along Shepherd. **Photos 15-1** through **15-8** illustrate some of the poor pavement segments which suggest immediate repair/replacement.

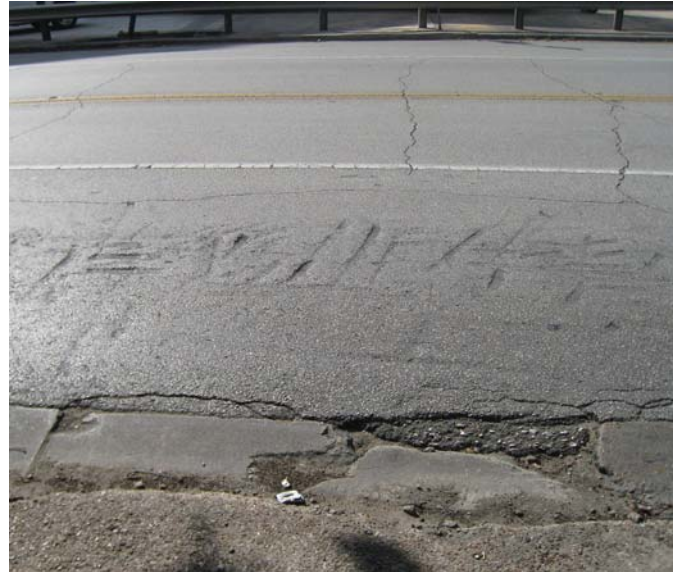
Photo 15-2, Segment 4A
Shepherd between McDuffie and Newhouse
 Cracking and scrapes in lane

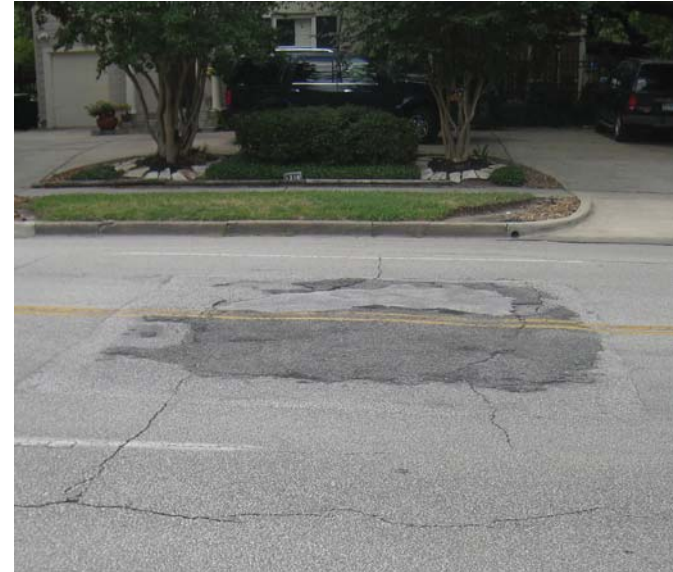
Photo 15-3, Segment 6B
Shepherd between Newhouse and Pine Valley
 Uneven patched pavement in middle of the road

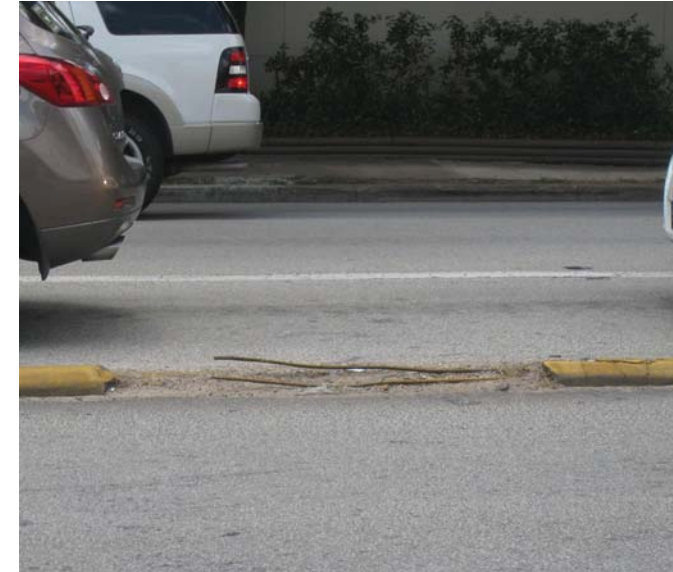
Photo 15-4, Segment 12A and 12B
Shepherd between Brentwood and W. Gray/Inwood
 Section of the median missing and exposed rebar

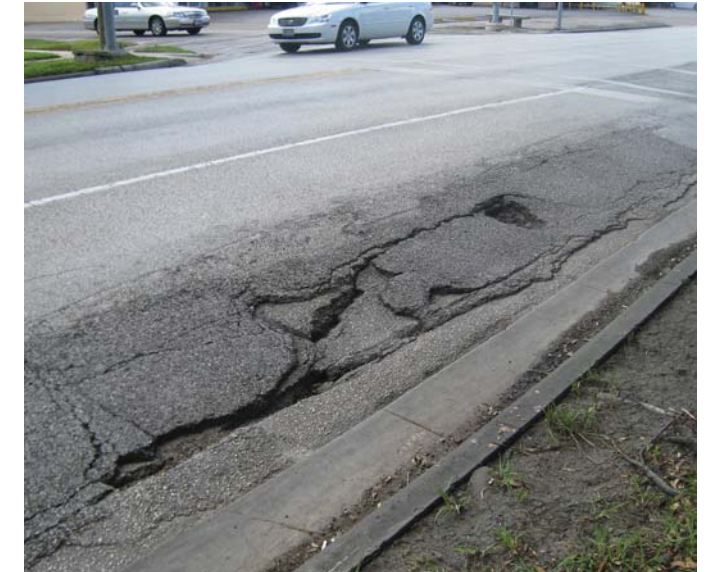
Photo 15-5, Segment 20A
Shepherd between Haddon and San Felipe/Vermont
 Severe cracking near curb

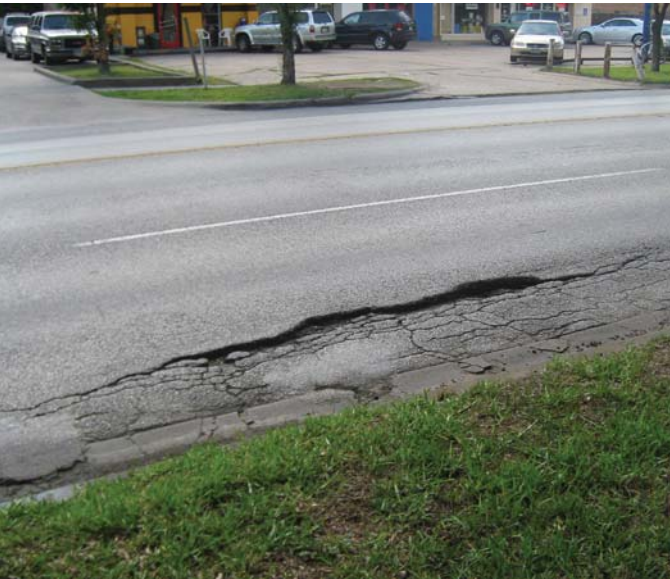
Photo 15-6, Segment 22A
Shepherd between San Felipe/Vermont and Welch
Severe cracking near curb

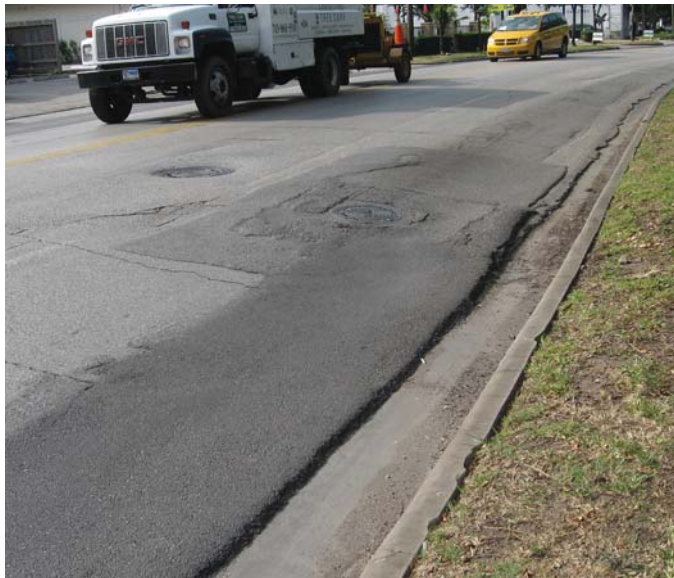
Photo 15-7, Segment 28A
Shepherd between Fairview and Westheimer
 Patching creates drop off at curb and gutter effectively narrowing the lane.

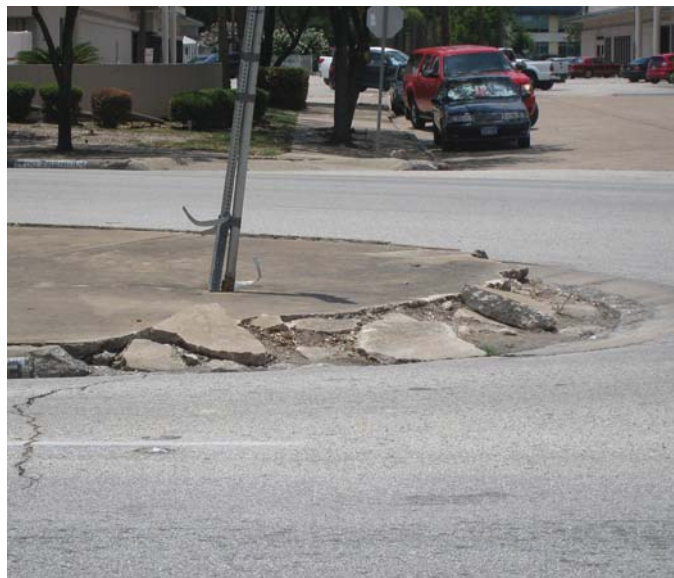
Photo 15-8, Segment 49
Shepherd at Portsmouth
 Median is cracked and broken. Chunks are displaced, creating possible traffic hazards.

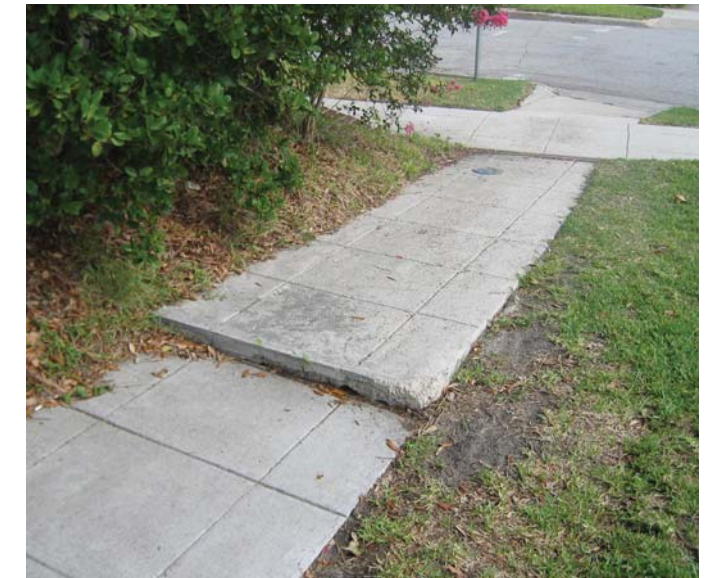
Photo 15-9, Segment 18A
Shepherd between Pelham and Haddon
 Sidewalk section has shifted, causing tripping hazard.

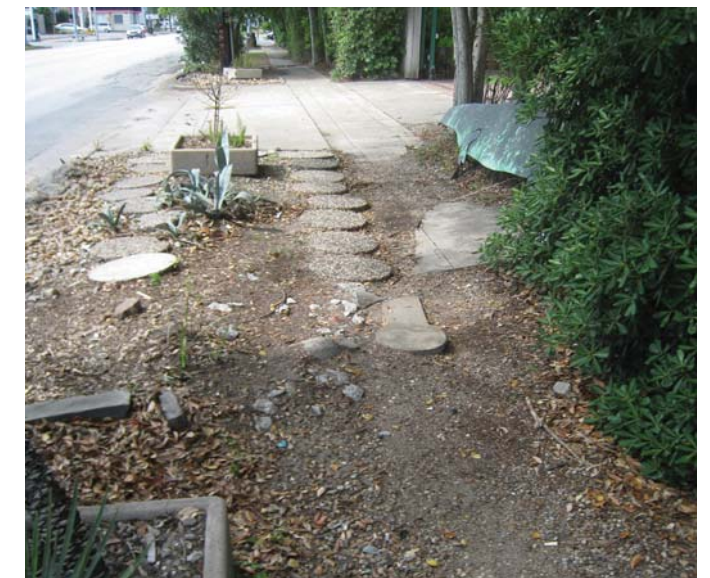
Photo 15-10, Segment 20A
Shepherd between Haddon and San Felipe/Vermont
 Missing sidewalk

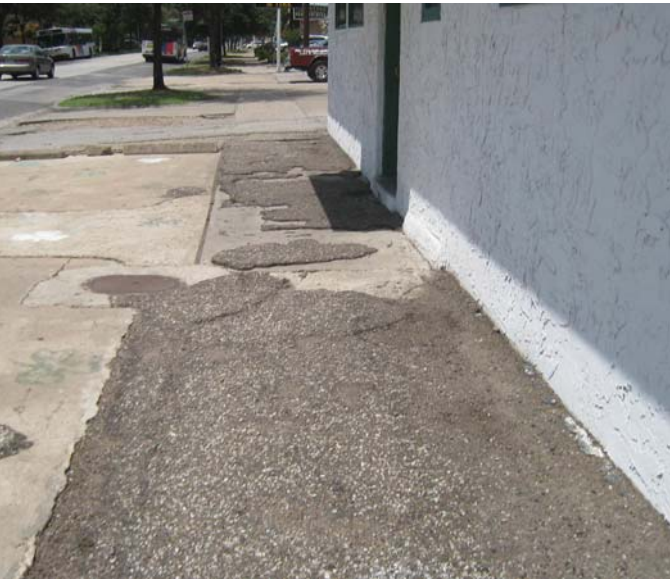
Photo 15-11, Segment 26B
Shepherd between Indiana/Avalon and Fairview
Asphalt over existing concrete is beginning to come up, creating possible tripping hazards.

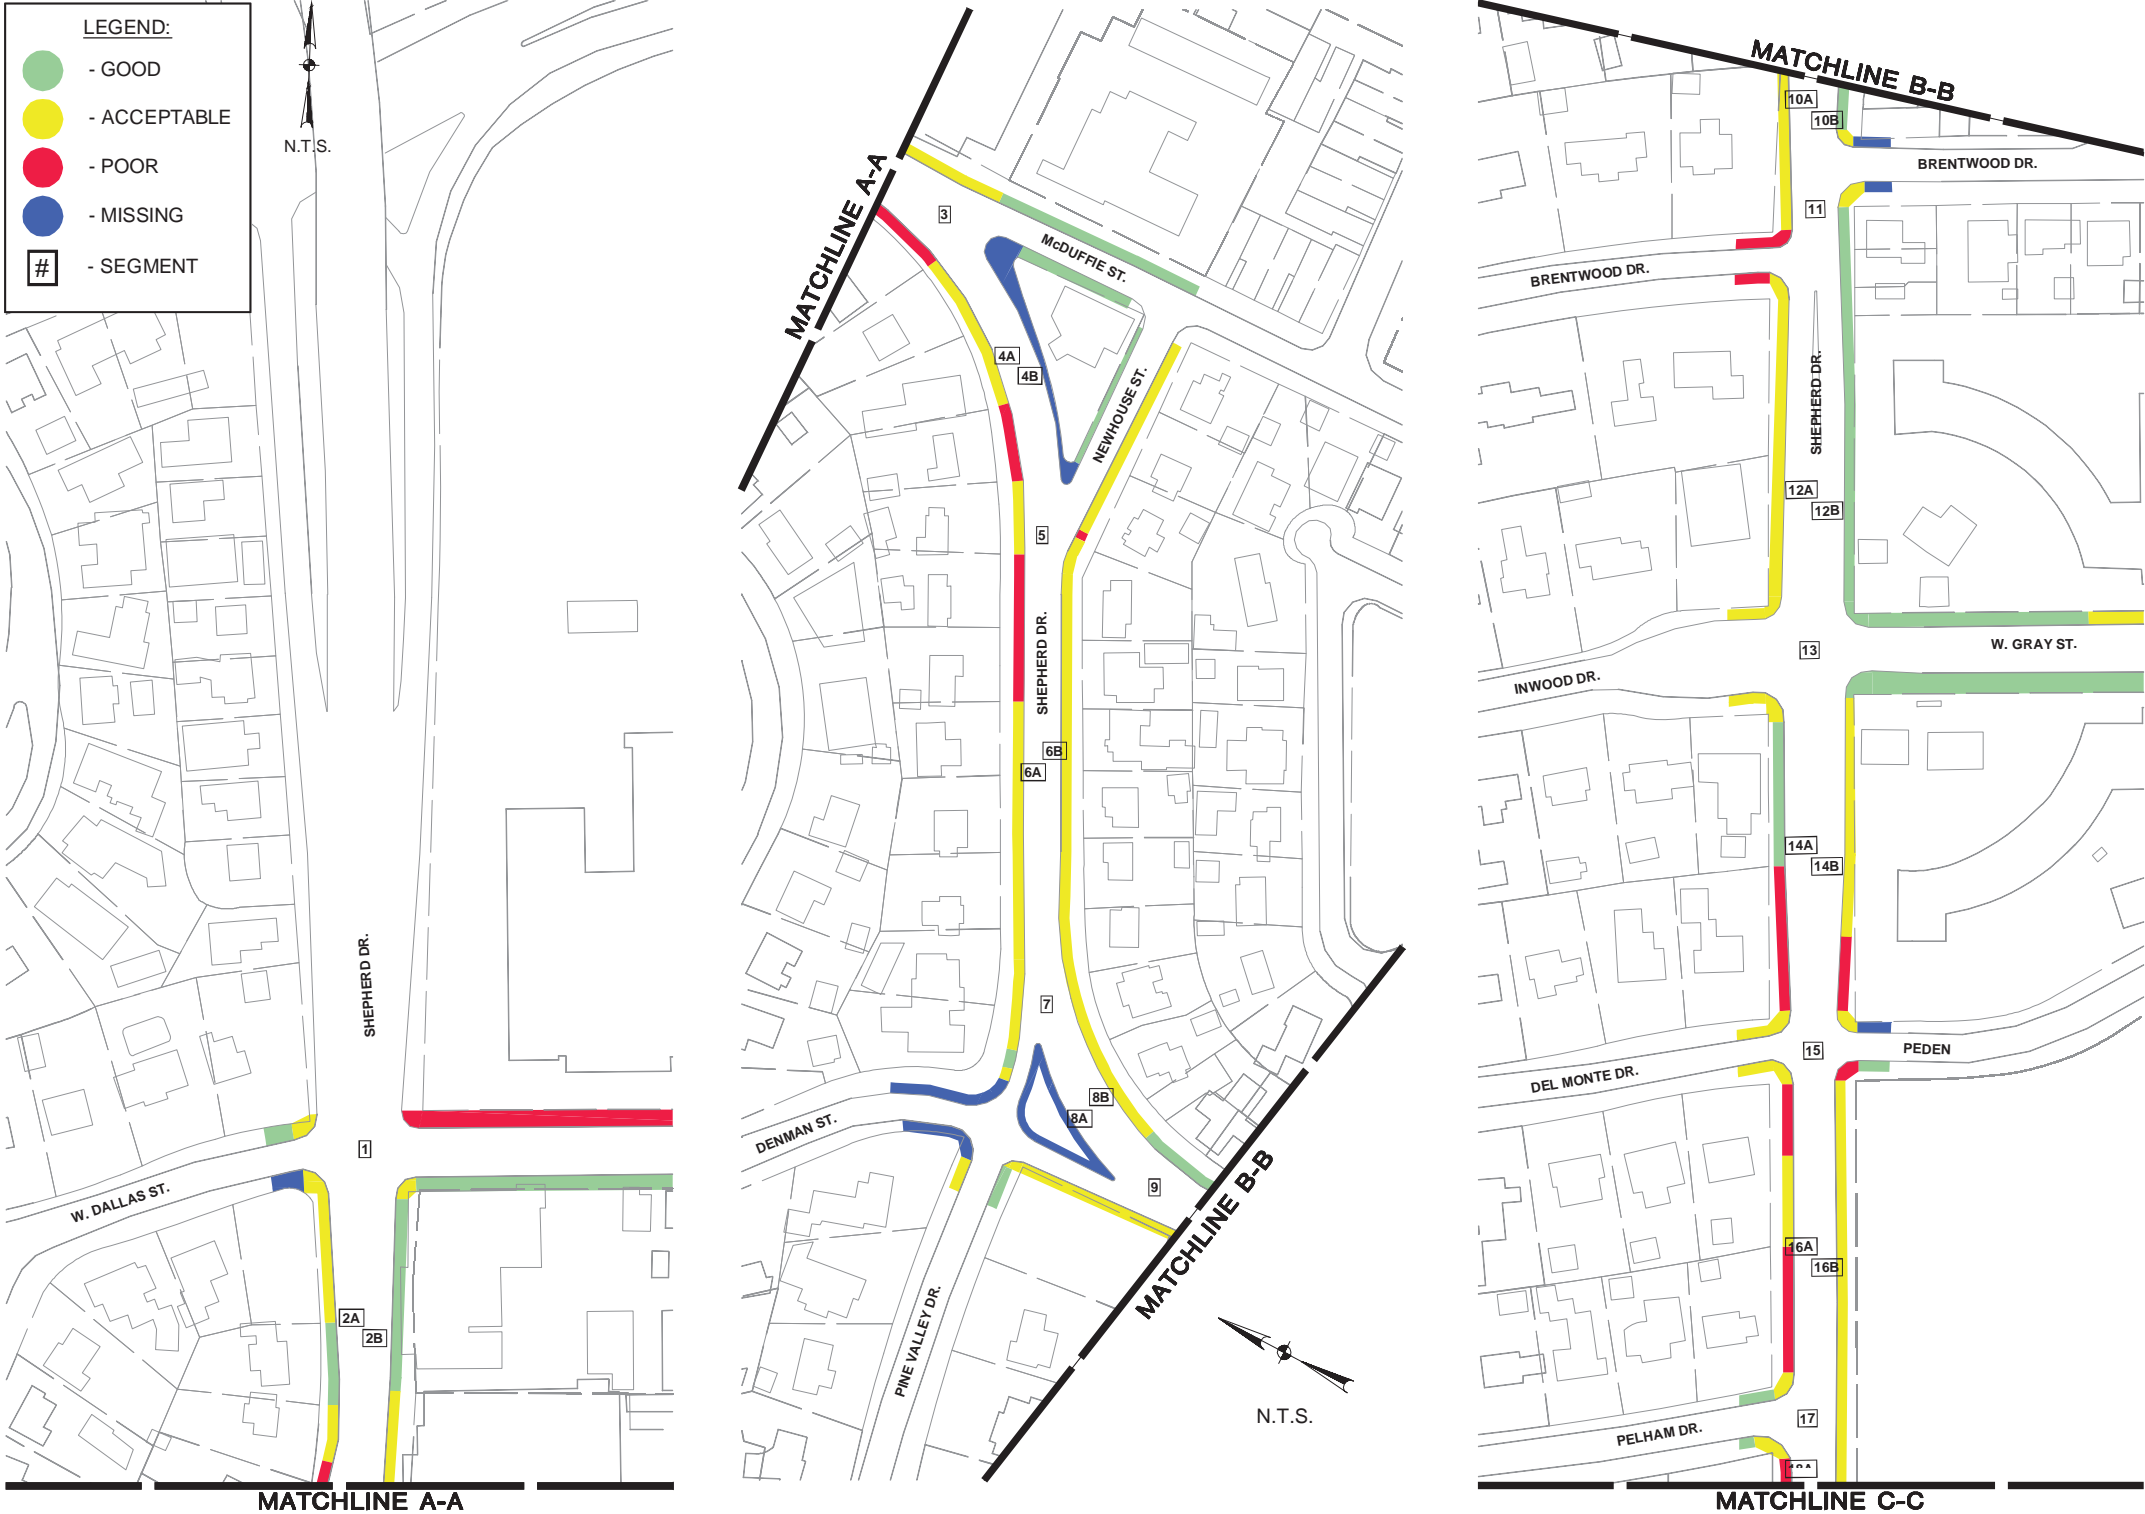
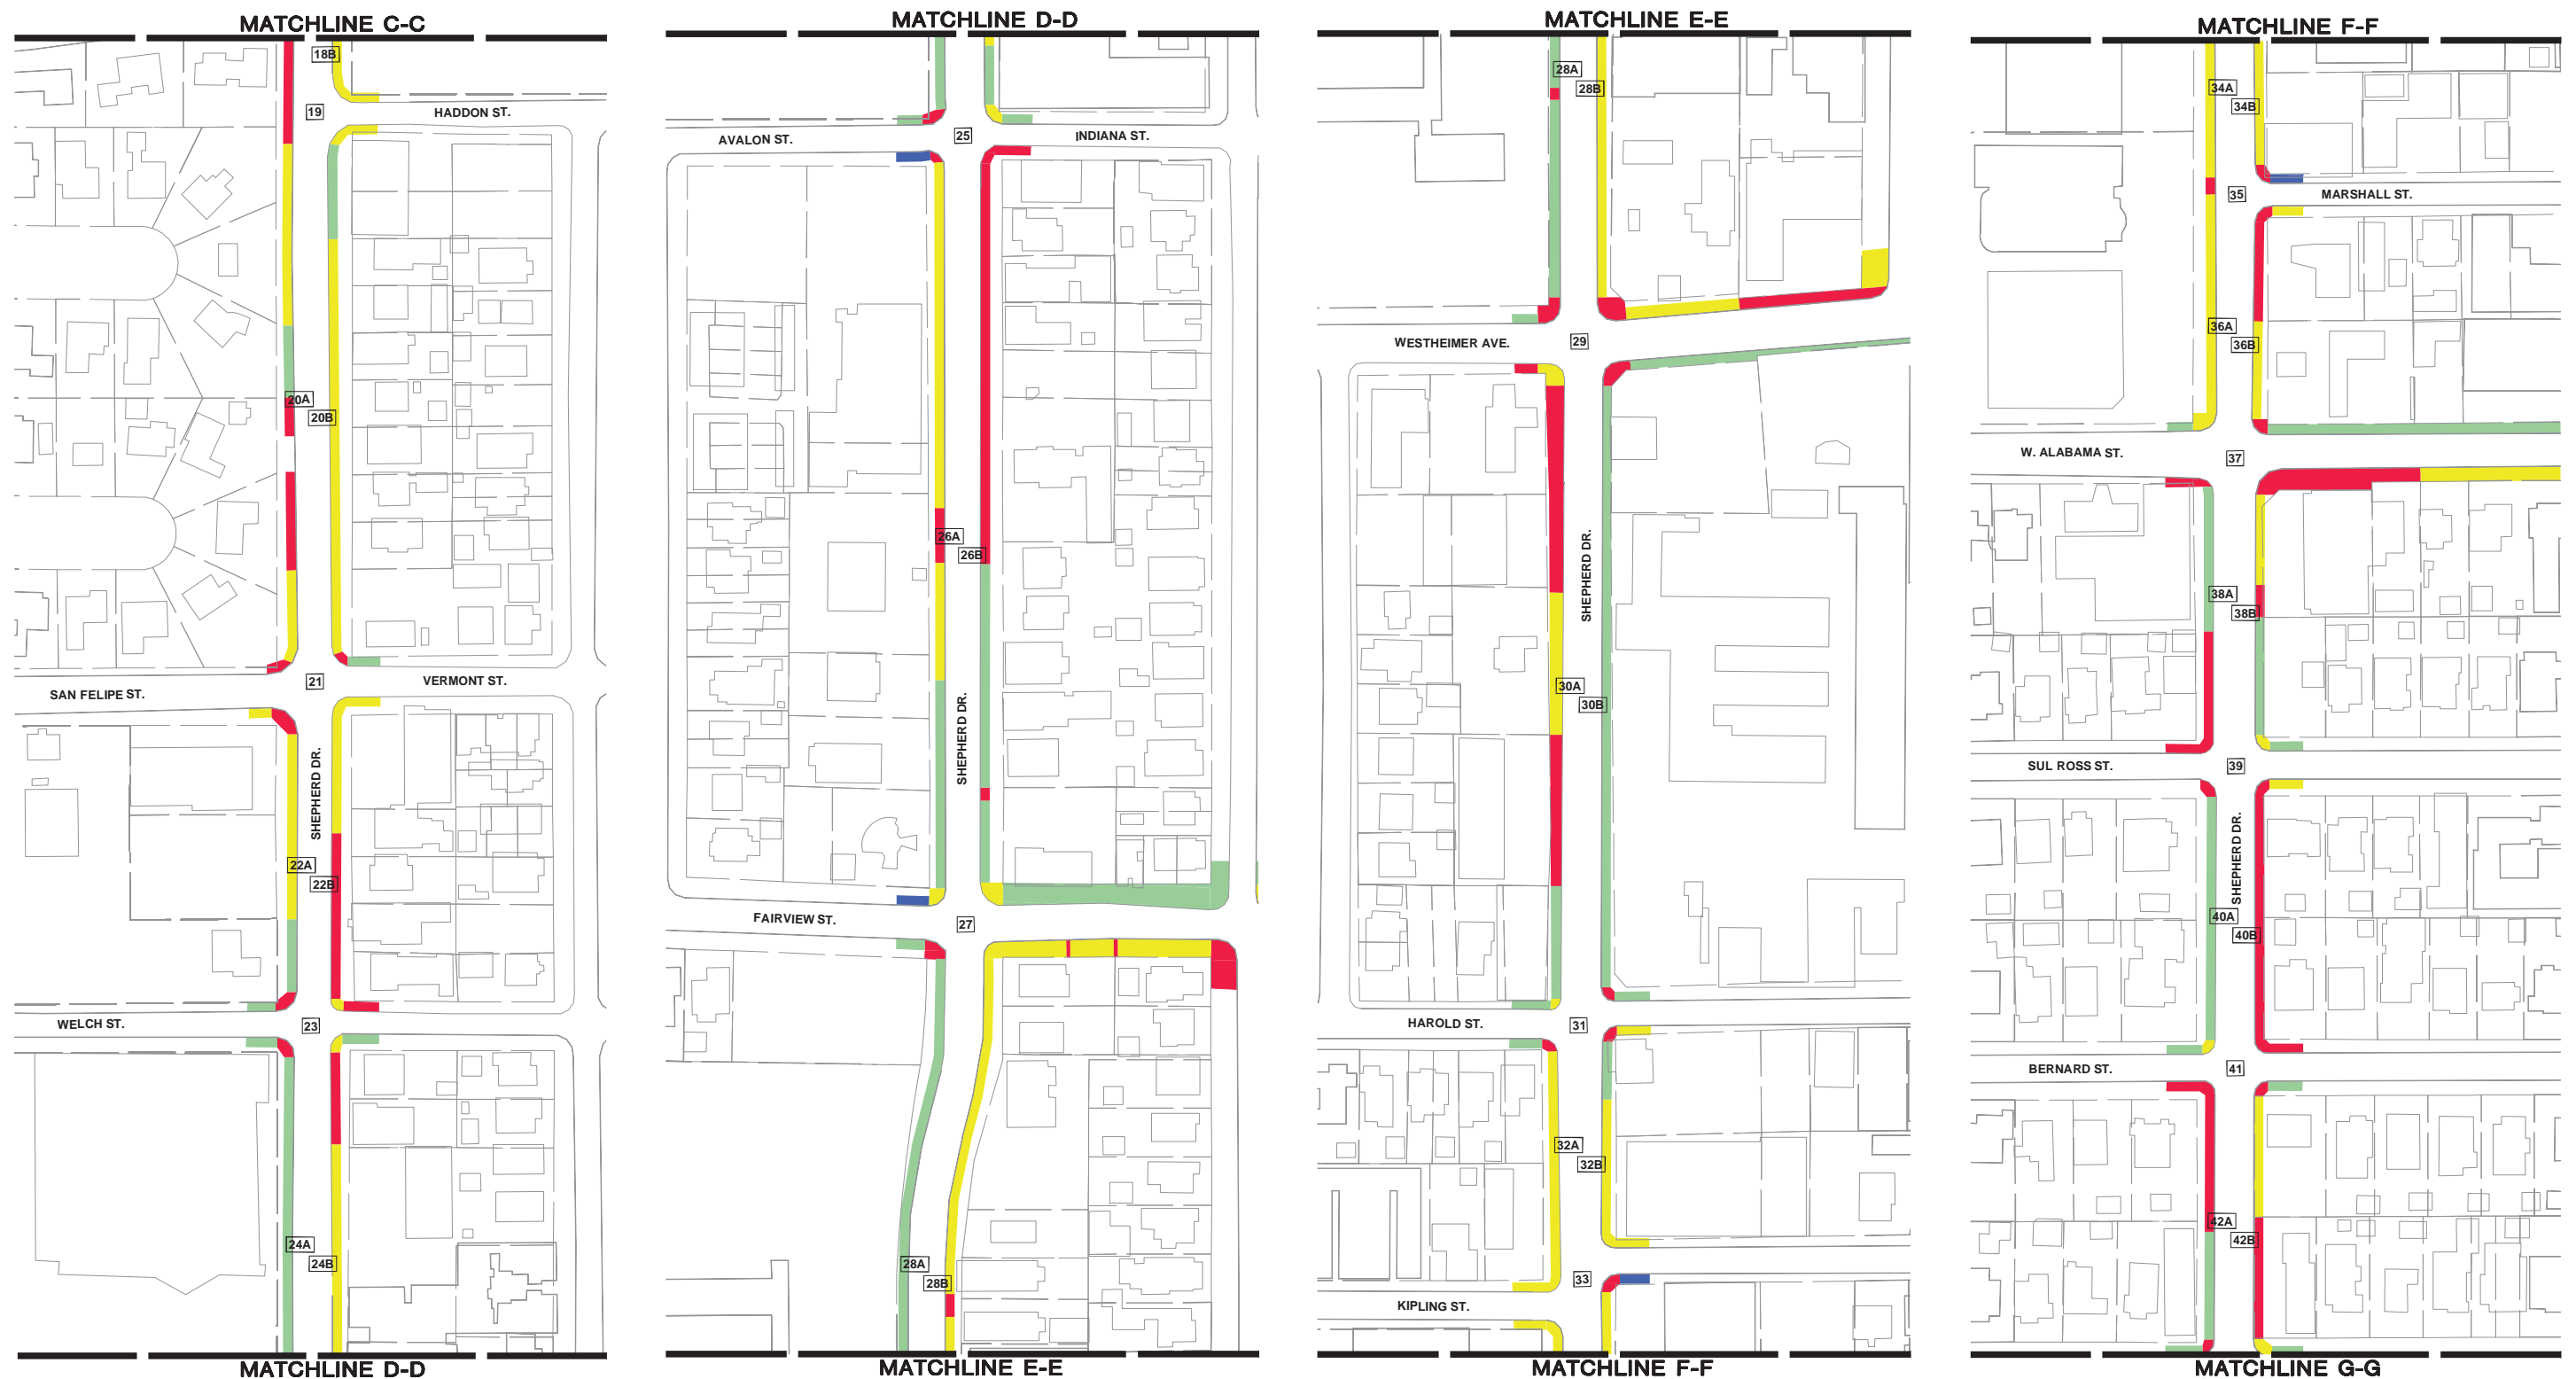
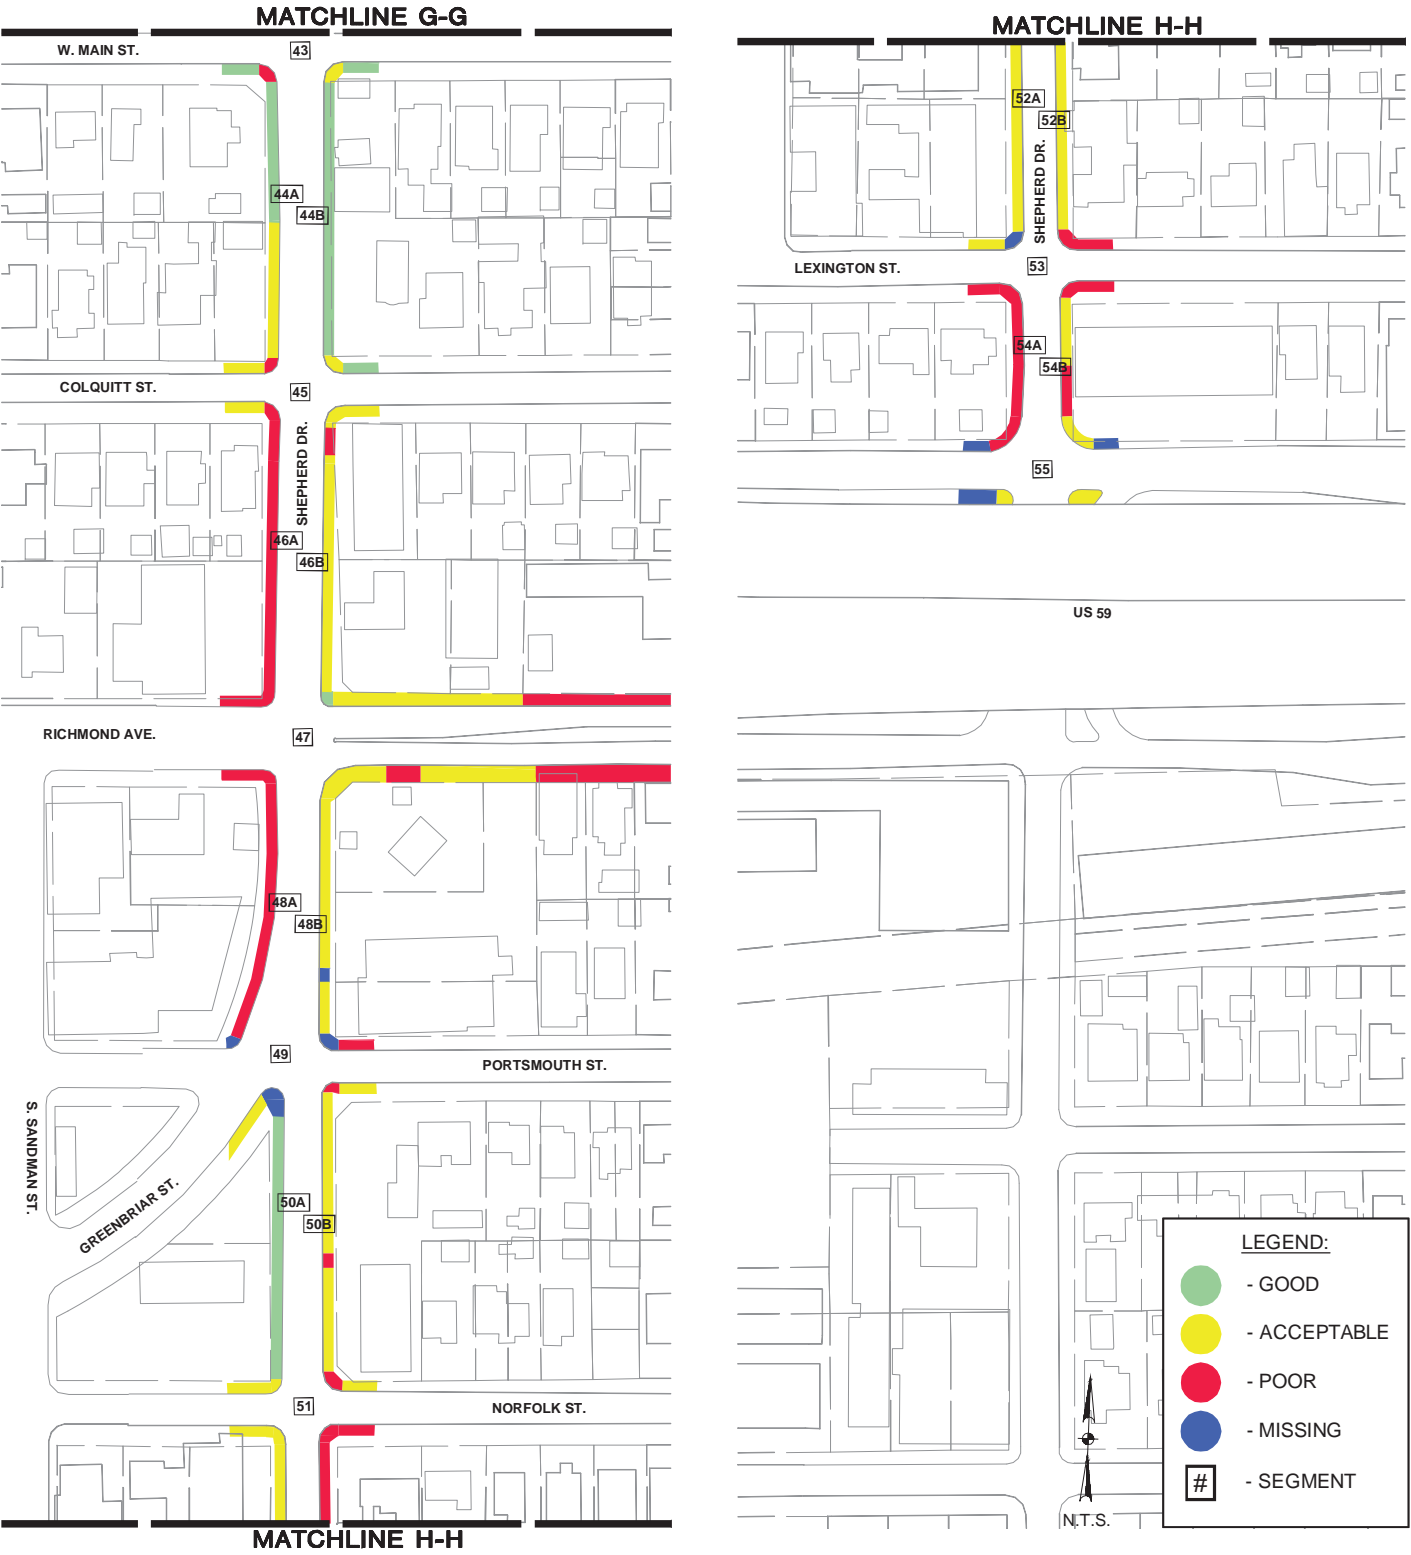
Figure 15-5
Shepherd Drive Pavement and Ramp Conditions

Sidewalks, ramps, and crosswalks on Shepherd between W. Dallas and US 59 were studied by means of visual observation and photos. **Table 15-3** summarizes sidewalk conditions, **Table 15-4** summarizes ramp conditions, and **Table 15-5** summarizes crosswalk conditions along Shepherd. **Figure 15-5** graphically depicts the results of the sidewalk and ramp crosswalk evaluation along Shepherd. Some of the common issues seen with sidewalks were insufficient width, cracking, upheaval, damaged/missing pavers, and/or presence of dirt, grass, and other obstructions. These issues create tripping hazards making it difficult for pedestrians including persons with disabilities to travel on the sidewalks. Issues observed with ramps were unevenness between ramps and pavement, broken ramps, steepness, and/or absence of ramps. Issues observed with crosswalks were absence of crosswalks, worn crosswalk pavement markings, and/or use of non-standard method of crosswalk delineation. **Photos 15-9** through **15-13** illustrate examples of poor sidewalks and ramps which suggest immediate repair/replacement.

- Construct missing ramps and reconstruct existing ramps
- Shepherd at all intersections

▪ Construct missing sidewalk and Reconstruct existing sidewalk

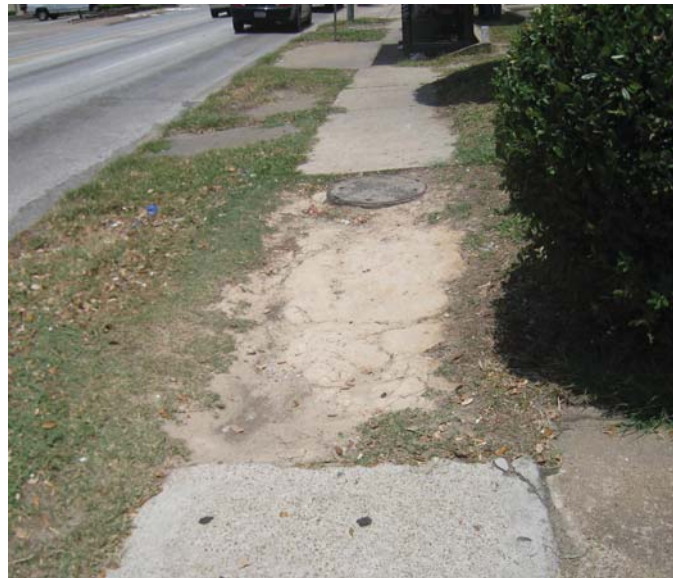
Photo 15-12, Segment 48B
Shepherd between Richmond and Portsmouth
 Missing sidewalk
