COMPREHENSIVE DISTRICT-WIDE MOBILITY STUDY

*An evaluation of pavement condition, pedestrian accessibility,
cut-through traffic, and markings within the Montrose District*

WALTER P MOORE

February 2012

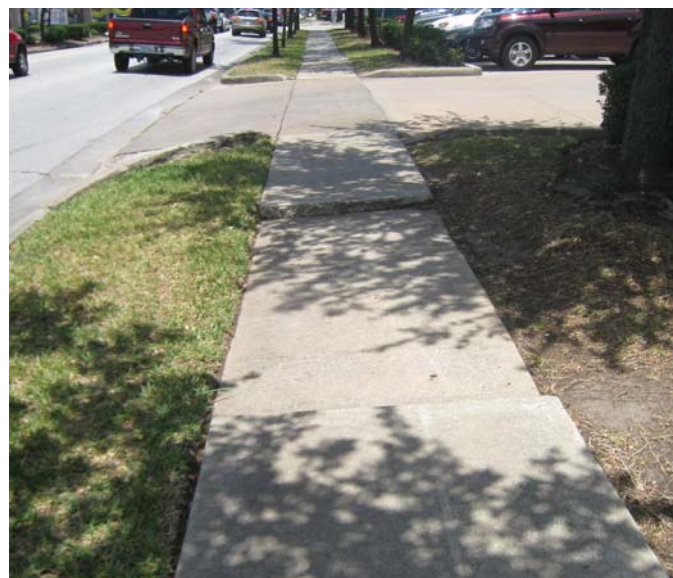
Photo 15-13, Segment 50B
Shepherd between Portsmouth and Norfolk
 One section of sidewalk has settled, creating tripping hazards.

▪ Construct missing sidewalk and Reconstruct existing sidewalk
